DISTRICT 4 ROAD SAFETY AUDIT REPORT

SR-9 (I-95) WORK ZONE

FROM: SR-808 (GLADES ROAD)

TO: CONGRESS AVENUE

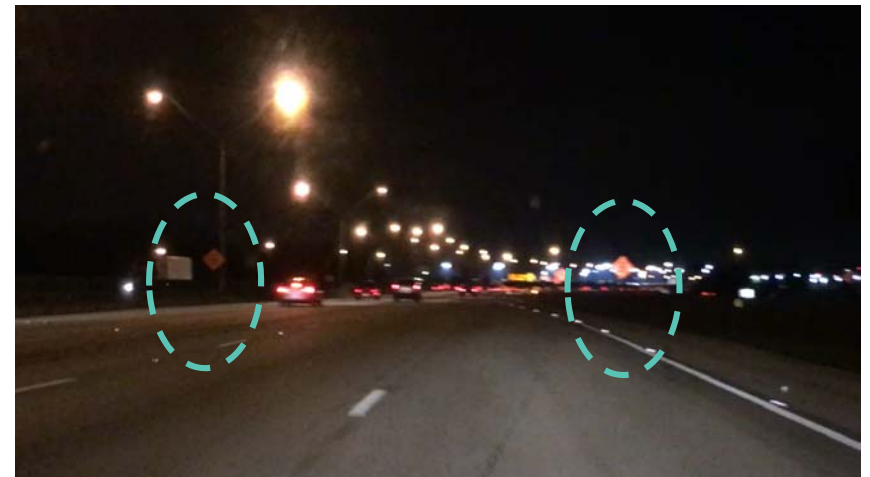
Figure 2: Road Work Signs

The beginning of the work zone is signed with standard 48 in signs, the same signs are used on the Yamato Road on-ramps for drivers entering the work zone in the middle. While the signs clearly denoted the work zone at night from the on-ramps, they appear comparatively small while traveling in the 8-lane section of I-95. **There is an opportunity to more clearly announce the roadwork ahead with larger signs or additional variable message signs in advance or work zone indicating to drivers to KEEP LEFT along I-95.**

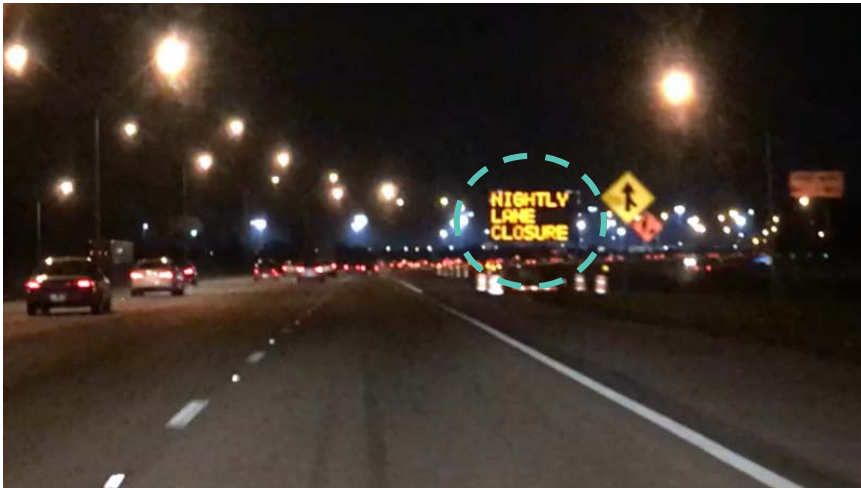
Figure 3: Variable Message Sign

Variable message signs are located along I-95 both northbound and southbound indicating the nightly lane closures between 9:00PM and 5:00AM. During the nighttime review, there was no lane closure northbound as all the work was occurring on the west side of I-95. Increased driver compliance can be achieved by providing real-time information that conveys the conditions of the roadway ahead rather than possible conditions. **Replacing the sign's message to read "Right Lane Closed, Keep Left" will provide positive guidance. An additional variable message sign that reads "Right Lane Closed Ahead 1 Mile" will provide drivers with additional advance notice. Those messages should only be displayed during the times and directions where lane closures are taking place (real-time information).**

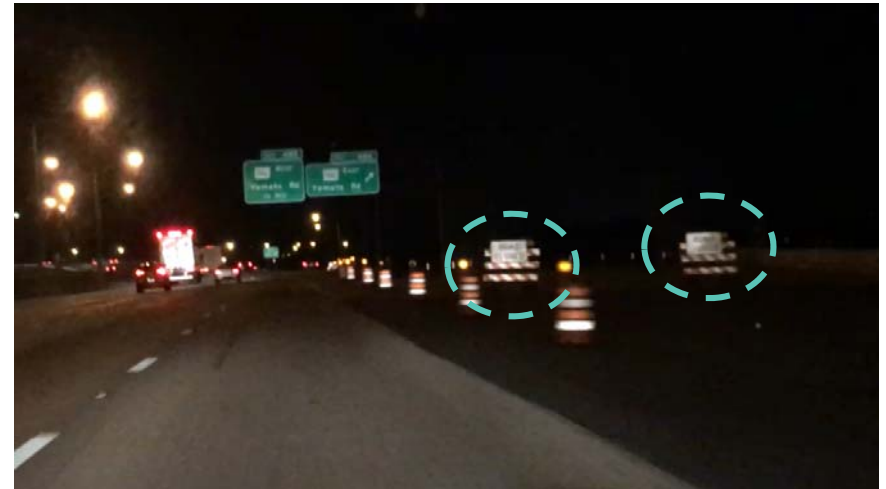
Figure 4: Road Closed at Yamato

Barrels placed along northbound shoulder approaching SR-794 (Yamato Road) in conjunction to ROAD CLOSED signs (denoting that new interchange is not yet open) make it look like the SR-794 off-ramp is closed. **Additional delineation along gore area will more clearly indicate the exit lane.**

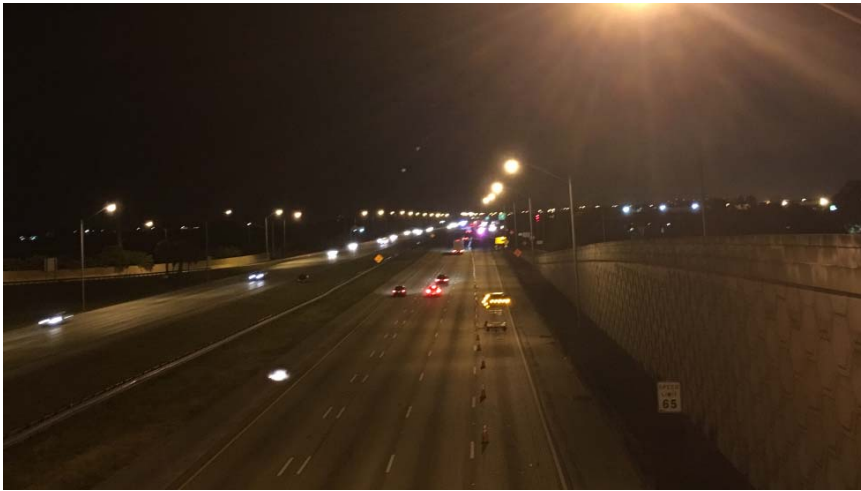
Figure 5: Southbound Lane Closure

Due to paving operation on the southbound shoulder south of Congress Avenue/Peninsula Corp Drive, construction related lane closures on November 9, 2015, began upstream near the influence area of the southbound off-ramp lane drop. Conflicts were observed in this area, particularly when drivers entered southbound from Linton Boulevard. **Limiting the interaction of nightly lane closures and exit lane drops will limit vehicle conflicts.**

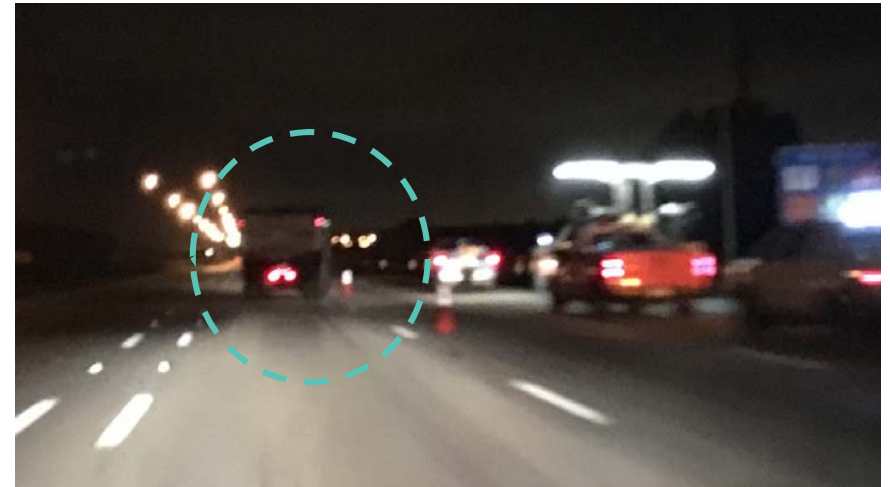
Figure 6: Dump Truck Entering Work Zone

Conflicts were observed for southbound drivers on the outside through lanes of I-95 between through vehicles and the dump trucks delivering asphalt during paving operations. Dump trucks were observed traveling in the outside lane southbound from Congress Avenue/Peninsula Corp Drive; from there drivers turned on the truck's hazard lights, slowed down and entered the work zone between traffic cones. Southbound drivers behind dump trucks were observed braking abruptly and changing lanes, this behavior can lead to sideswipe and rear-end crashes. **These conflicts can be reduced if truck drivers enter the work zone through the shoulder or closed lane from the on-ramp.**

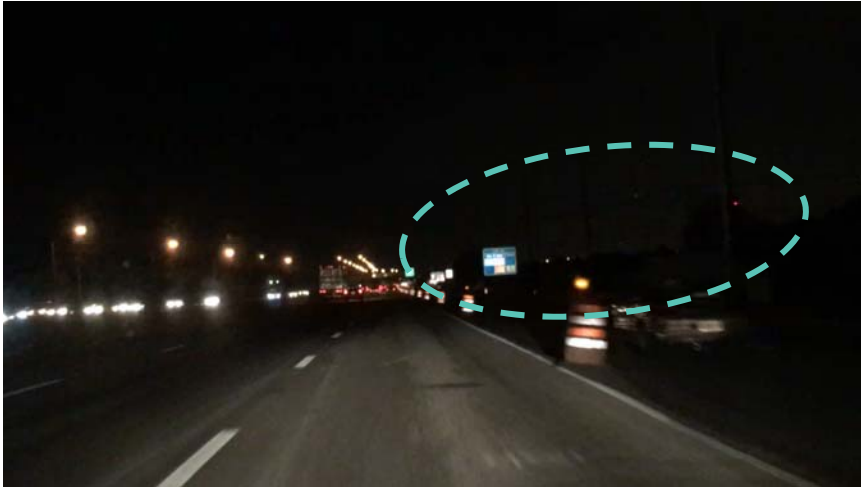
Figure 7: Lighting Section Out

The lighting on the west side of I-95 south of Congress Avenue/Peninsula Corp Drive was out. According to the project manager, the lighting has been relocated due to the lighting and wired; however, a collision disconnected the power on Monday, November 9th, 2015, **the lights will be operational again within 48 hours.**

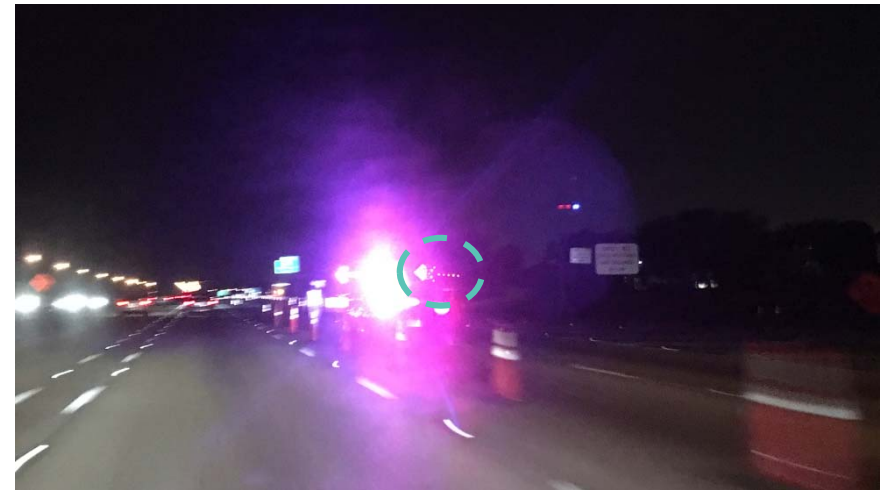
Figure 8: Blinding Police Lights

It was noted during the review that the police cars were placed at times near decision points in a location where the red/blue lights were blinding to oncoming drivers. This was most prominent at the southbound onramp from Congress Avenue/Peninsula Corp Drive for southbound drivers along I-95; a police car was placed near the gore area next to a arrow board (shown in the picture just right of the police lights) in the area where the overhead lighting was out. **Placement of police cruises in advance of conflict points rather than at the conflicts points can reduce driver confusion.**

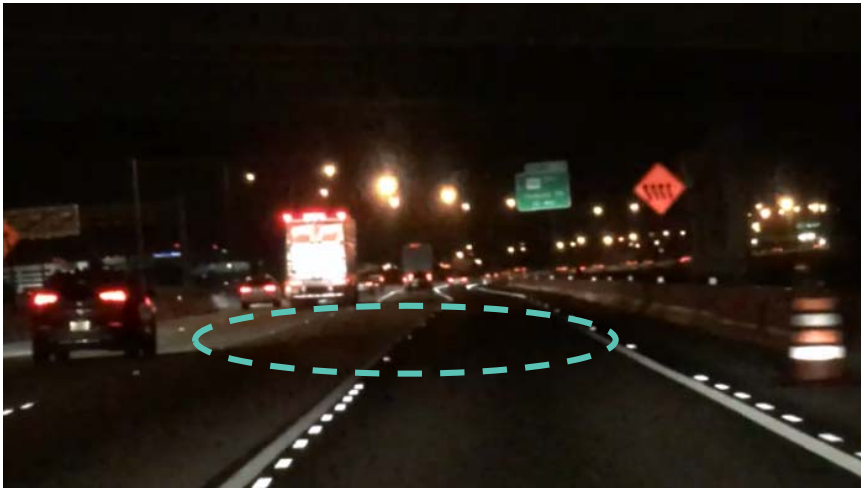
Figure 9: RPMs in Tangent Section

Raised pavement markings (RPMs) through two lane shift transitions are installed to standard. RSA team members noted that the tangent section between lane shifts under the NW 40 Street / Spanish River Boulevard overpass appears shorter than the transitions. It appears to a driver than the RPMs in the tangent area, located in a darker spot under the overpass, are missing. **Continuing RPMs through the tangent area will better delineate the intended travel path.**

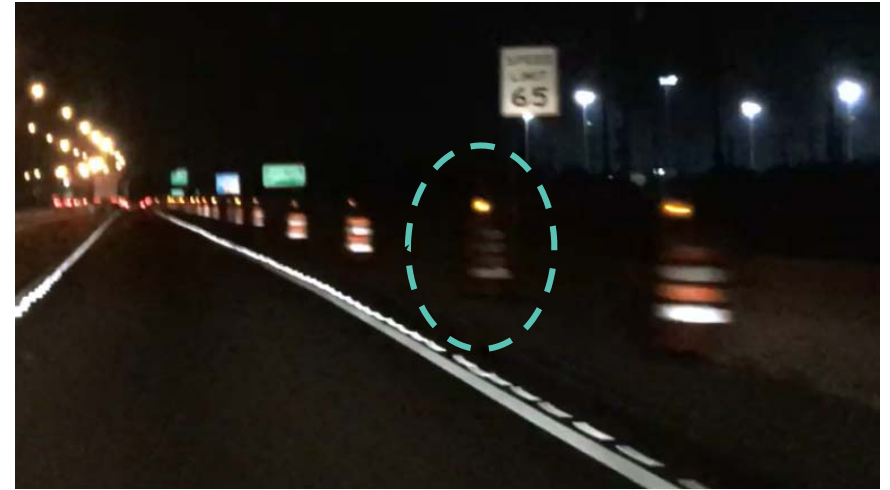
Figure 10: Non Reflective Barrel

Barrels are regularly inspected and marked for replacement when their retro-reflectivity is diminished. **Continued regular inspection and replacement of faded barrels maintains delineation consistent.**

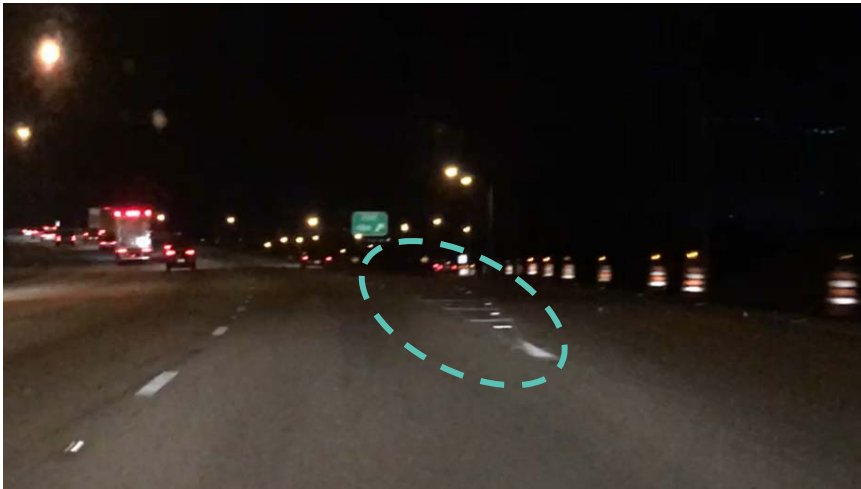
Figure 11: RPMs in Gore Area

The thermoplastic and raised pavement markings were worn / missing in various locations throughout the work zone. This is not a part of the construction; nevertheless, **refurbishing the pavement markings can help guide drivers through the work zone; particularly the shoulder and gore areas.**

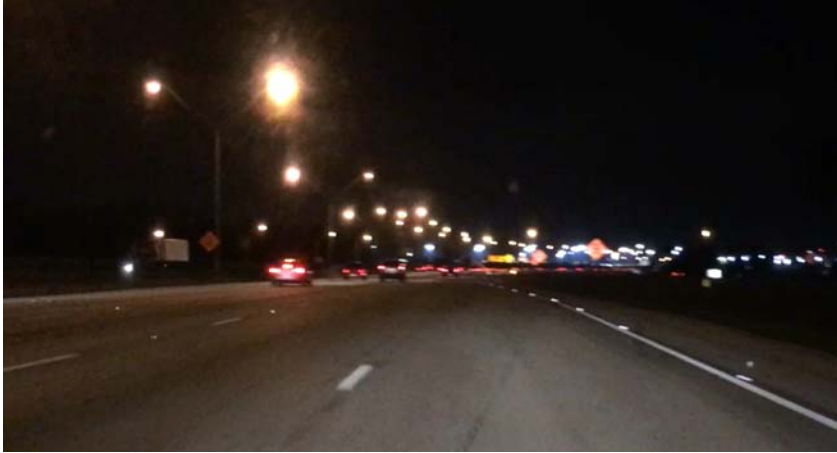
ID	Location Description:	Spot Observation Overview:	Suggestions for Consideration:
01	Approaches to work zone	Standard size work zone signs	Enhance advance signage

The beginning of the work zone is signed with standard 48 in signs, the same signs are used on the Yamato Road on-ramps for drivers entering the work zone in the middle. While the signs clearly denoted the work zone at night from the on-ramps, they appear comparatively small while traveling in the 8-lane section of I-95.

There is an opportunity to more clearly announce the roadwork ahead with larger signs or additional variable message signs in advance or work zone indicating to drivers to KEEP LEFT along I-95.

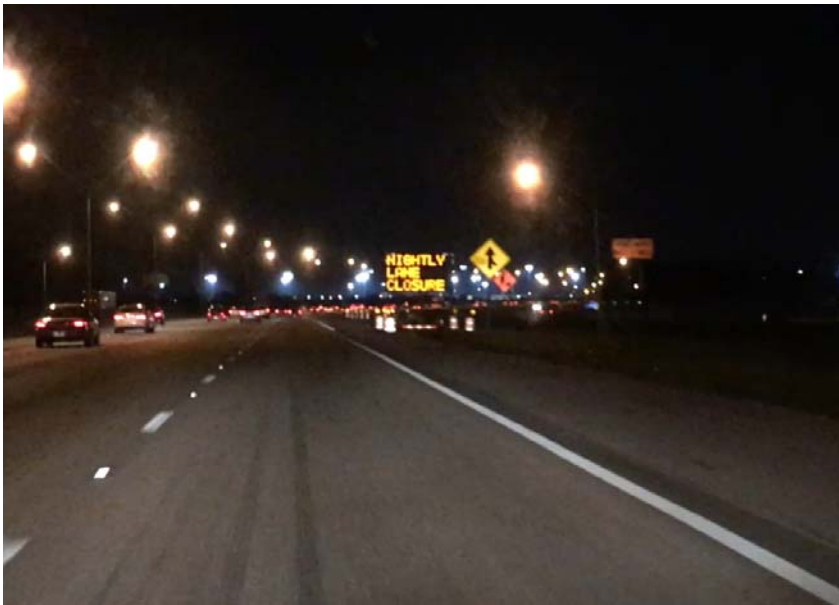
ID	Location Description:	Spot Observation Overview:	Suggestions for Consideration:
02	NIGHTLY LANE CLOSURE signs	Signs indicate lane closures in both directions	Only indicate closures in direction of closure

Variable message signs are located along I-95 both northbound and southbound indicating the nightly lane closures between 9:00PM and 5:00AM. During the nighttime review, there was no lane closure northbound as all the work was occurring on the west side of I-95. Increased driver compliance can be achieved by providing real-time information that conveys the conditions of the roadway ahead rather than possible conditions.

Replacing the sign’s message to read “Right Lane Closed, Keep Left” will provide positive guidance. An additional variable message sign that reads “Right Lane Closed Ahead 1 Mile” will provide drivers with additional advance notice. Those messages should only be displayed during the times and directions where lane closures are taking place (real-time information).

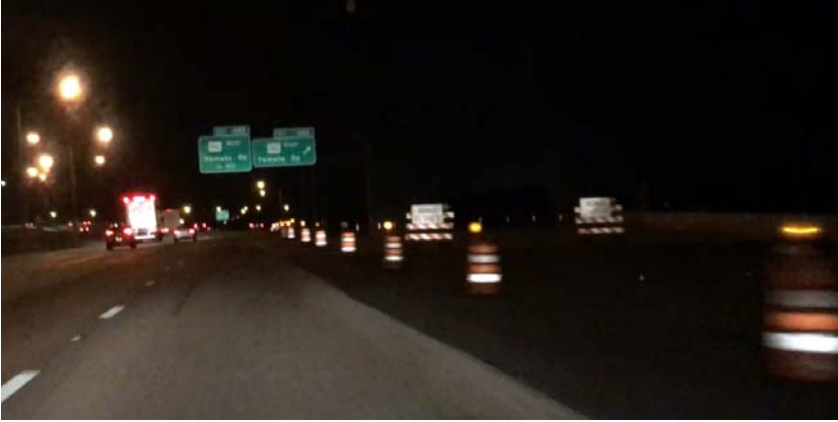
ID	Location Description:	Spot Observation Overview:	Suggestions for Consideration:
03	Northbound approach to Yamato Road	Exit appears to be closed	Delineate gore area

<i>Spot Observation Details:</i>	
		Barrels placed along northbound shoulder approaching SR-794 (Yamato Road) in conjunction to ROAD CLOSED signs (denoting that new interchange is not yet open) make it look like the SR-794 off-ramp is closed.	
		<i>Suggestion Details:</i>	
		Additional delineation along gore area will more clearly indicate the exit lane.	
		<i>Agency:</i>	<i>Improvement Type:</i>
		FDOT	Markings
		<i>Time Frame:</i>	<i>EEE:</i>
		Short-term	Engineering
		<i>Level of Effort:</i>	<i>Comment:</i>
		Low

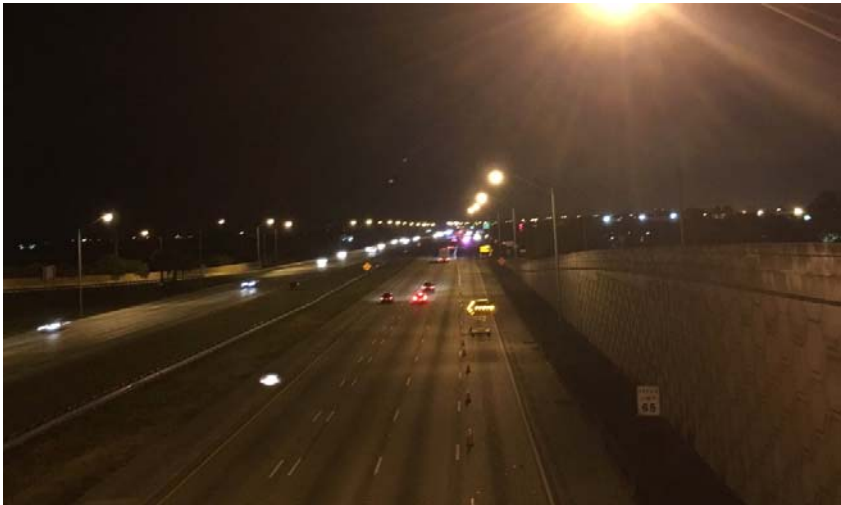
ID	Location Description:	Spot Observation Overview:	Suggestions for Consideration:
04	Southbound approach to Congress Avenue	Conflicts at lane closure where construction lane drops	When possible locate lane closures away from off ramps

Due to paving operation on the southbound shoulder south of Congress Avenue, construction related lane closures on November 9, 2015, began upstream near the influence area of the southbound off-ramp lane drop. Conflicts were observed in this area, particularly when drivers entered southbound from Linton Boulevard.

Limiting the interaction of nightly lane closures and exit lane drops will limit vehicle conflicts.

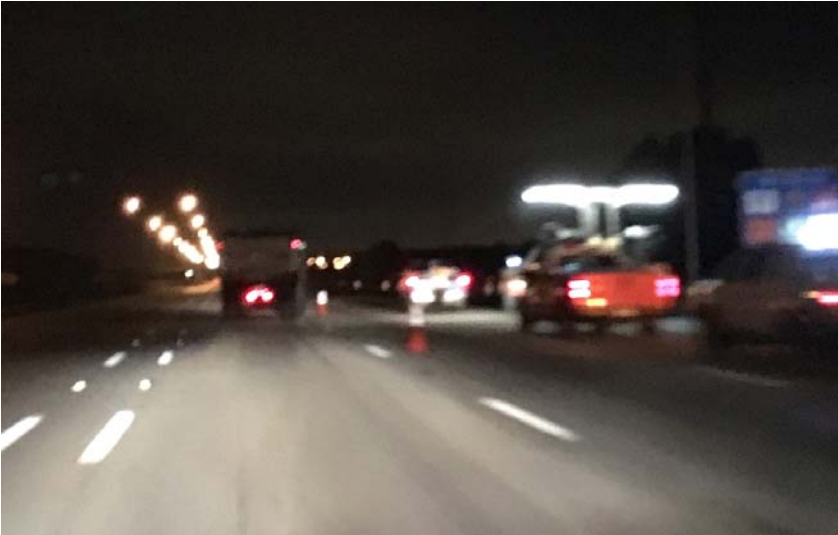
ID	Location Description:	Spot Observation Overview:	Suggestions for Consideration:
05	Southbound at Congress Avenue	Dump trucks creating conflicts in through lanes	Encourage use of shoulder when possible

Spot Observation Details: <p>Conflicts were observed for southbound drivers on the outside through lanes of I-95 between through vehicles and the dump trucks delivering asphalt during paving operations. Dump trucks were observed traveling in the outside lane southbound from Congress Avenue; from there drivers turned on the truck's hazard lights, slowed down and entered the work zone between traffic cones. Southbound drivers behind dump trucks were observed braking abruptly and changing lanes, this behavior can lead sideswipe and rear-end crashes.</p>	
		Suggestion Details: <p>These conflicts can be reduced if truck drivers enter the work zone through the shoulder or closed lane from the on-ramp.</p>

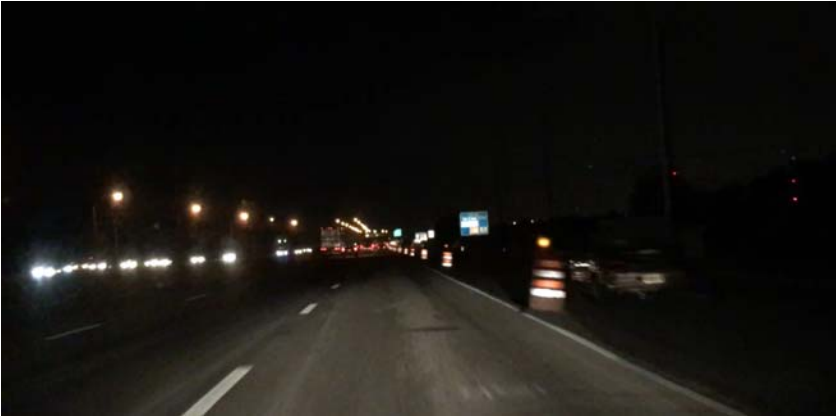
ID	Location Description:	Spot Observation Overview:	Suggestions for Consideration:
06	Lighting southbound at Congress Avenue	Overhead lighting out	Fix lighting section

Spot Observation Details: <p>The lighting on the west side of I-95 south of Congress Avenue was out. According to the project manager, the lighting has been relocated due to the lighting and wired; however, a collision disconnected the power on Monday, November 9th, 2015.</p>	
		Suggestion Details: <p>Ensure that lights will be operational again within 48 hours.</p>	
		Agency: FDOT	Improvement Type: Lighting
		Time Frame: Short-term	EEE: Engineering
		Level of Effort: Low	Comment:

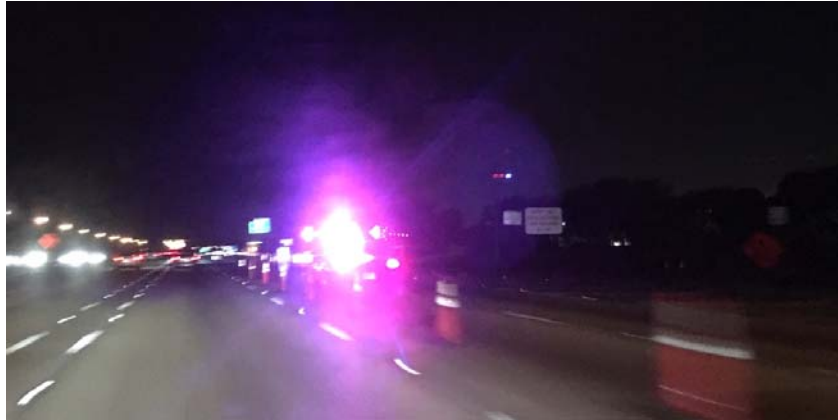
07	Approach to southbound lane closure at Congress Avenue	Police lights blinding	Located off duty police in advance of lane closure
----	--	------------------------	--

It was noted during the review that the police cars were placed at times near decision points in a location where the red/blue lights were blinding to oncoming drivers. This was most prominent at the southbound onramp from Congress Avenue for southbound drivers along I-95; a police car was placed near the gore area next to a variable message board in the area where the overhead lighting was out.

Placement of police cruises in advance of conflict points rather than at the conflicts points can reduce driver confusion.

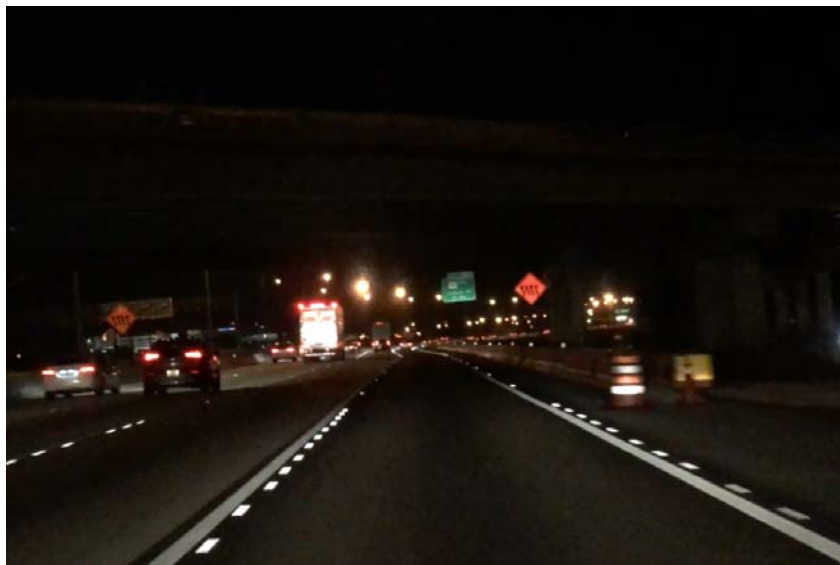
ID	Location Description:	Spot Observation Overview:	Suggestions for Consideration:
08	Tangent section between lane shifts	Short section of RPMs at normal spacing	Extend tight spacing through tangent section

Raised pavement markings (RPMs) through two lane shift transitions are installed to standard. RSA team members noted that the tangent section between lane shifts under the NW 40 Street / Spanish River Boulevard overpass appears shorter than the transitions. It appears to a driver than the RPMs in the tangent area, located in a darker spot under the overpass, are missing.

Continuing RPMs through the tangent area will better delineate the intended travel path.

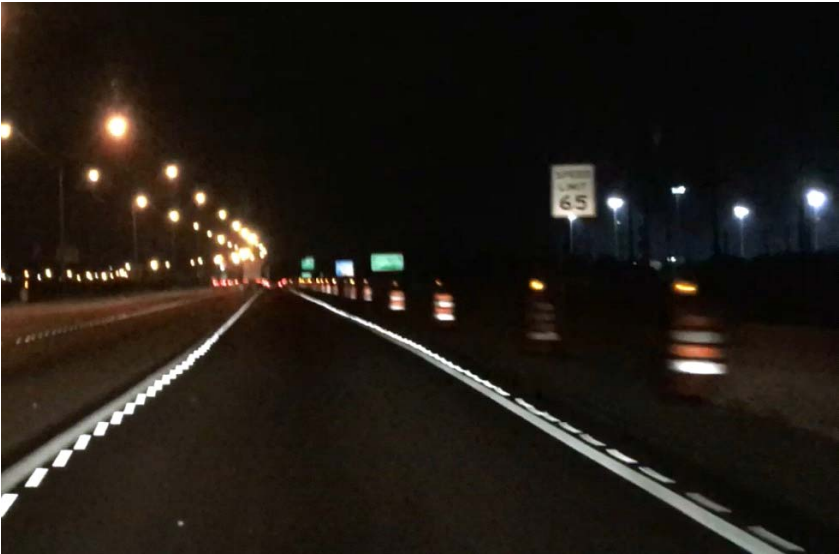
ID	Location Description:	Corridorwide Observation Overview:	Suggestions for Consideration:
C01	Shoulders throughout	Faded barrels	Replace barrels

Barrels are regularly inspected and marked for replacement when their retro-reflectivity is diminished.

Continued regular inspection and replacement of faded barrels maintains delineation consistent.

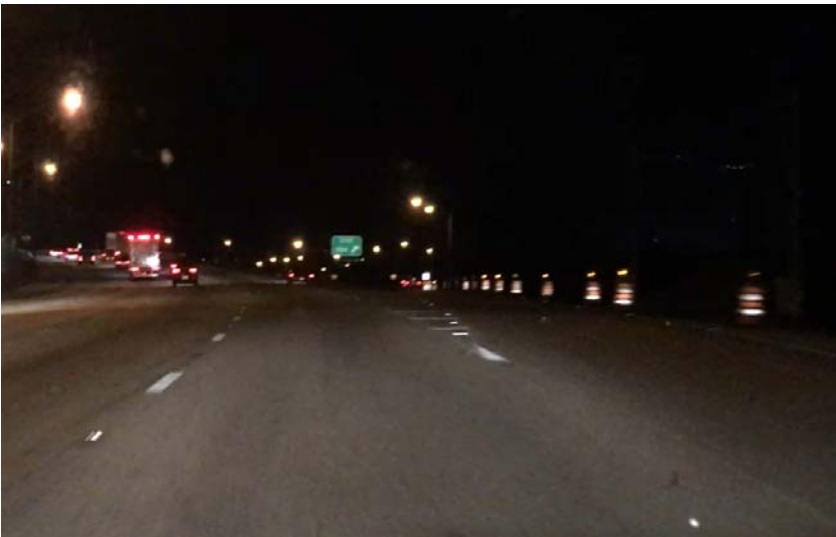
ID	Location Description:	Corridorwide Observation Overview:	Suggestions for Consideration:
C02	Pavement markings throughout	Pavement markings area worn	Refurbish markings where appropriate

The thermoplastic and raised pavement markings (RPMs) were worn / missing in various locations throughout the work zone. This is not a part of the construction.

Refurbishing the pavement markings can help guide drivers through the work zone; particularly the shoulder and gore areas. Consider providing additional RPMs in exit gore areas.
