DISTRICT 4 ROAD SAFETY AUDIT REPORT

SR-704 (OKEECHOBEE BOULEVARD) FROM VISTA PARKWAY/DEALER CENTER TO STAFFORD AVENUE, EXCLUDES MILITARY TRAIL

Study Roadway: SR-704 (Okeechobee Boulevard) from
Vista Parkway/Dealer Center to Stafford Avenue,
excludes Military Trail

Project Location: West Palm Beach, Palm Beach County

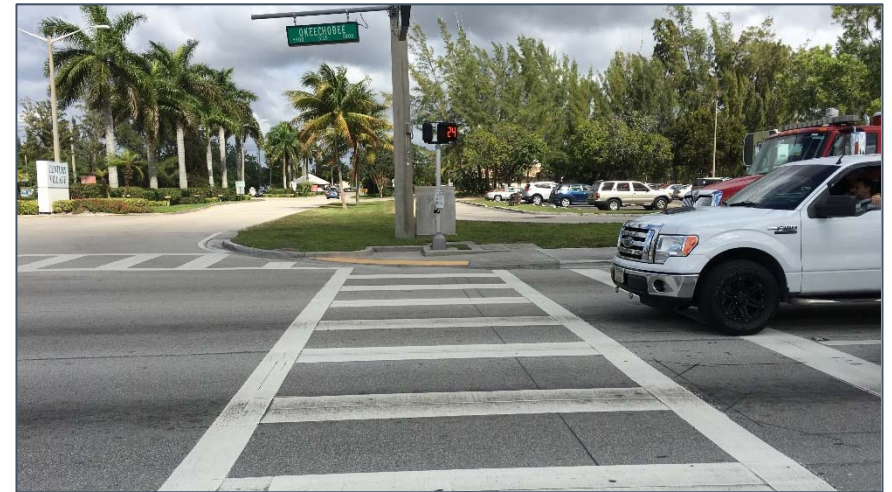
Figure 14: Special Emphasis Crosswalks at West Drive

Due to the number of pedestrian crashes near and around signalized intersections, **provide special emphasis crosswalk markings at all signalized crossings.**

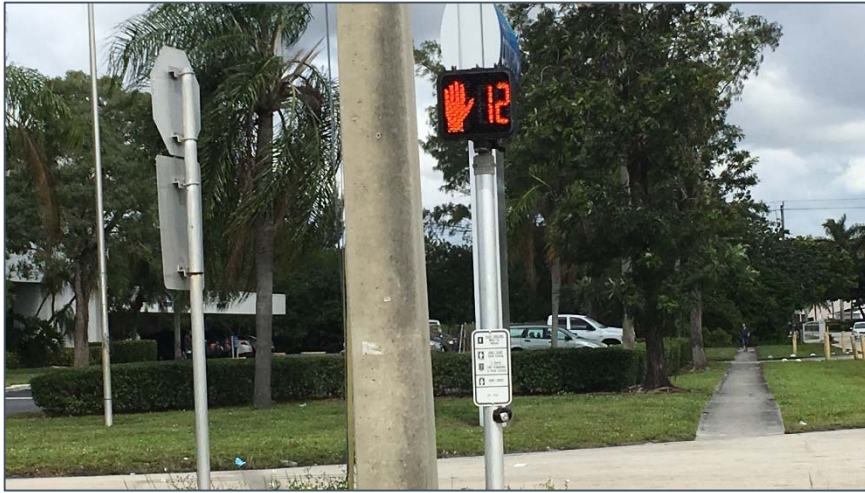
Figure 17: Countdown Pedestrian Indication

The team noted that the time provided by countdown pedestrian heads was not adequate for crossing. Observed countdown timings for the “DO NOT WALK” phase are summarized in Table 7.

It is recommended to modify or extend the countdown timings to be equal or greater than the calculated countdown times shown in Table 8.

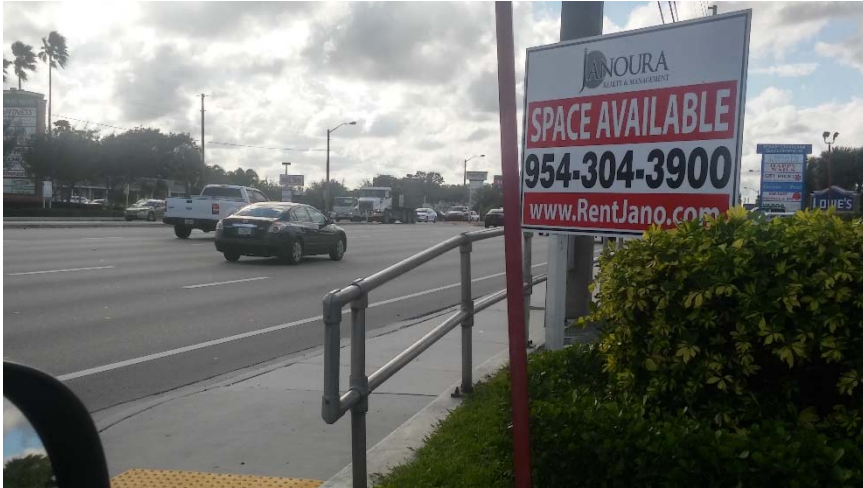
Figure 19: Driveway Sight Obstructions

Visibility was limited at driveways, as signs, bushes, and other objects obstruct the visibility of the sidewalk (see Figure 19).

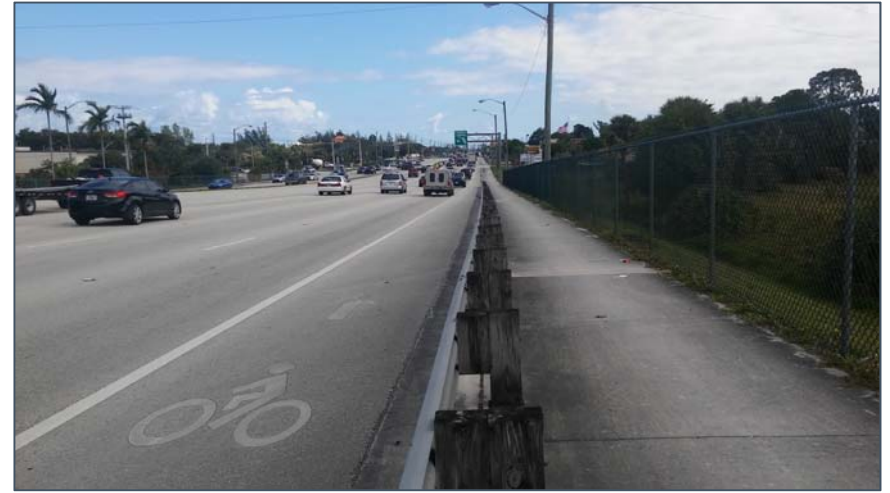
Figure 20: Existing Bike Lanes along West Side of Corridor

Marked bicycle lanes are located along SR-704 (Okeechobee Boulevard) from west of the corridor and ending at the Turnpike/College Plaza. The remainder of the corridor has 2–4-ft shoulders (with the exception of a 600-ft section along westbound traffic at the bridge just west of the Turnpike) and key-hole striping at driveways/cross-streets/right-turn lanes.

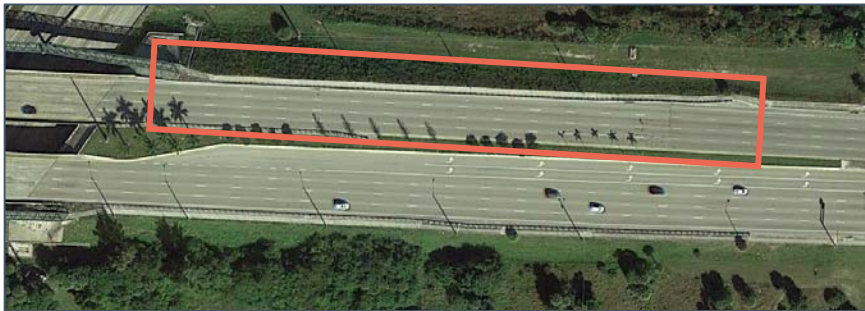
Figure 21: Westbound Overpass Approach Aerial

The westbound bike lane narrows for approximately 600 ft along the SR-704 (Okeechobee Boulevard) overpass over Florida’s Turnpike (see Figure 21).

Per FDOT, 14-ft lanes or wider are wide enough to share between bicyclists and vehicles; this location has a 10-ft outside lane. It is recommended that the **“SHARE THE ROAD” sign be removed at this location.**

Per 9B.06 of the MUTCD, with the exception of limited-access roadways, every travel lane is also a bikeway. Bicyclists may legally take the lane without special signs or markings needed where travel lanes are too narrow for bicyclists and motor vehicles to operate side by side. **Consider providing R4-11 (“BICYCLISTS MAY USE FULL LANE”) signs.**

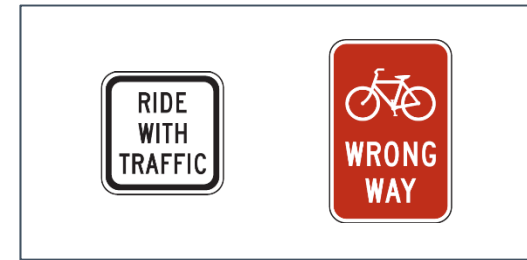
Figure 23: MUTCD “RIDE WITH TRAFFIC” (R9-3Cp) and “BICYCLES WRONG WAY” (R5-1b) Signs

Ten bicycle crashes were the result of bicyclists traveling contraflow on the sidewalk or bike lanes along the SR-704 (Okeechobee Boulevard). This crash type is typically the result of drivers looking left for adequate gaps in traffic upstream and not expecting approaching bicycle traffic from the sidewalks/shoulders from the right. To encourage bicyclists to travel with traffic, **install R9-3Cp (“RIDE WITH TRAFFIC”) and R5-1b (“BICYCLES WRONG WAY”) signs**, as shown in Figure 23.

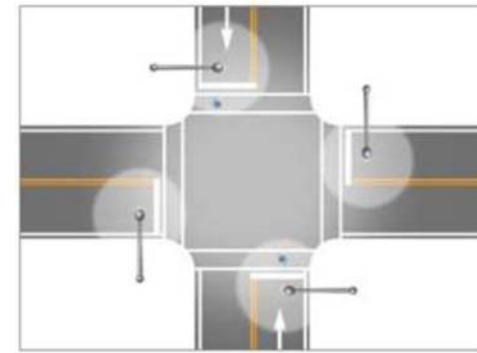
Figure 29: Intersection Lighting Layout Design

Figure 29 provides an example of preferred lighting locations. Currently, the FDOT Central Office is working to develop standards for crosswalk luminance which, once finalized, can be used to design lighting enhancements where needed.

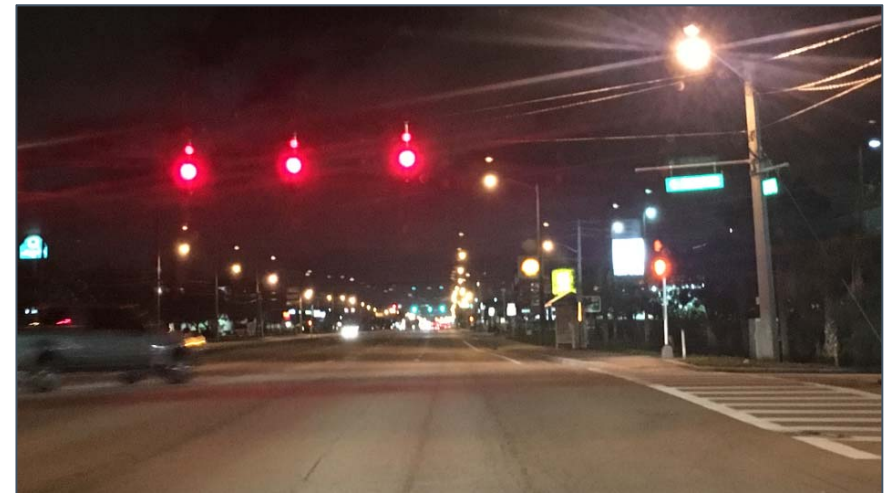
Figure 30: SR-704 (Okeechobee Boulevard) during Night Observations

Generally, lighting along SR-704 (Okeechobee Boulevard) is spaced at approximately 180-200 ft. 293 (23%) of the overall 1,295 crashes occurred during nighttime conditions. As shown Figure 30, during night reviews, most of the corridor and intersection quadrants appeared to be well-lit.

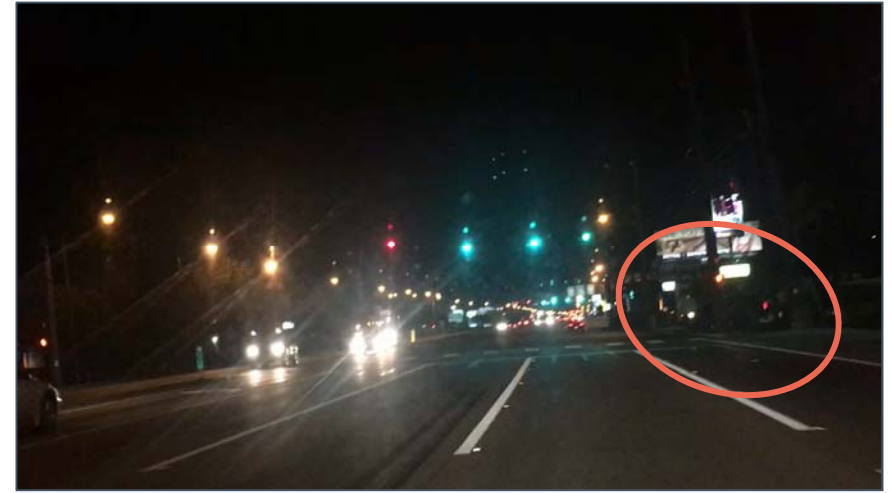
Figure 32: Biscayne Boulevard/Cross County Plaza Looking West

Quadrant lighting was identified at all other intersections, with the exception of SR-704 (Okeechobee Boulevard) at Cross County/Biscayne Boulevard. At this intersection there is lighting only on the southwest quadrant of the intersection (see Figure 32) and the north side appeared darker. A nighttime bicycle crash occurred at this intersection within the crosswalk on the east side. As a long-term improvement, **consider installing additional lighting along the remaining three corners of the intersection.**

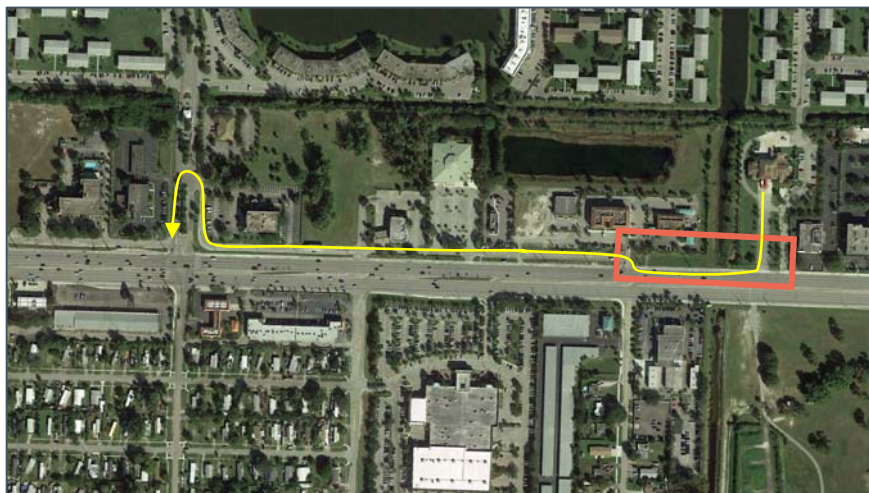
Figure 33: Existing Emergency Route to Bypass Congestion

According to Lieutenant Kyle Ventry of Palm Beach County Fire Rescue Station 23, emergency vehicles use the frontage road just north of SR-704 (Okeechobee Boulevard) to bypass congestion. To save on response times, Lieutenant Ventry requests **the frontage road be extended east and connect to the fire station driveway.**

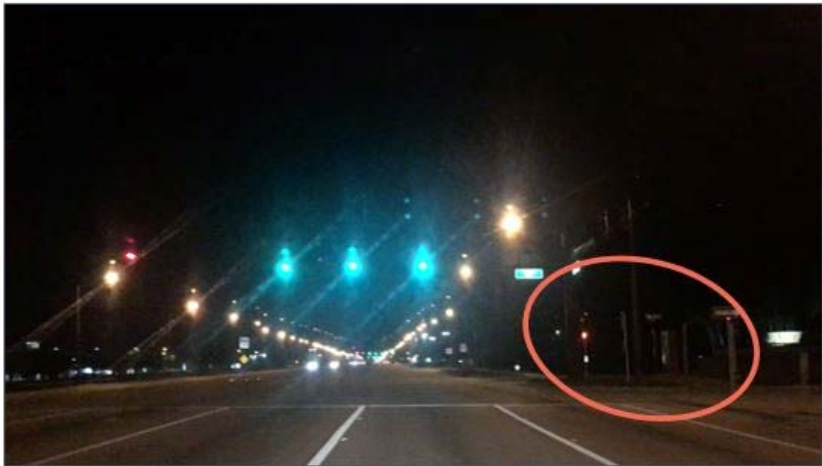
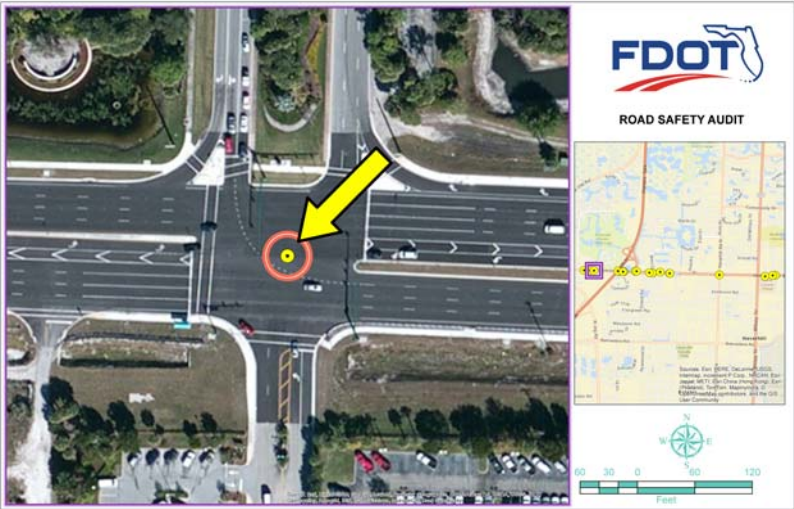
ID	Location Description:	Spot Observation Overview:	Suggestions for Consideration:
01	North side of SR-704 (Okeechobee Boulevard) at Vista Parkway	Dark spot along wide median	Provide additional lighting

Generally, lighting along SR-704 (Okeechobee Boulevard) is spaced at approximately 180-200 ft. 293 (23%) of the overall 1,295 crashes occurred during nighttime conditions. During night reviews, most of the corridor and intersection quadrants appeared to be well-lit.

In light of the nighttime pedestrian crash history, evaluate the lighting level at the north quadrant of Vista Parkway and enhance the lighting if illumination levels are found to be low.

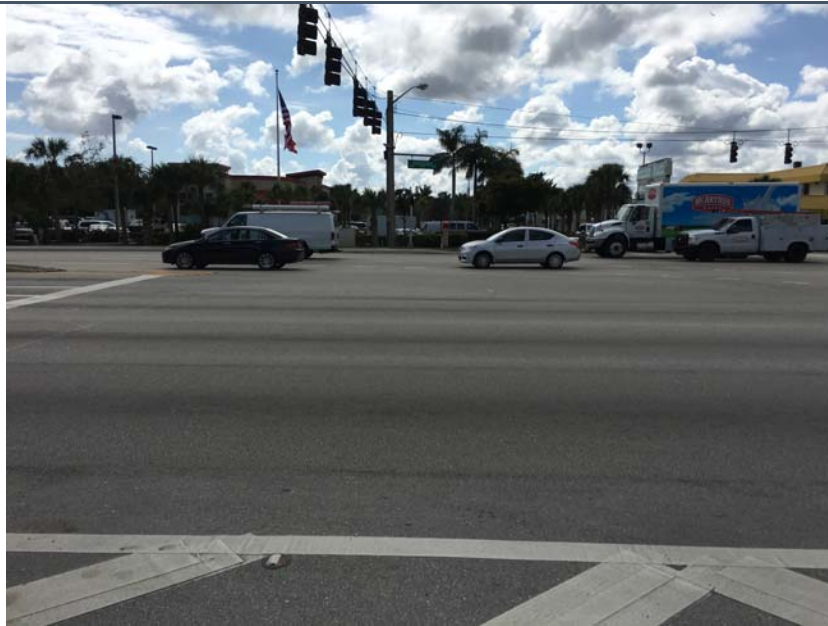
ID	Location Description:	Spot Observation Overview:	Suggestions for Consideration:
02	Crossings at signalized intersections	Three signalized intersections have protected crossings on three of four legs	Provide pedestrian features on all signalized intersection legs

The RSA team noted that three signalized intersections have protected crossings on three of four legs, the three intersections are:

As a long-term improvement, encourage pedestrians to use protected signalized crossings by providing pedestrian features on the missing leg at the aforementioned three locations.

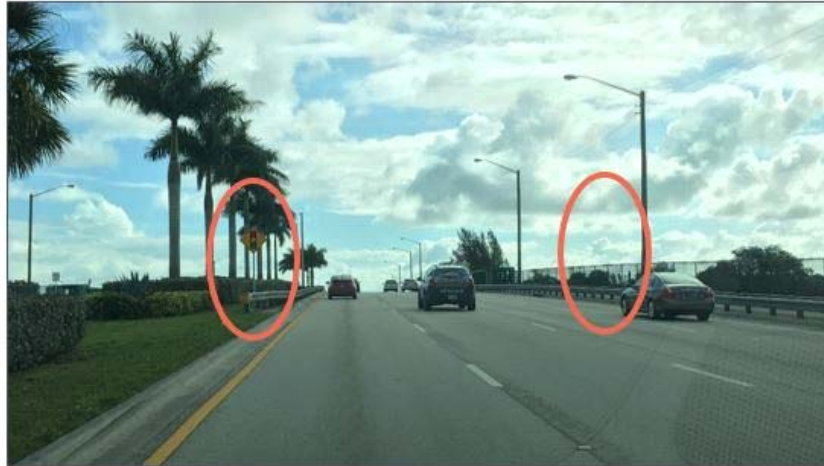
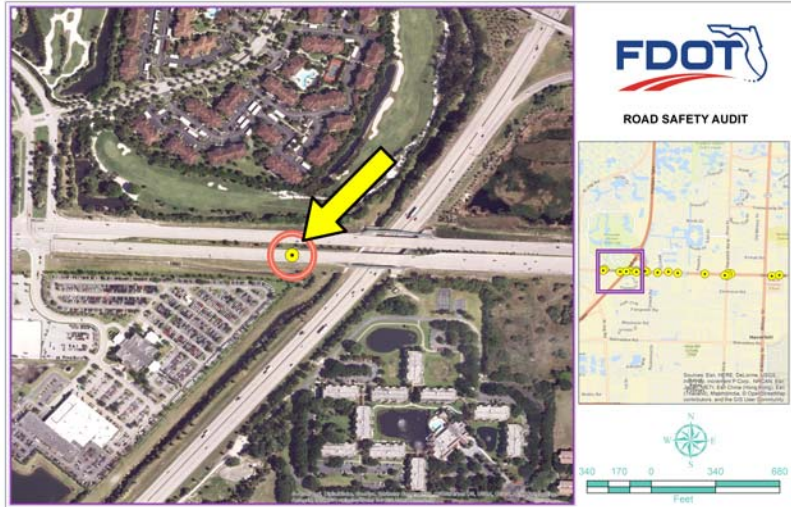
ID	Location Description:	Spot Observation Overview:	Suggestions for Consideration:
03	Florida Turnpike eastbound approach	Single signal ahead warning along multilane road	Provide additional "SIGNAL AHEAD" signs

Rear-end and sideswipe crashes were identified on approach to the Turnpike Access/College Plaza signal. A single SIGNAL AHEAD warning sign is provided in the median on the north side of SR-704 (Okeechobee Boulevard) eastbound. It was noted during the sight visit that due to the number of through lanes, a large vehicle can block the view of the existing warning sign.

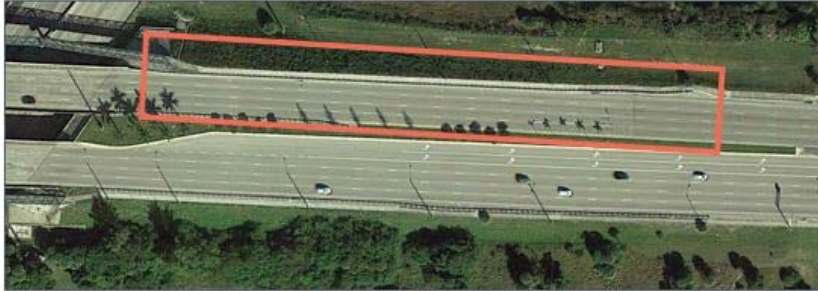
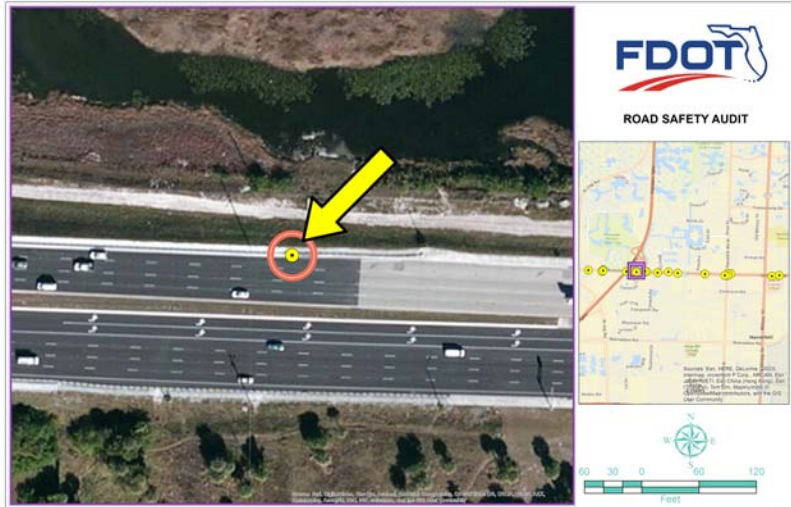
ID	Location Description:	Spot Observation Overview:	Suggestions for Consideration:
04	Bike lane along SR-704 (Okeechobee Blvd)	Bike lane narrows along overpass	Evaluate the feasibility of providing a continuous bike lane

Spot Observation Details:

The westbound bike lane along SR-704 (Okeechobee Boulevard) narrows for approximately 600 feet along the overpass over Florida's Turnpike.

In the short-term, provide a curb cut and ramp east of the guardrail to provide a choice for cyclists to cross along the pedestrian overpass in lieu of traversing along through lanes with vehicles. Consider striping a Bike Symbol on the ramp and providing R9-3/R9-3a (NO PEDESTRIAN CROSSING) signs to discourage pedestrians from using the ramp and leaving the sidewalk. Typically fast-moving cyclists are not recommended to use sidewalks as motorists are not expecting them; however, along this bridge there are no vehicular conflict points, there are minimal pedestrians, and the sidewalk width is approximately 8-ft wide.

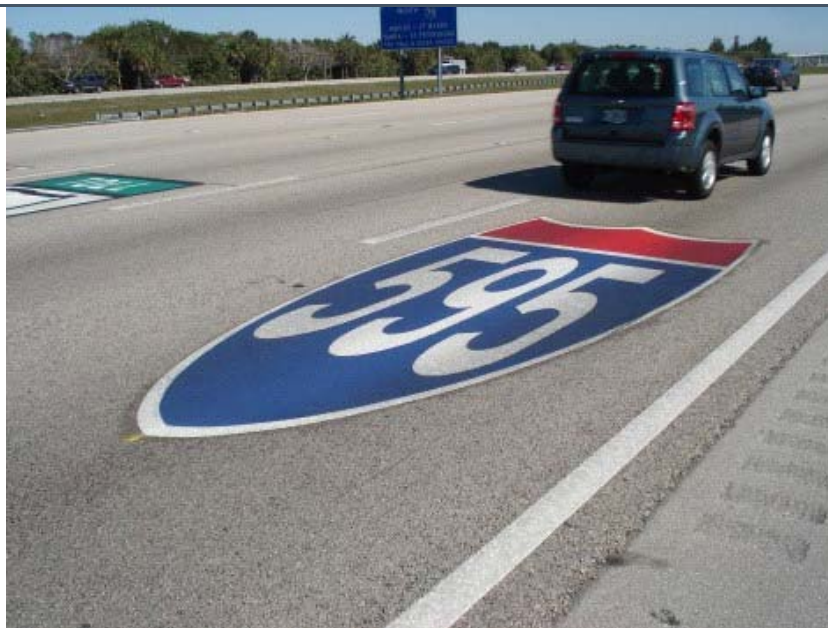
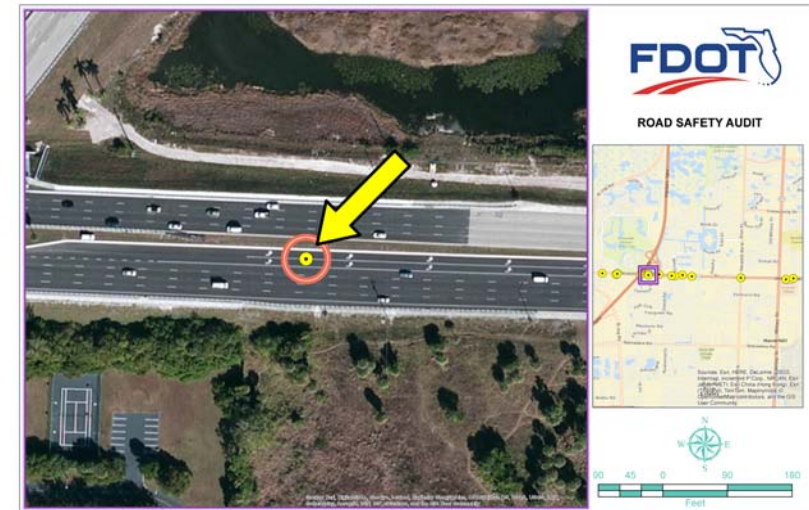
ID	Location Description:	Spot Observation Overview:	Suggestions for Consideration:
05	Florida Turnpike	Both northbound and southbound on-ramps are on the north side of SR-704 (Okeechobee Boulevard)	Add "Turnpike Left Lanes" and "Turnpike Right Lanes" signs

Spot Observation Details:

The Turnpike interchange is located east of the overpass on the north side of SR-704 (Okeechobee Boulevard); all on/off-ramps are on the north side of SR-704 (Okeechobee Boulevard).

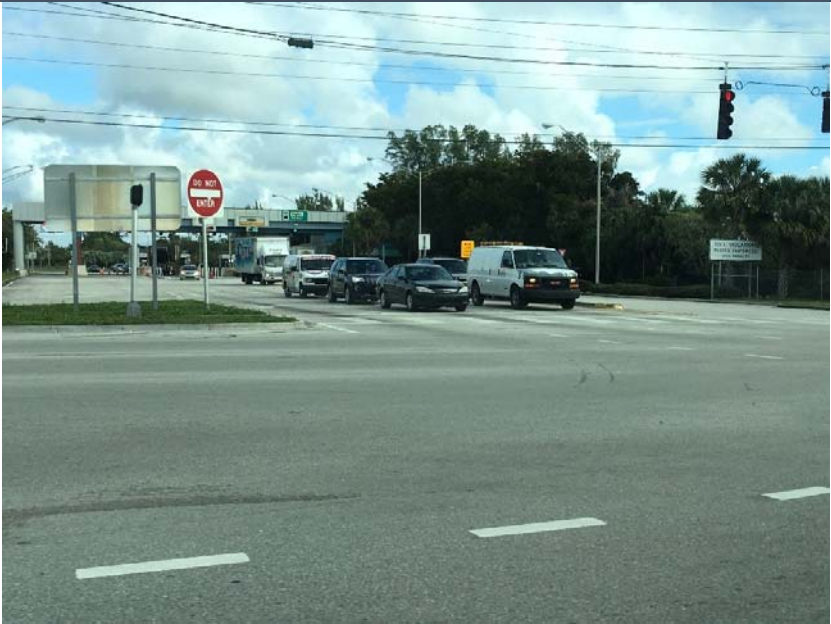
ID	Location Description:	Spot Observation Overview:	Suggestions for Consideration:
06	Florida Turnpike	All four off-ramps and on-ramps to and from the Turnpike are located on the north side of SR-704 (Okeechobee Boulevard).	Extend the inside yellow edge-line.

Spot Observation Details:

All off-ramps and on-ramps to and from the Turnpike are located on the north side of SR-704 (Okeechobee Boulevard); at night, particularly if there are no southbound drivers, an eastbound driver turning left from the inside left-turn lane can turn too tightly into the southbound lanes.

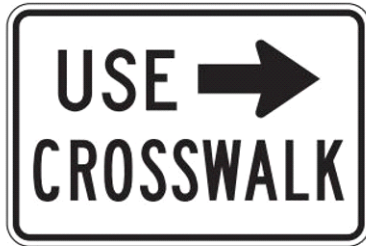
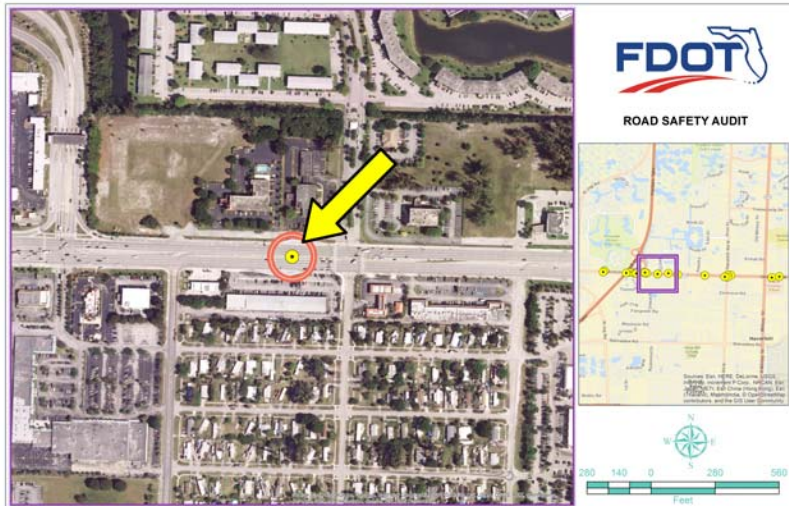
ID	Location Description:	Spot Observation Overview:	Suggestions for Consideration:
07	Various signalized intersection approaches	Pedestrians crossing mid-block at bus stops	Install "USE CROSSWALK" signs

The RSA team observed pedestrians crossing mid-block along SR-704 (Okeechobee Boulevard) throughout the study area near bus stops. Crashes have been reported around bus stops. A number of crossings also were observed at signalized intersection influence areas.

Note that these signs already have been approved and installed at SR-809 (Military Trail) as part of a July 2015 pedestrian safety study; the signs inclusion at other locations would make the SR-809 (Military Trail) recommendations a systemic improvement.

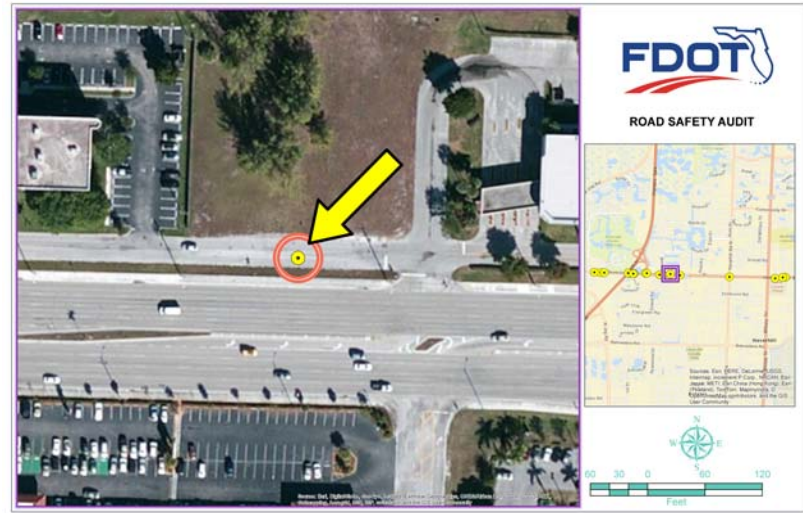
ID	Location Description:	Spot Observation Overview:	Suggestions for Consideration:
08	Frontage road just north of SR-704 (Okeechobee Boulevard)	Emergency vehicles use the frontage road	Connect frontage road to driveway

Spot Observation Details:

According to Lieutenant Kyle Ventry of Palm Beach County Fire Rescue Station 23, emergency vehicles use the frontage road just north of SR-704 (Okeechobee Boulevard) to bypass congestion along westbound SR-704.

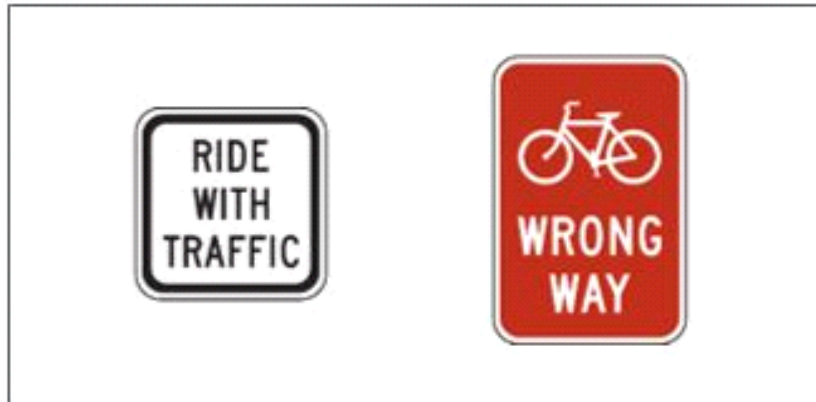
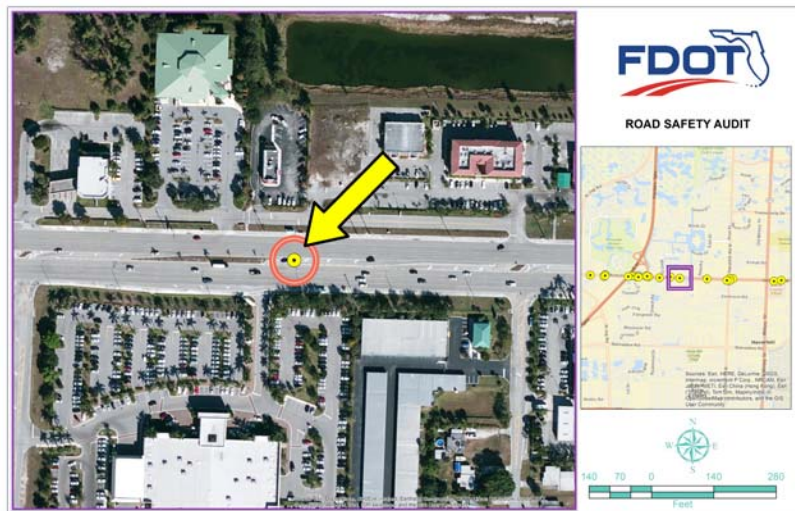
ID	Location Description:	Spot Observation Overview:	Suggestions for Consideration:
09	SR-704 (Okeechobee Blvd)	Bicycle crashes traveling contraflow on the sidewalk or bike lanes	Add "Ride with Traffic" and "Bicycles Wrong Way" signs

Spot Observation Details:

Ten bicycle crashes were the result of bicyclists traveling contraflow on the sidewalk or bike lanes along the SR-704 (Okeechobee Boulevard).

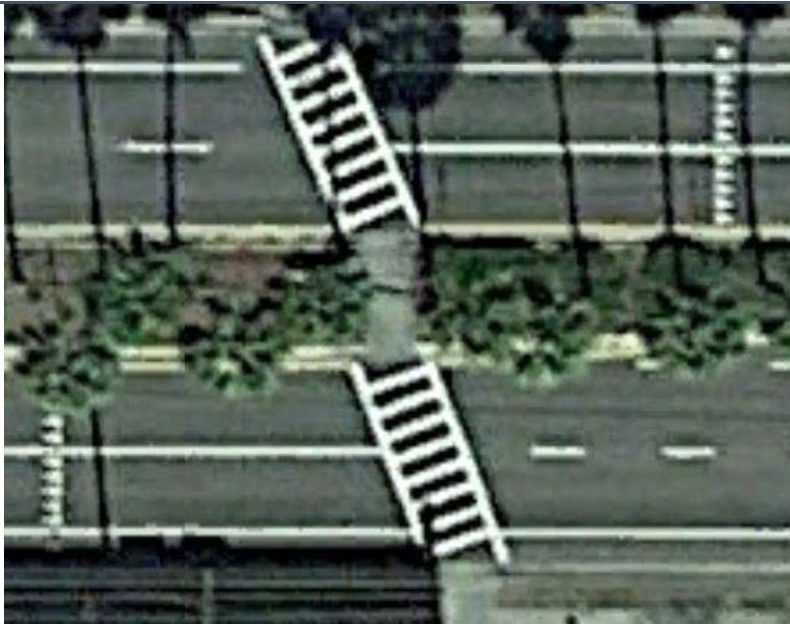
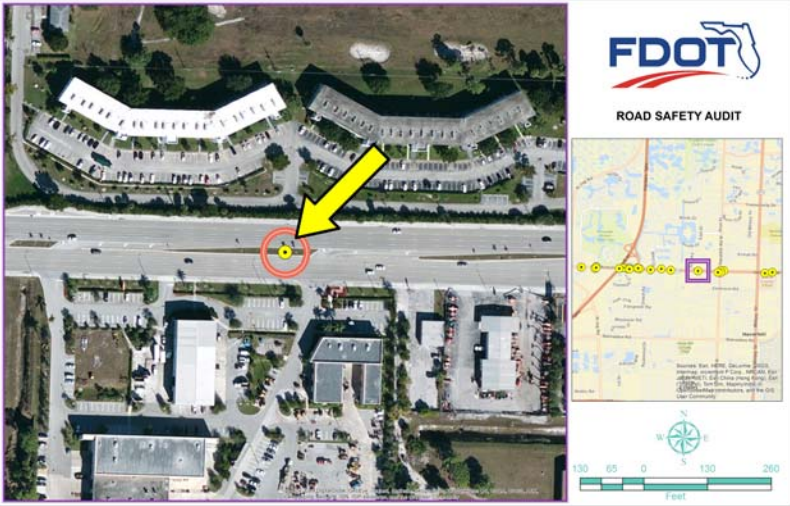
ID	Location Description:	Spot Observation Overview:	Suggestions for Consideration:
10	Various mid-block near bus stops	Pedestrian/bicycle-related crashes identified near bus stops	Evaluate feasibility of mid-block crossings

Spot Observation Details:

Approximately 8 pedestrian/bicycle-related crashes were identified mid-block in the vicinity of bus stops corridorwide from 2010 to 2014.

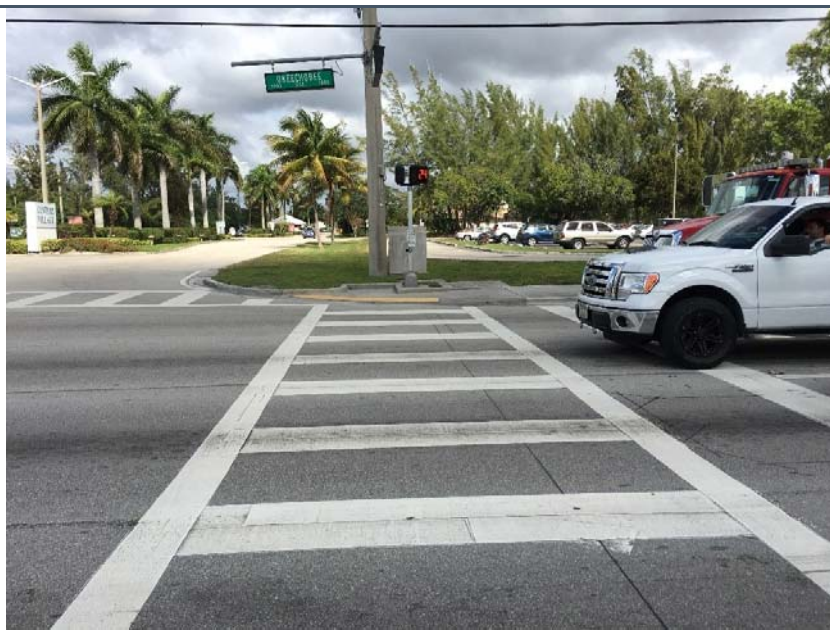
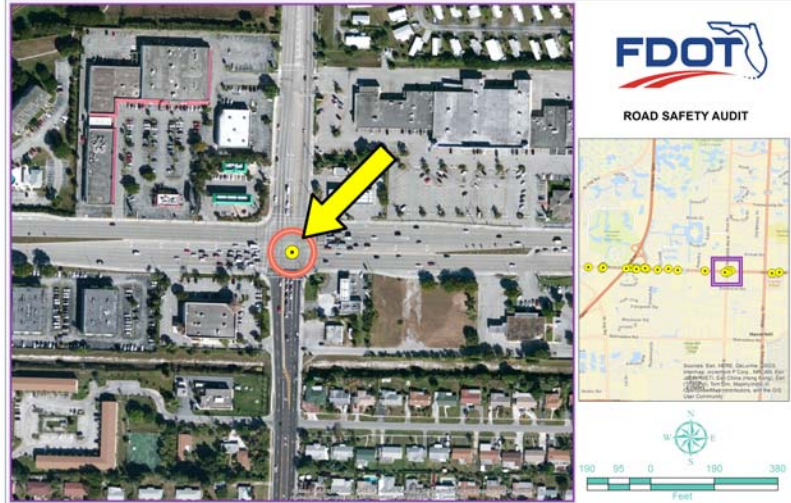
ID	Location Description:	Spot Observation Overview:	Suggestions for Consideration:
12	Various Signalized Intersections	Pedestrian crashes near and around signalized intersections	Provide special emphasis crosswalk markings

Due to the number of pedestrian crashes near and around signalized intersections, provide consistent markings by installing special emphasis crosswalk markings at all signalized crossings.

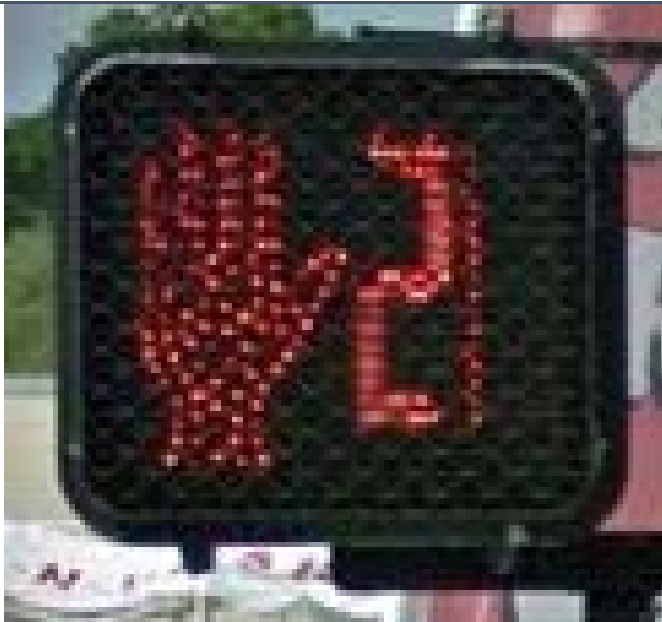
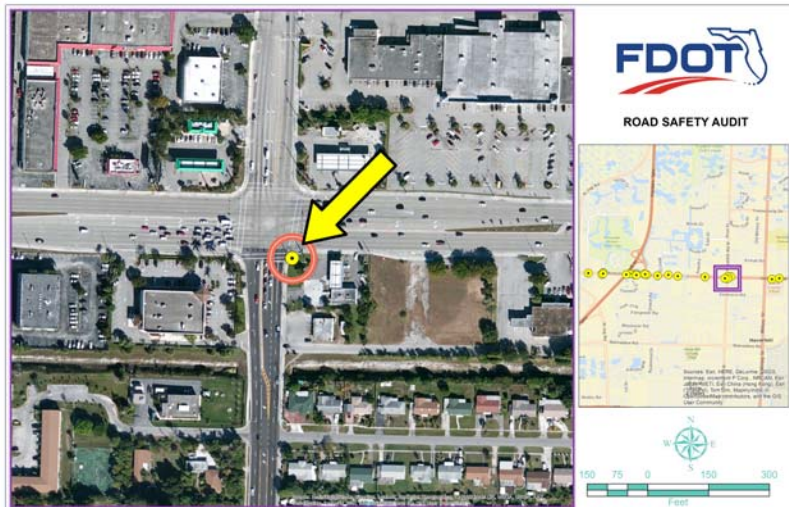
ID	Location Description:	Spot Observation Overview:	Suggestions for Consideration:
13	Various Signalized Intersections	Pedestrians were arriving after the countdown head displayed "Don't Walk"	Use the "rest in walk" feature for all minor street crossings.

"Rest in walk" is used in vehicle-actuated systems with a variable-duration vehicular green phase. The vehicular phase is either "resting" (with no vehicles detected on conflicting phases) or being extended by approaching vehicles. During the "resting" phase, the parallel concurrent pedestrian phase remains in "WALK." In the absence of a conflicting call, the "WALK" remains on indefinitely. It is only after a conflicting phase call is detected that the pedestrian change interval "DON'T WALK" phase (flashing orange hand) begins timing.

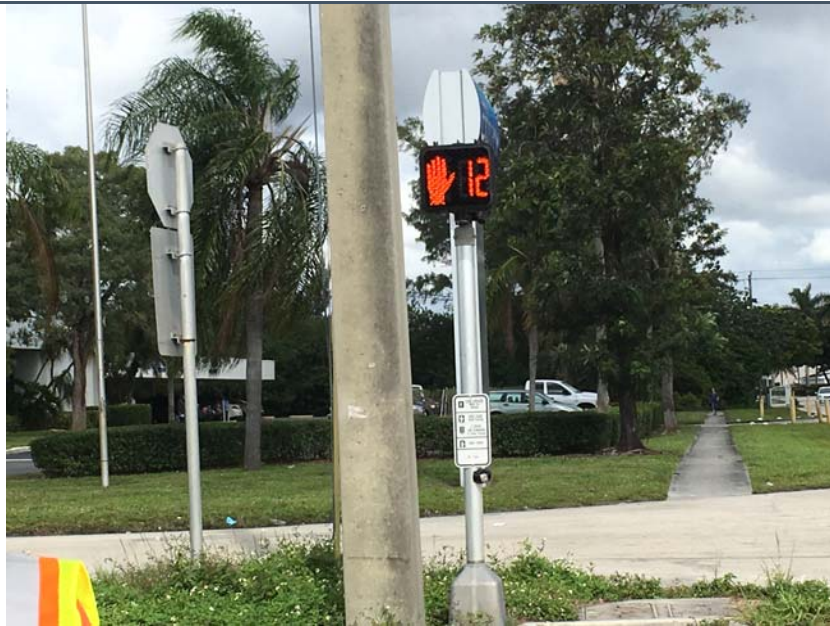
ID	Location Description:	Spot Observation Overview:	Suggestions for Consideration:
14	Various Signalized Intersections	Short pedestrian crossing time	Evaluate clearance intervals

Spot Observation Details:

Based on field observations, the team noted that the time provided by countdown pedestrian heads was not adequate for crossing. Observed countdown timings for the “DO NOT WALK” phase.

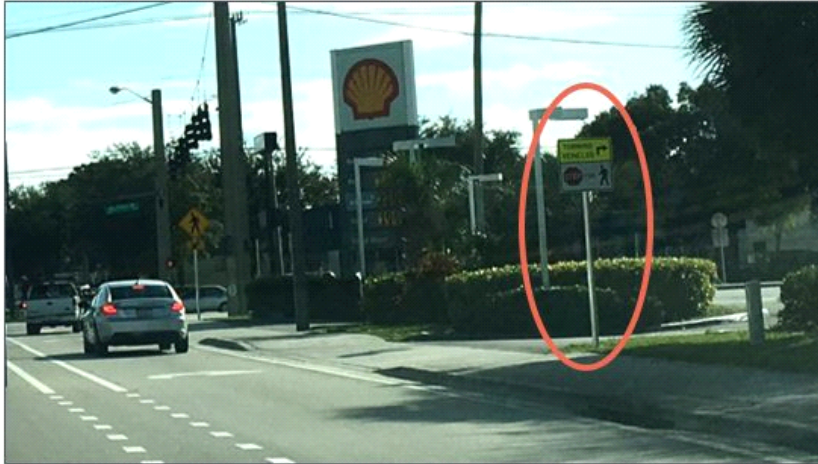
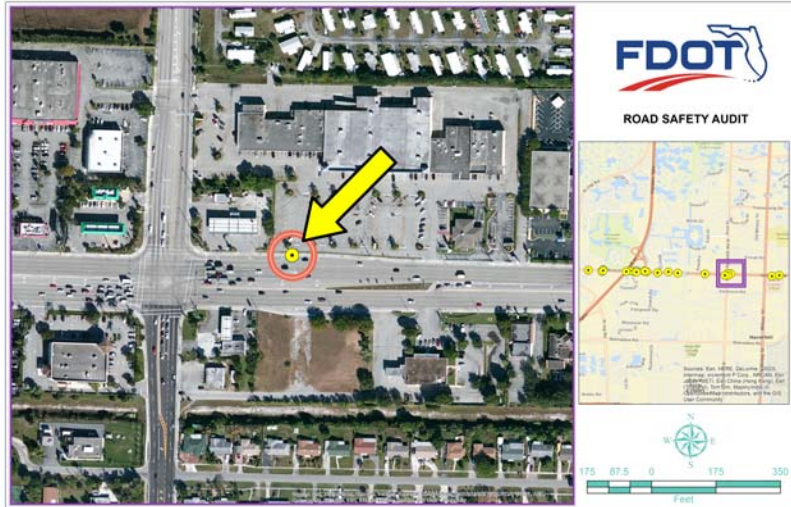
ID	Location Description:	Spot Observation Overview:	Suggestions for Consideration:
15	Various Signalized Intersection Approaches	Reinforce protected crossing corridorwide	Install pedestrian signs on approach to signals

Spot Observation Details:

Bicycle and pedestrian crashes have been reported throughout the study corridor including signalized intersections. Signalized intersection approaches do not include pedestrian warning signs; signalized approaches include:

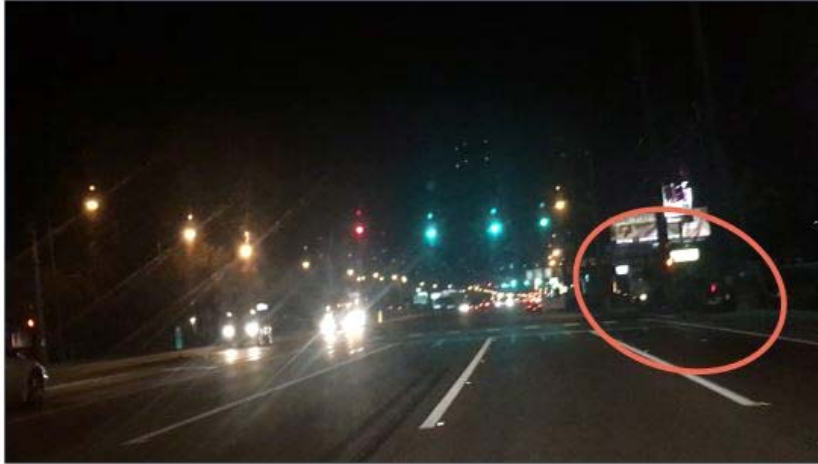
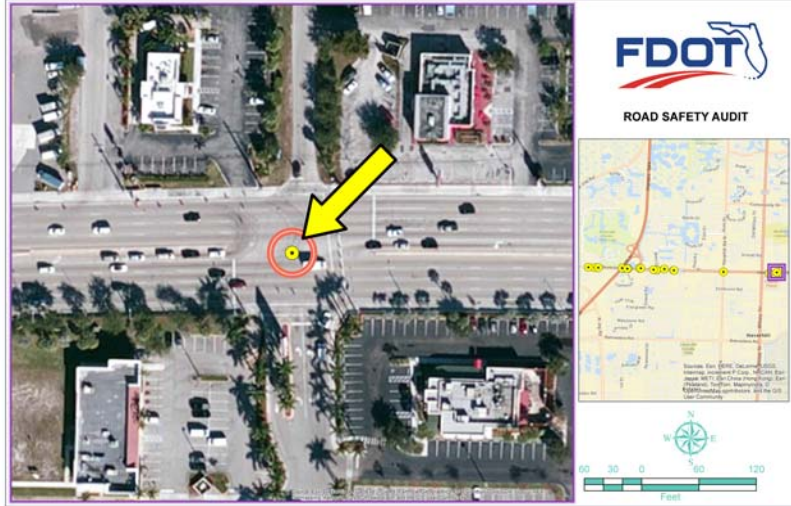
ID	Location Description:	Spot Observation Overview:	Suggestions for Consideration:
16	SR-704 (Okeechobee Boulevard)	No quadrant lighting at Cross County/Biscayne Boulevard	Installing additional lighting

Spot Observation Details:

Quadrant lighting was identified at all other intersections, with the exception of SR-704 (Okeechobee Boulevard) at Cross County/Biscayne Boulevard. At this intersection there is lighting only on the southwest quadrant of the intersection (see Figure 32) and the north side appeared darker. A nighttime bicycle crash occurred at this intersection within the crosswalk on the east side.
