# DISTRICT 4 ROAD SAFETY AUDIT REPORT

SR-704 (OKEECHOBEE BOULEVARD)

AT FLORIDA AVENUE / ROSEMARY AVENUE

OCTOBER 2015

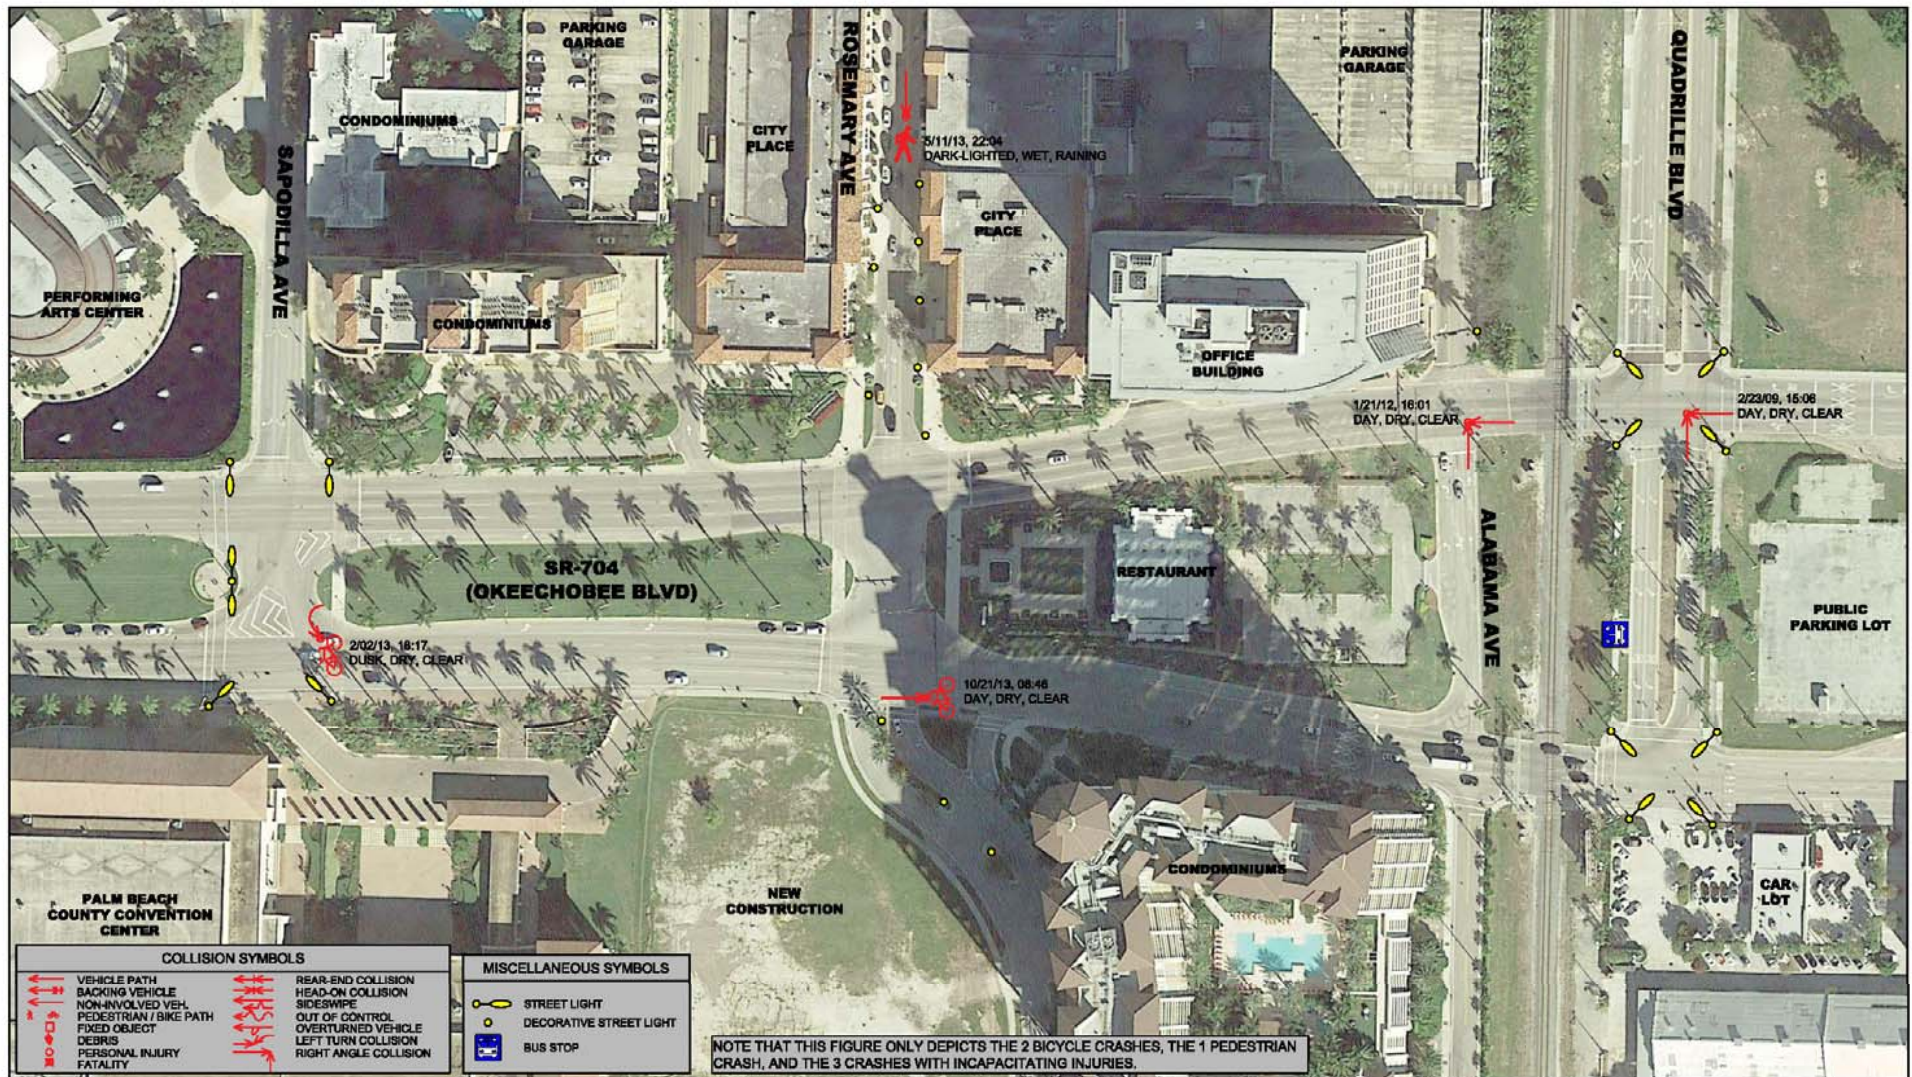
**Figure 2: SR-704 (Okeechobee Boulevard) at Florida Avenue / Rosemary Avenue Collision Diagram**

Figure 2, on the following page, is a map / collision diagram of SR-704 (Okeechobee Boulevard) from milepost 8.778 (South Sapodilla Avenue) to milepost 9.011 (US-1 / South Quadrille Boulevard) that depicts all the pedestrian and bicycle-related crashes as well as any crashes with incapacitating injuries. The diagram also depicts locations of bus stops and street lighting.

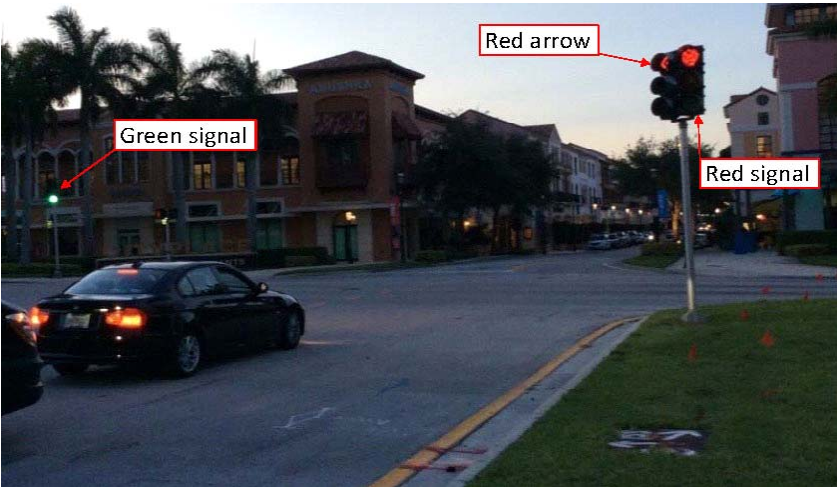
ID	Location Description:	Spot Observation Overview:	Suggestions for Consideration:
01	SR-704 at Florida Avenue / Rosemary Avenue	Vehicles stopped in intersection	Modify signal phasing, review alternative solutions

Eastbound left-turning vehicles from SR-704 (Okeechobee Boulevard) were observed turning left towards northbound Florida Avenue / Rosemary Avenue and then stopping within the intersection during both the green and red phases. Vehicles that observed the ground-mounted signal change to red within the median would stop at that signal. It is noted that the photo depicts a green ball on the northwest side of the intersection but a red arrow and a red ball within the median, which makes it unclear to motorists whether or not to go through the remainder of the intersection.

- A) On Figure A4, (A) depicts the existing signal head configuration and movement.
- B) Remove "confusing" signal heads.
- C) Move signal heads to a new mast arm and consider converting the northwest movement to run as permissive as the northwest crosswalk could run the "Walk" phase concurrently.
- D) Verify the feasibility of realigning the eastbound left-turn lane through the median similar to that of a Single Point Urban Interchange (SPUI).

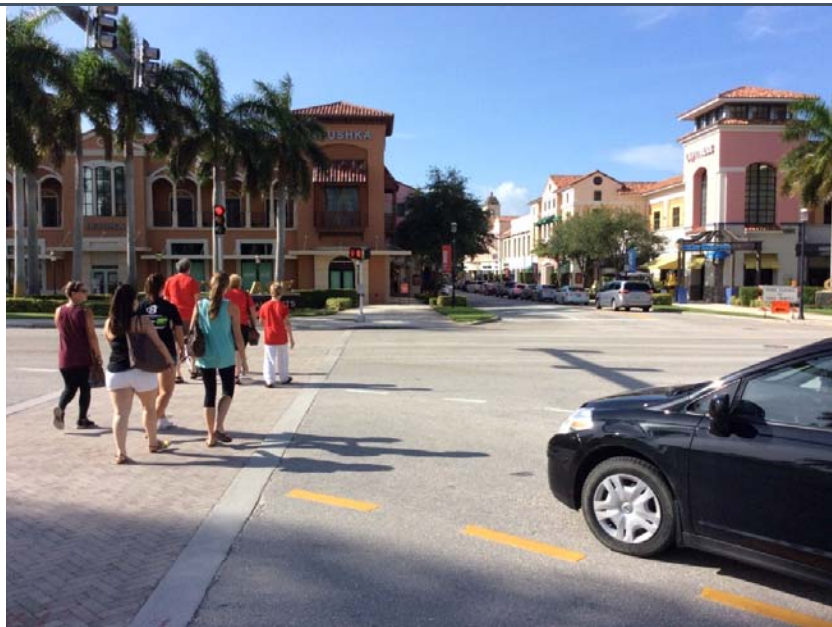
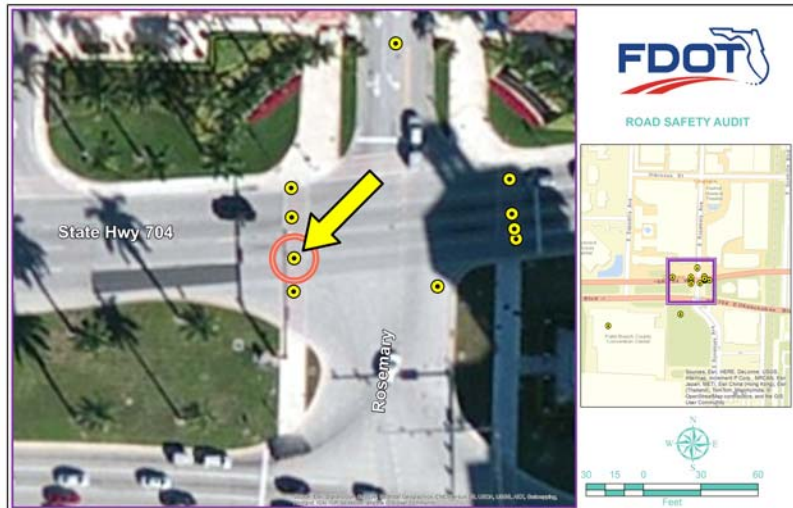
ID	Location Description:	Spot Observation Overview:	Suggestions for Consideration:
02	North / south crosswalk on northwest quadrant	Conflict between pedestrians and eastbound U-turns	Prohibit eastbound U-turns or add "TURNING VEHICLES YIELD TO PEDESTRIANS" sign, add pedestrian phase

Conflict between pedestrians and eastbound U-turns were observed within the southbound crosswalk north of the median at SR-704 (Okeechobee Boulevard) and Florida Avenue / Rosemary Avenue.

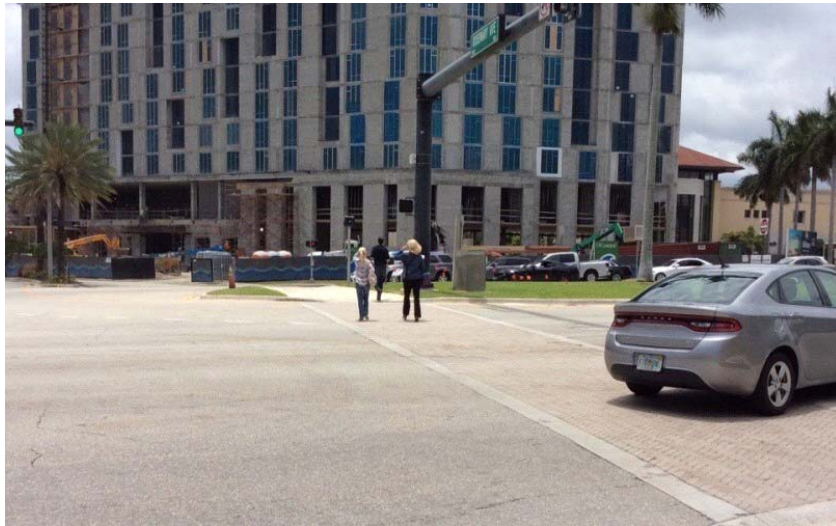
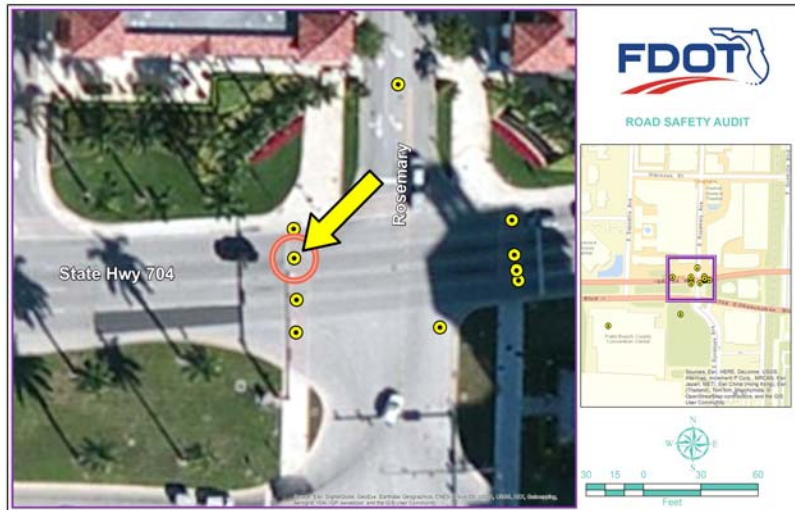
ID	Location Description:	Spot Observation Overview:	Suggestions for Consideration:
03	All crosswalks	Conflict between pedestrians and right turns	Install "TURNING VEHICLES YIELD TO PEDESTRIANS" signs, consider "blank-out" signs, and consider LPI

Conflicts observed between right-turning vehicles and pedestrians crossing in the crosswalks of SR-704 (Okeechobee Boulevard) and Florida Avenue / Rosemary Avenue.

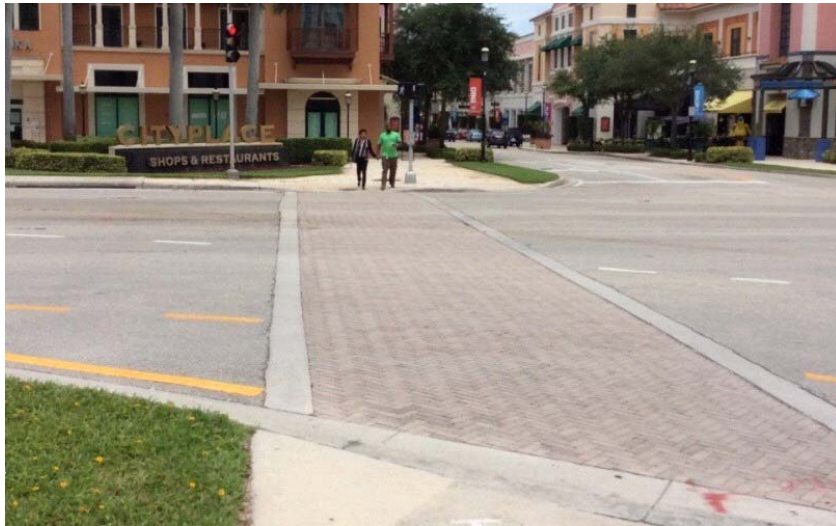
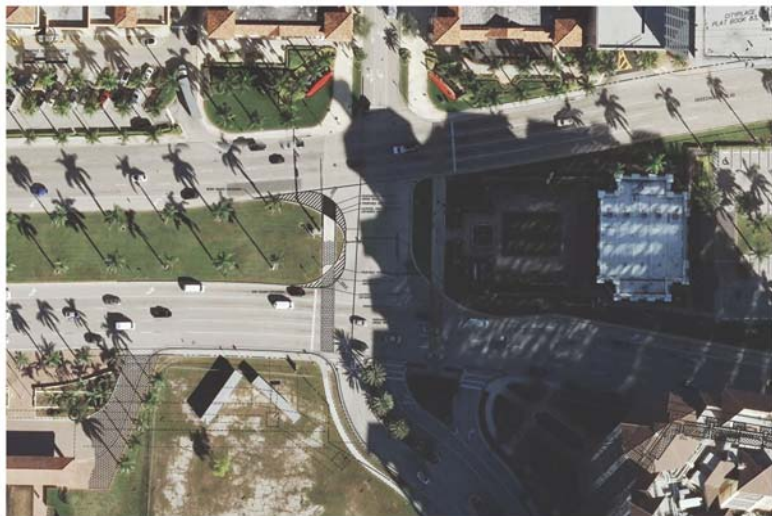
ID	Location Description:	Spot Observation Overview:	Suggestions for Consideration:
04	North / south crosswalk on northwest and southeast quadrants	Pedestrian crossing distances are long	Reduce crossing distances by modifying median

Pedestrian crossing distances are long to cross the north / south crosswalks of SR-704 (Okeechobee Boulevard) and Florida Avenue / Rosemary Avenue.

To reduce the crossing time for pedestrians, consider modifying the west leg of the median to shorten the crossing distances for pedestrians. It is noted that the developer of the Convention Center Hilton Hotel is developing a concept of a revised median to reduce crossing distance for pedestrians. An "Auto Turn" analysis is recommended to ensure that the proposed concept provides appropriate control radii for the design vehicle in accordance with the current FDOT requirements. The concept is provided as Figure A1 in the Appendix.

It is noted that brick paver crosswalks are not allowed per current FDOT standards and policies. Prior to finalizing the concept, the developer needs to implement appropriate corrective actions.

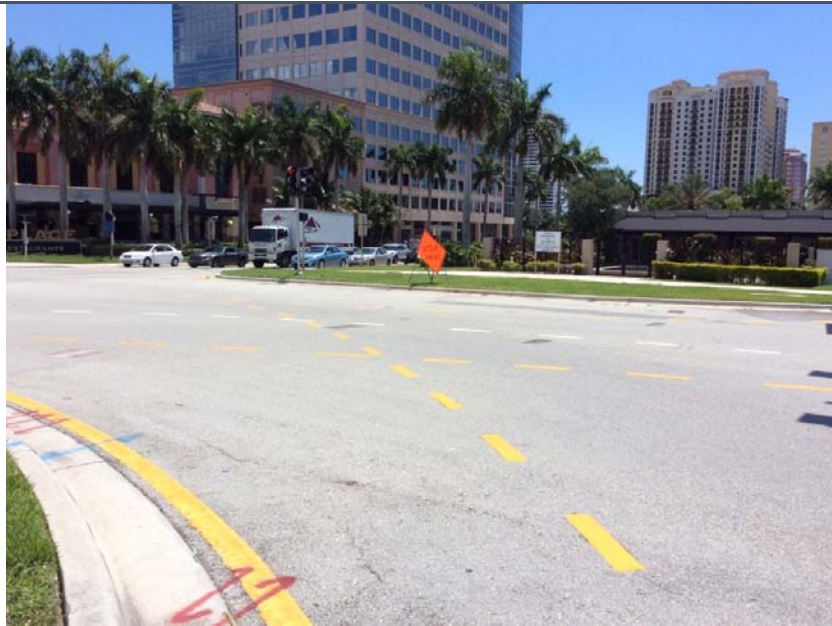
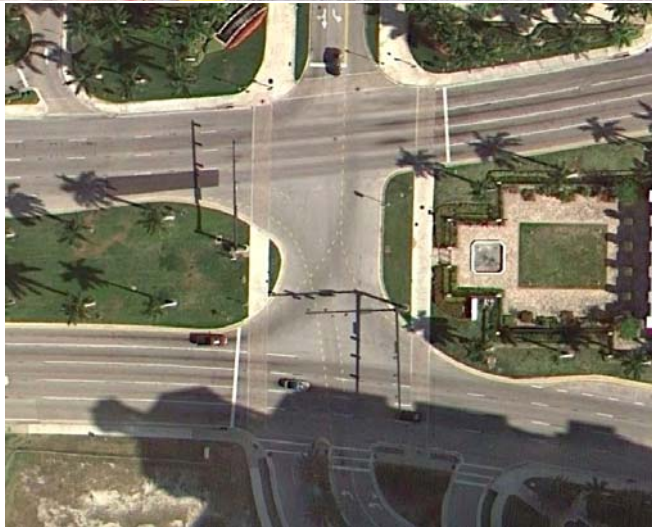
ID	Location Description:	Spot Observation Overview:	Suggestions for Consideration:
05	SR-704 at Florida Avenue / Rosemary Avenue	Confusing striping	Modify striping in median

Eastbound left-turns, the southbound movement, and the northbound movement were observed not utilizing the guide striping within the median of SR-704 (Okeechobee Boulevard) at Florida Avenue / Rosemary Avenue as the striping is confusing.

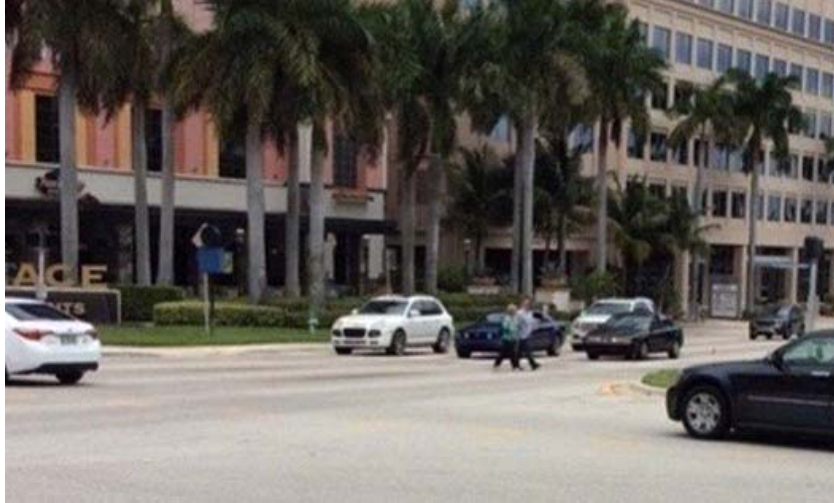
ID	Location Description:	Spot Observation Overview:	Suggestions for Consideration:
06	North / south crosswalk on northeast quadrant	Pedestrian(s) crossing on "DO NOT WALK"	Add pedestrian phase during eastbound left-turn phase

Pedestrians were observed waiting an extended period of time and then decided to cross during the "DO NOT WALK" phase, which was also the eastbound left-turn phase for SR-704 (Okeechobee Boulevard). It is noted that the signal phasing varied with InSync throughout the observations. Generally, the phasing was observed in the following order: Phase 2, Phase 1, Phase 2, Phase 3, Phase 4. The signal phasing gave pedestrians the impression that their phase was skipped to cross north and south SR-704 (Okeechobee Boulevard).

To allow additional time for pedestrians to cross the northbound crosswalk of SR-704 (Okeechobee Boulevard), consider adding a pedestrian phase for the northeast crosswalk concurrently with the eastbound left-turn phase. Also, consider revising the signal phasing to the following order: Phase 2, Phase 1, Phase 4, Phase 3. The signal phasing diagram is also provided as Figure A2 in the Appendix.

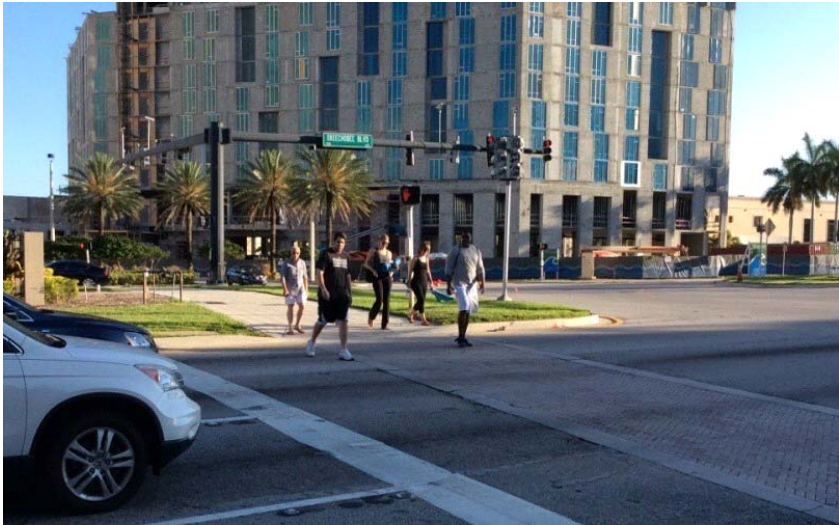
ID	Location Description:	Spot Observation Overview:	Suggestions for Consideration:
07	North / south crosswalk on northeast quadrant	Pedestrian(s) crossing on "DO NOT WALK"	Add automatic pedestrian calls

Pedestrians were observed waiting an extended period of time and then decided to cross during the "DO NOT WALK" phase.

Allow for automatic pedestrian calls for the northbound and southbound crosswalks on the north side of the median to encourage pedestrians to walk during the "WALK" phase. These automatic pedestrian calls are in conjunction with the prior recommendation of modifying the signal phasing and adding a pedestrian phase to the northwest crosswalk.

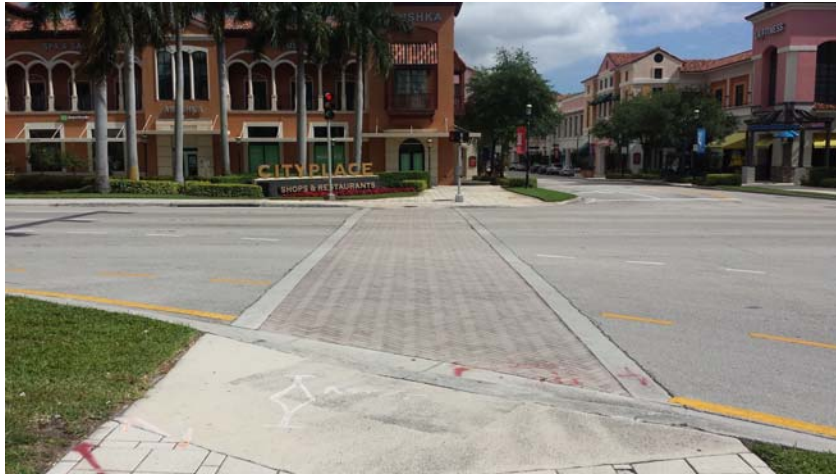
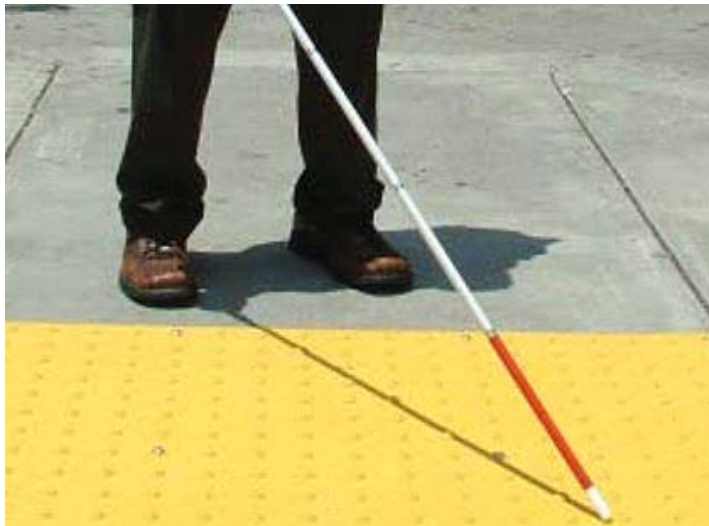
ID	Location Description:	Spot Observation Overview:	Suggestions for Consideration:
08	All pedestrians ramps	Truncated domes not contrasting	Provide contrasting truncated domes, further review of each pedestrian ramp

The detectable warning surfaces are not contrasting with the sidewalk at all of the pedestrian ramps.

To enhance visibility for the visually-impaired, it is recommended that the detectable warning surfaces contrast visually with adjacent walking surfaces per the Americans with Disabilities Act (ADA) Standards for Transportation Facilities 705.1.3.

Consider a further review of the pedestrian ramps to verify the ramps are in accordance with ADA and FDOT requirements.

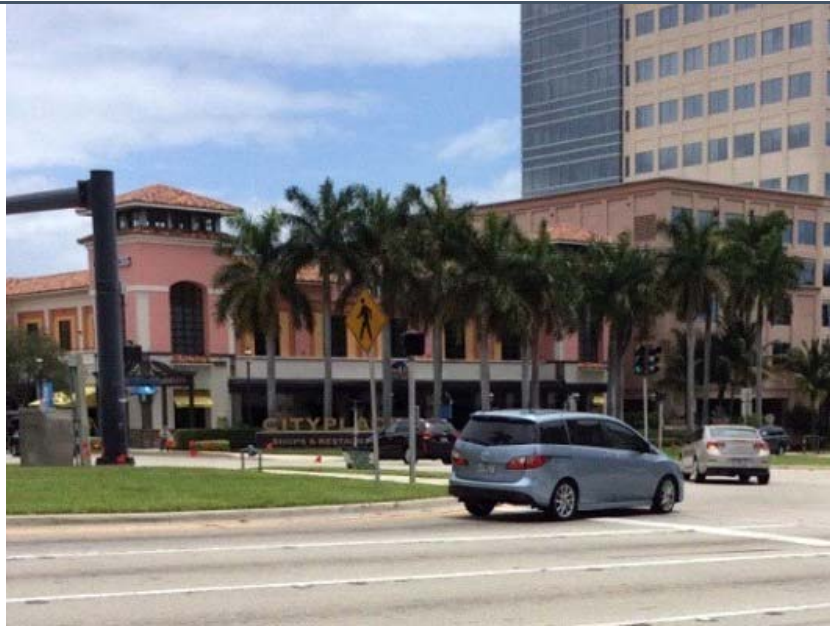
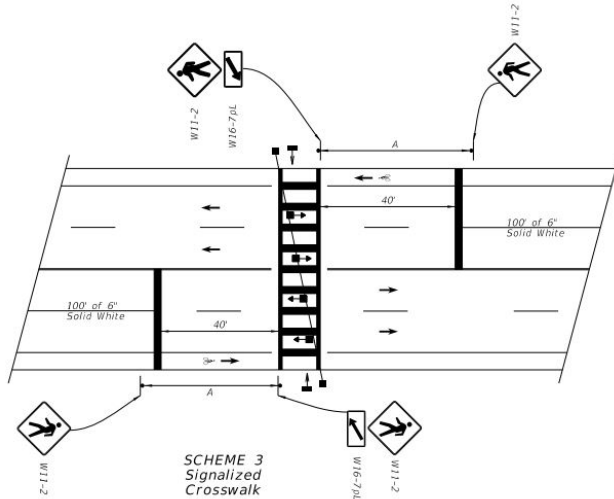
ID	Location Description:	Spot Observation Overview:	Suggestions for Consideration:
09	SR-704 at Florida Avenue / Rosemary Avenue	Minimal pedestrian warning signs	Add Pedestrian Warning Signs (W11-2) and supplemental plaques

At the intersection of SR-704 (Okeechobee Boulevard) at Florida Avenue / Rosemary Avenue there are minimal pedestrian warning signs to advise motorists of pedestrians in the area.

Consideration should be given to adding more signs warning motorists of upcoming pedestrians similar to FDOT Design Standards Index 17346 Sheet 10, Scheme 3, Signalized Crosswalk. Consider installing Pedestrian Warning Signs (W11-2) with a Downward Arrow plaque (W16-7) at the crosswalk within the median and to the right of the roadway. Also, consider adding Pedestrian Warning (W11-2) sign 300 feet prior to the crosswalk within the median and to the right of the roadway.

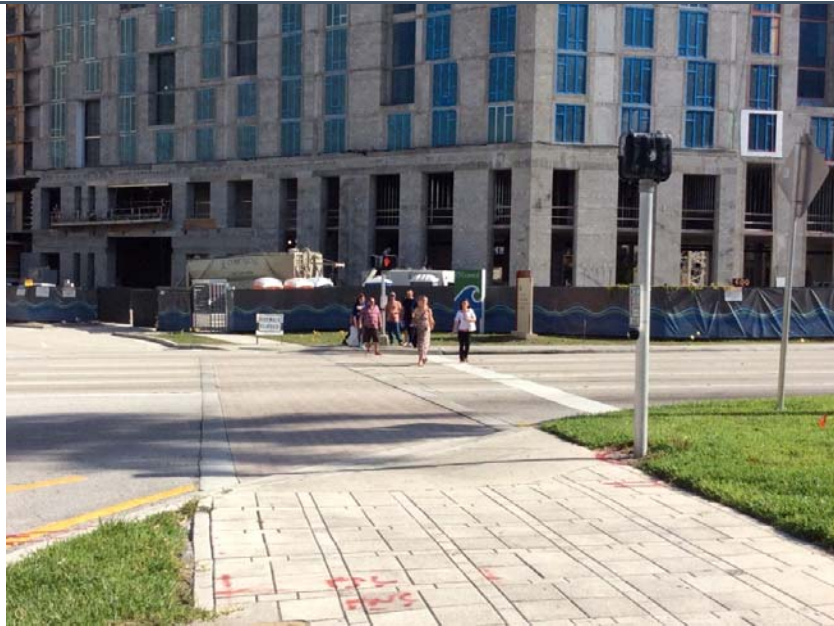
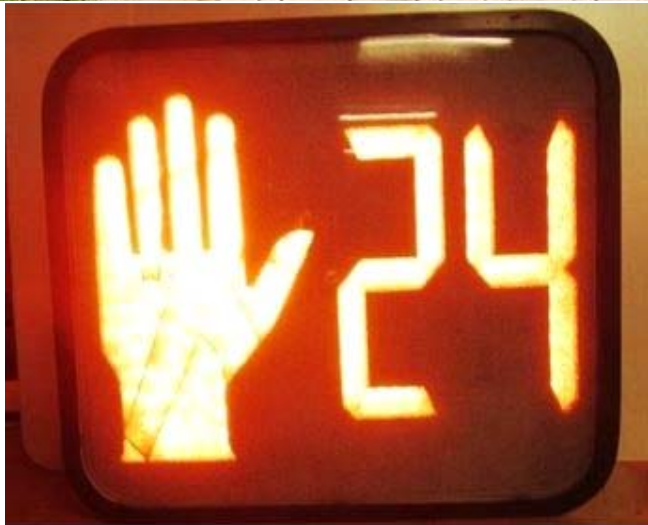
ID	Location Description:	Spot Observation Overview:	Suggestions for Consideration:
10	All crosswalks	Short "WALK" and "DO NOT WALK" phases	Increase "WALK" and "DO NOT WALK" phases

At all of the crosswalks, the existing "WALK" phase is only 5 seconds. Also, there is not enough time provided during the pedestrian "DO NOT WALK" phase. See existing pedestrian timings in the Appendix.

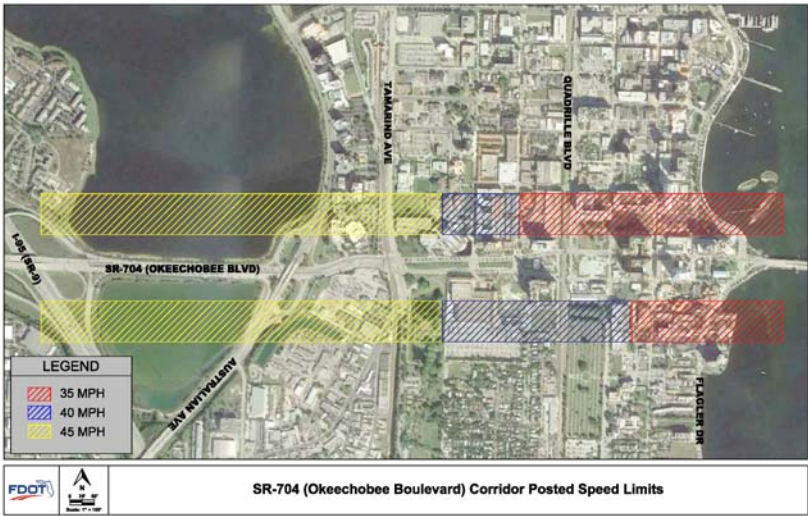
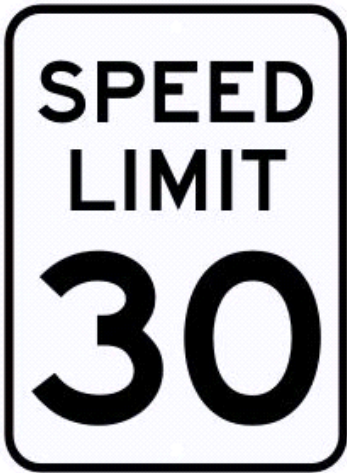
ID	Location Description:	Spot Observation Overview:	Suggestions for Consideration:
12	SR-704 at Florida Avenue / Rosemary Avenue	Citizen recommended to reduce speed limit	Conduct speed study

A citizen recommended reducing the speed limit within the vicinity of City Place, along SR-704 (Okeechobee Boulevard), from 40 mph to 30 mph, indicating that this corridor has these posted speeds nearby. A review of posted speed limits shows that the speed limits along the corridor are as shown in the figure to the left and as in Figure A3 in the Appendix.

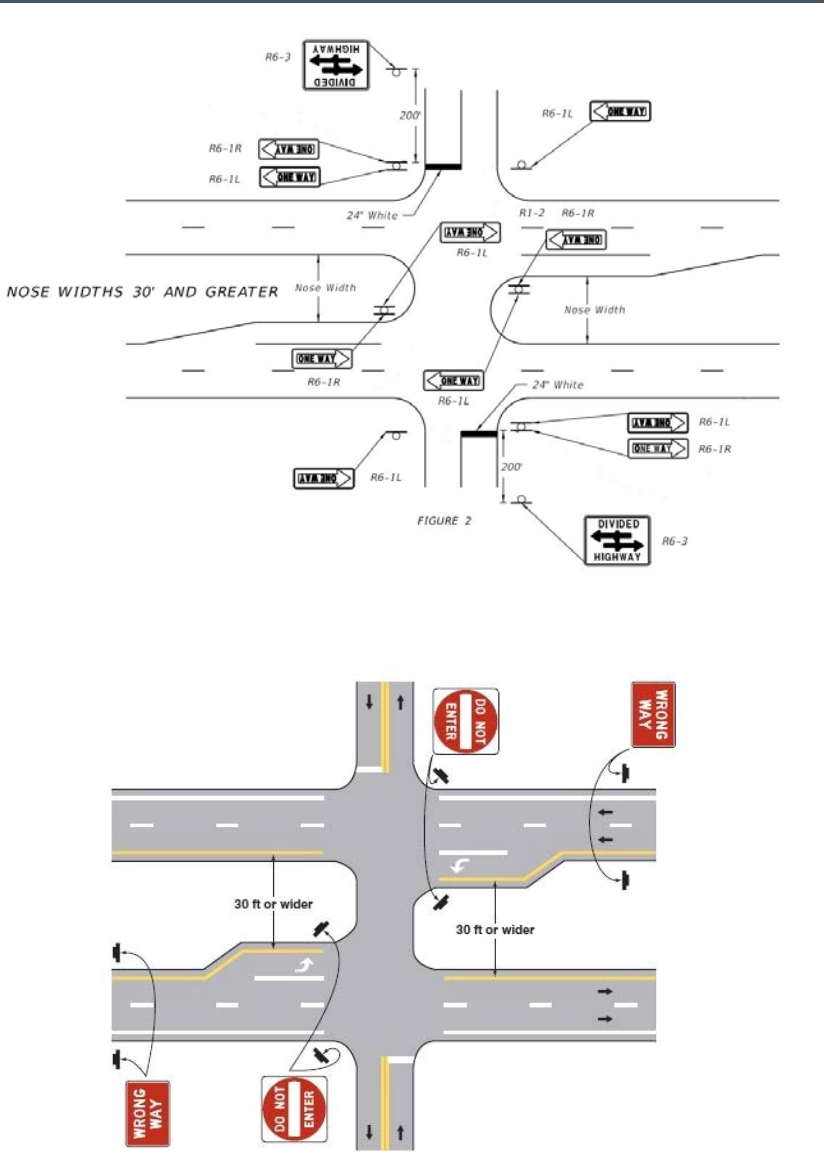
ID	Location Description:	Spot Observation Overview:	Suggestions for Consideration:
13	SR-704 at Florida Avenue / Rosemary Avenue	Citizen concern of wrong way turning	Install "ONE-WAY", "DIVIDED HIGHWAY", "DO NOT ENTER", and "WRONG WAY" signs

The large median can result in miscommunication of proper turning behavior from Florida Avenue / Rosemary Avenue to SR-704 (Okeechobee Boulevard). Although no specific crash pattern was observed indicating a tendency of wrong way turning, a citizen concern recommended "DO NOT ENTER" signs as a "best practice" measure.

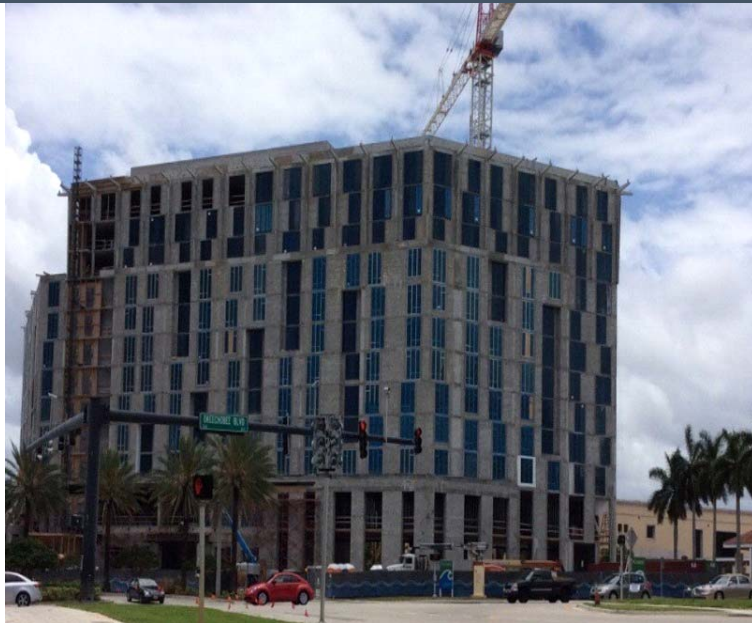
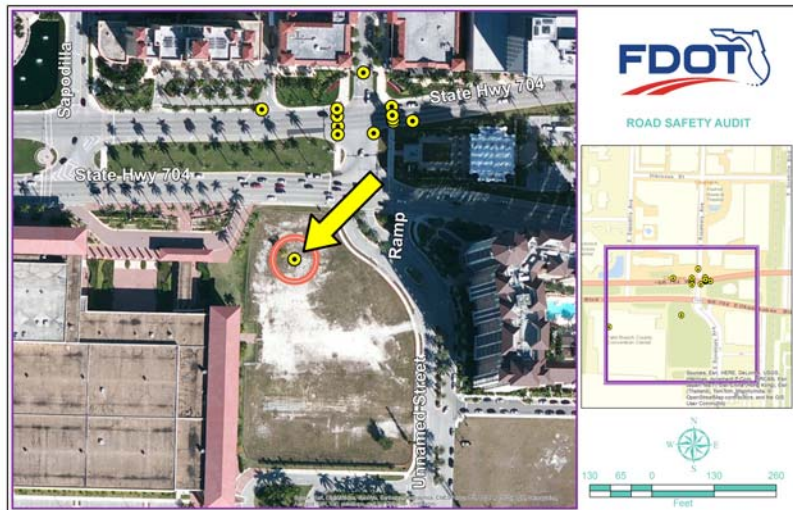
ID	Location Description:	Corridorwide Observation Overview:	Suggestions for Consideration:
C01	Southwest corner of SR-704 at Florida Avenue / Rosemary Avenue	Construction site of Convention Center Hilton Hotel	Improve pedestrian features prior to opening

Construction of Convention Center Hilton Hotel was observed. The hotel is expected to open in 2016 with 400 rooms. Construction crews were observed crossing at the intersection during afternoon observations. The opening is anticipated to draw high volumes of pedestrians, particularly during events. It also is anticipated that many pedestrians will cross the intersection of SR-704 (Okeechobee Boulevard) and Florida Avenue / Rosemary Avenue to reach the Convention Center Hilton Hotel / the City Place attractions.

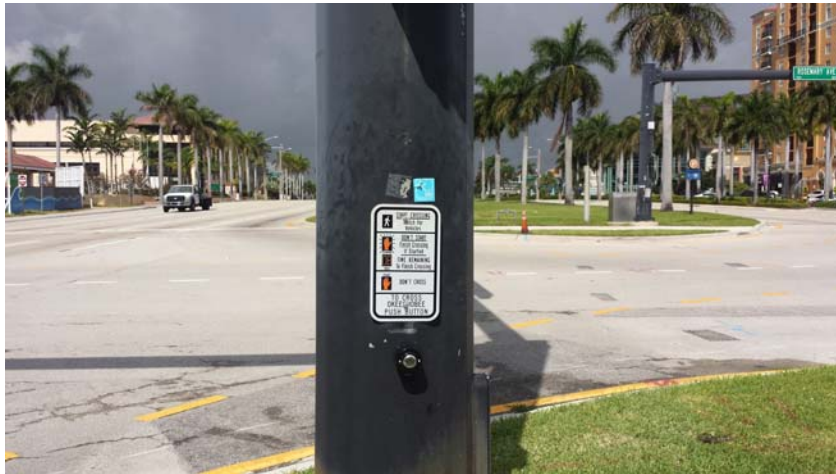
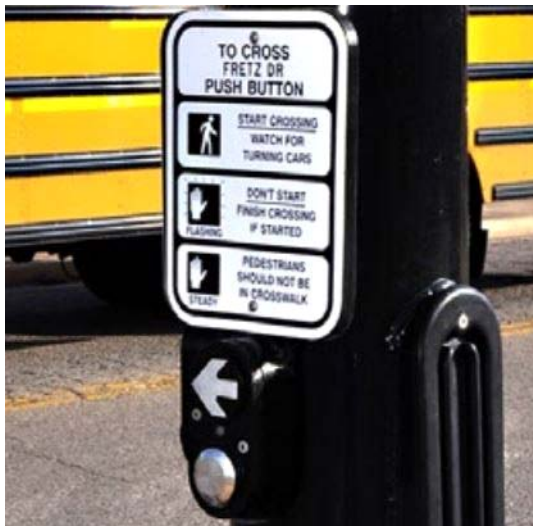
Pedestrians were observed pushing the push button for pedestrian signal multiple times and / or pressing the wrong button.

A further review is recommended to determine the need for and feasibility of installing Audible Pedestrian Signals at the intersection that provide audible prompts for the pedestrians when to cross the roadway, thereby helping pedestrians to comply with signal indications.

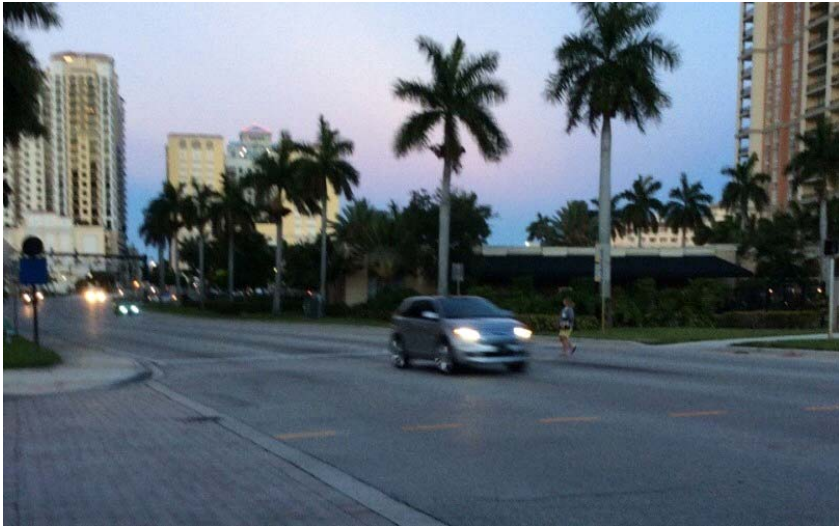
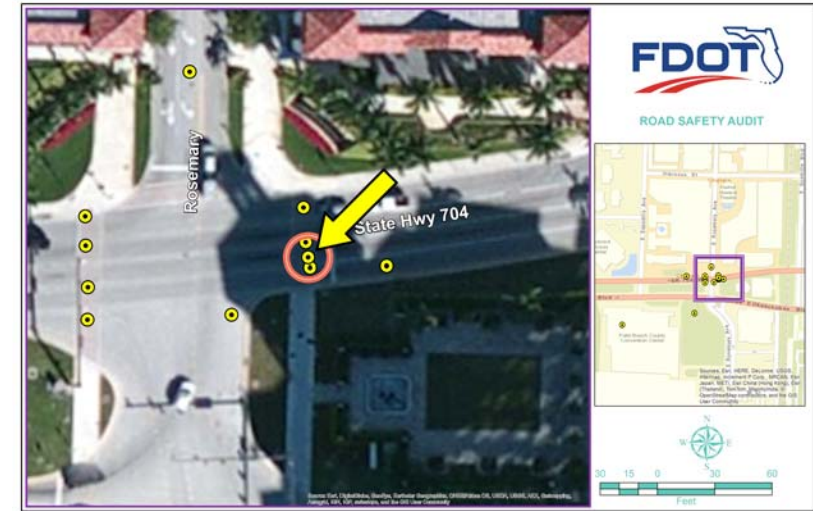
ID	Location Description:	Corridorwide Observation Overview:	
<b>C08</b>	All crosswalks	Pedestrian(s) crossing on "DO NOT WALK"	Suggestions for Consideration: Educate and enforce public of Florida laws related to pedestrian signals

A northbound pedestrian was observed waiting an extended period of time and then crossed during the "DO NOT WALK" phase or during the westbound phase of SR-704 (Okeechobee Boulevard).
