# DISTRICT 4 ROAD SAFETY AUDIT REPORT

SR-A1A (OCEAN BOULEVARD)

FROM: BOCA HIGHLAND BEACH CLUB

TO: NORTHERN TOWN LIMITS OF HIGHLAND BEACH

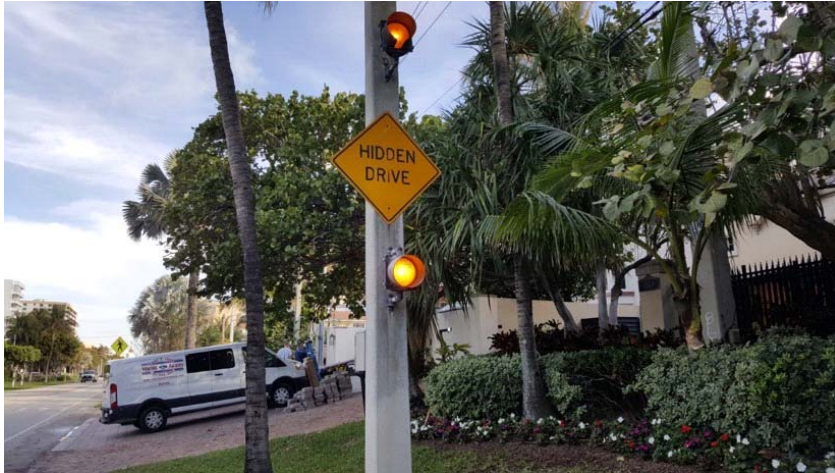
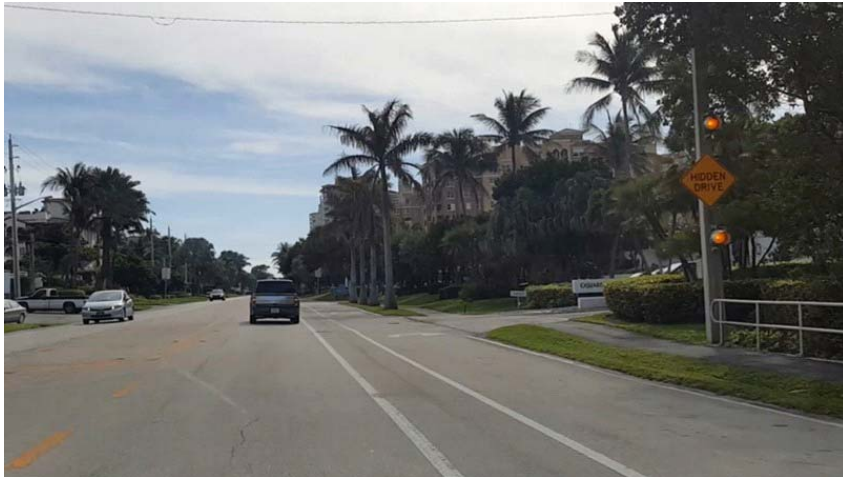
ID	Location Description:	Spot Observation Overview:	Suggestions for Consideration:
01	SR-A1A, north of Town Hall and north of Casuarina Condominiums	From field reviews it was unclear why there are northbound and southbound "Hidden Driveway" signs with flashing beacons	Remove the northbound and southbound "Hidden Driveway" signs and flashing beacons

From field reviews it was unclear why there are northbound and southbound "HIDDEN DRIVEWAY" signs with flashing beacons just north of Town Hall for northbound traffic and north of Casuarina Condominiums for southbound traffic. The driveways in this section are no different than any of the others driveways along the rest of the study area on SR-A1A. The sign's purpose dates back to the 1980's and most likely the conditions for which the sign was installed for no longer applies, as the area has since changed.

In addition, it was noted that the northbound "HIDDEN DRIVEWAY" was not visible as trees were blocking its visibility.

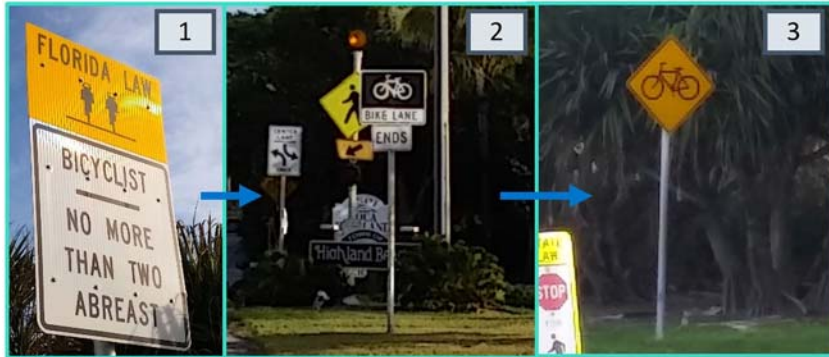
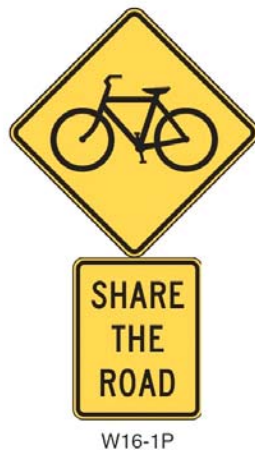
ID	Location Description:	Spot Observation Overview:	Suggestions for Consideration:
02	SR-A1A at Crosswalk #1	Bike signage is unclear	Remove "FLORIDA LAW BICYCLIST NO MORE THAN TWO ABREAST" and add "SHARE THE ROAD" signs

Travelling northbound along SR-A1A from Boca Raton to Highland Beach, the bike lanes transition to shoulders. As the bike lane transitions, there are multiple signs advising bicyclists and vehicular traffic of the transition. The signs include the following:

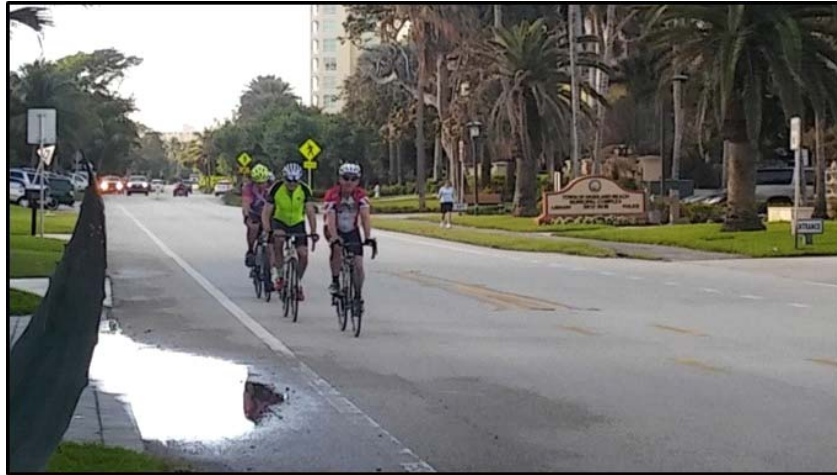
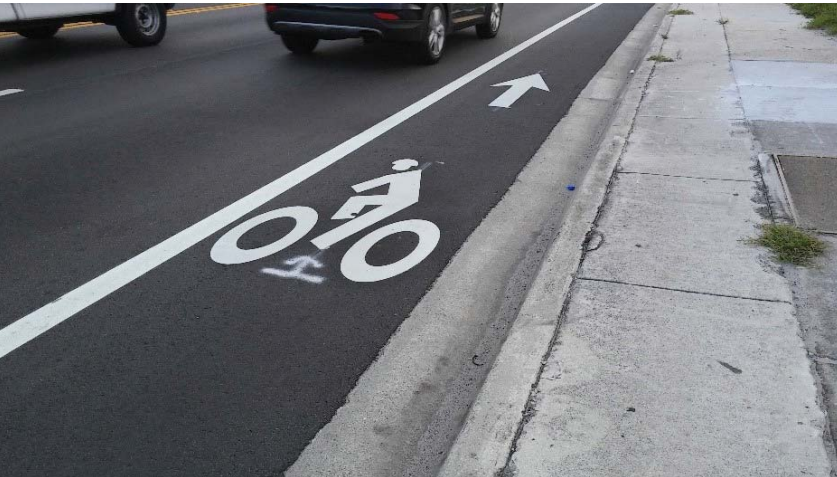
ID	Location Description:	Spot Observation Overview:	Suggestions for Consideration:
03	SR-A1A within Highland Beach	Shoulders are provided throughout Highland Beach but there are no bike lanes	Consider reviewing the feasibility of providing bike lanes or sharrows along SR-A1A in Highland Beach

Shoulders are provided throughout Highland Beach but there are no bike lanes. Two crashes with bicyclists occurred in the study area in five years. Bicyclists were observed during all field observations and were observed riding along the shoulder or the traffic lanes.

Due to the number of bicyclists using the shoulder and the lanes of SR-A1A, review the feasibility of providing bike lanes along SR-A1A in Highland Beach. If bike lanes are not feasible, it is recommended to stripe sharrows along SR-A1A within Highland Beach. Note that there are no resurfacing projects along this section of SR-A1A scheduled in the next five years per FDOT's Five Year Work Program.

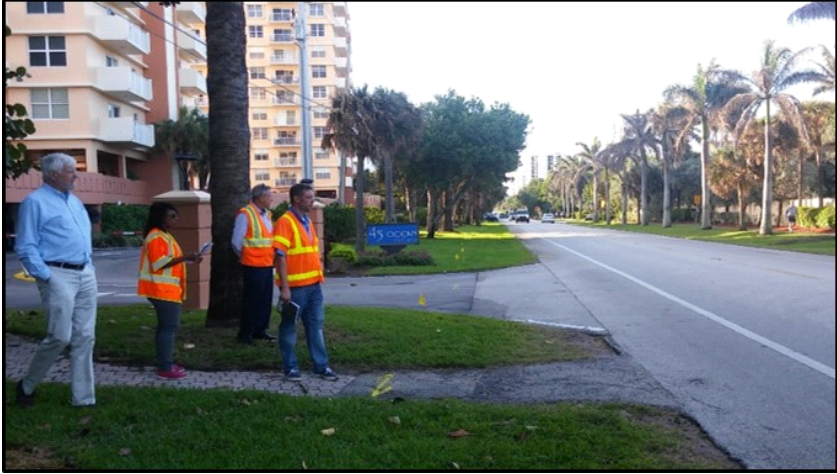
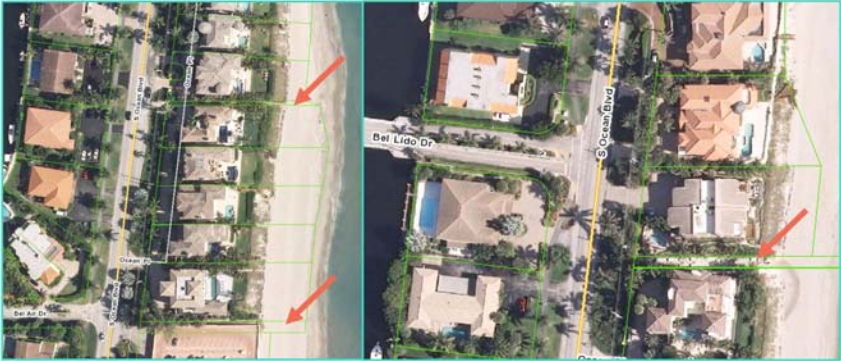
ID	Location Description:	Spot Observation Overview:	
04	SR-A1A at 3 unmarked locations	Residents request additional crosswalk locations	No recommendation at this time

<p><b>Spot Observation Details:</b></p> <p>Residents of Highland Beach requested additional crosswalks as the residents live on the west side and have beach access on the opposing side of SR-A1A. From the West Palm Beach Property Appraiser website, three (3) beach access locations were identified that do not have mid-block crossings. These locations include the following:</p> <ul style="list-style-type: none"> <li>- Bel Lido Drive at 45 Ocean</li> <li>- Bel Air Drive</li> <li>- 370 feet north of Bel Air Drive</li> </ul> <p>During field observations, no pedestrians were observed crossing at these locations. However, it is noted that field reviews were conducted on a weekday and the crossings may be busier during the weekend.</p>

<p><b>Suggestion Details:</b></p> <p>During field reviews no pedestrians were observed crossing at the requested mid-block crossing locations. Therefore, it is highly unlikely there is sufficient pedestrian demand to meet the thresholds of Section 3.8 of the Traffic Engineering Manual (TEM). Therefore, it is not recommended to add mid-block crossing at this time.</p> <p>If pedestrian demand does increase, conduct pedestrian and bicycle counts at these locations to determine if the minimum levels of pedestrian demand is met per Section 3.8 of the TEM.</p>	
<b>Agency:</b>		<b>Improvement Type:</b>	
FDOT		Pedestrian, Pavement Markings, Signs	
<b>Time Frame:</b>		<b>EEE:</b>	
Long		Engineering	
<b>Level of Effort:</b>		<b>Comment:</b>	
High		-

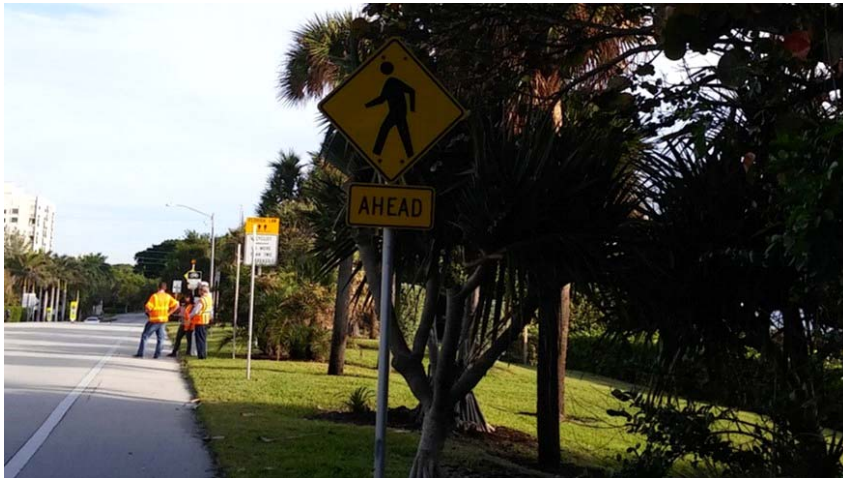
ID	Location Description:	Spot Observation Overview:	Suggestions for Consideration:
05	SR-A1A at the 8 mid-block crosswalks	Vehicles were observed not stopping for pedestrians at mid-block crosswalks	Install advanced "PEDESTRIAN WARNING" (W11-2) with "AHEAD" (W16-9p) signs 250 feet from the crosswalks per FDOT Design Standards Index 17346 Sheet 13

Vehicles were observed not stopping for pedestrians with or without safety vests at the mid-block crosswalks along SR-A1A during all field observations. In addition, many of the crosswalks do not have advanced "PEDESTRIAN WARNING" (W11-2) with "AHEAD" (W16-9p) warning signs as shown on the table to the left.

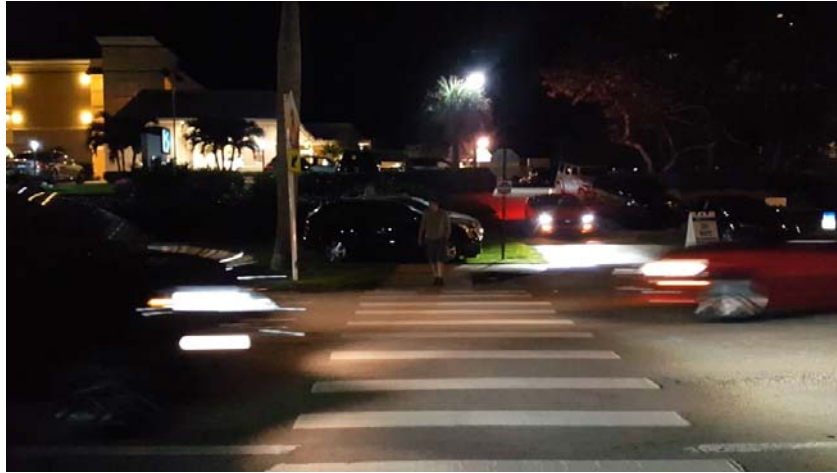
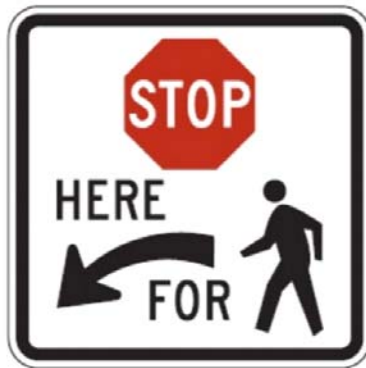
ID	Location Description:	Spot Observation Overview:	Suggestions for Consideration:
06	SR-A1A at the 8 mid-block crosswalks	Vehicles were observed not stopping for pedestrians at mid-block crosswalks	Install "STOP HERE FOR PEDESTRIANS" (R1-5bL) signs at the mid-block crosswalks per Scheme 2 of FDOT Design Standards Index 17346 Sheet 13

Vehicles were observed not stopping for pedestrians with or without safety vests at the mid-block crosswalks along SR-A1A during all field observations.

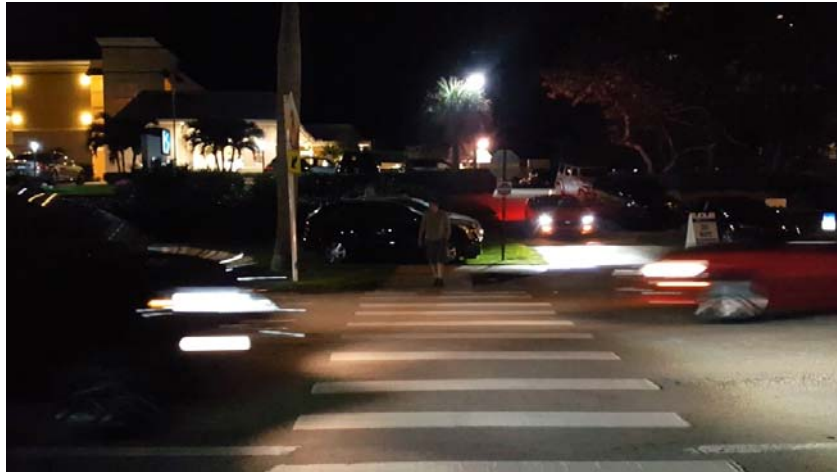
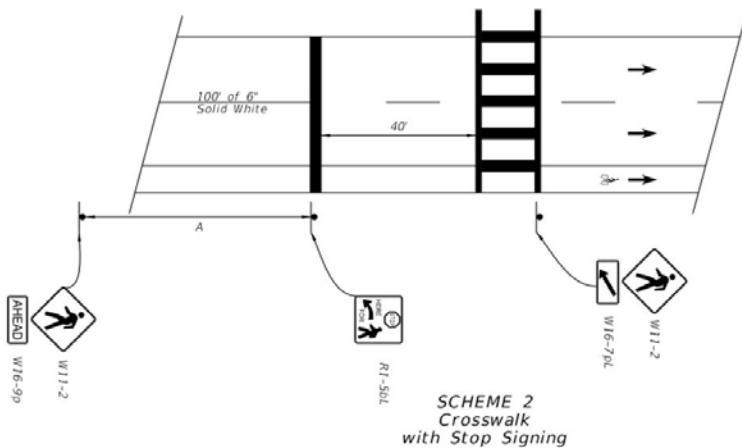
ID	Location Description:	Spot Observation Overview:	Suggestions for Consideration:
07	SR-A1A at the 8 mid-block crosswalks	Vehicles were observed not stopping for pedestrians at mid-block crosswalks	Stripe mid-block crosswalks per Scheme 2 of FDOT Design Standards Index 17346 Sheet 13

Vehicles were observed not stopping for pedestrians with or without safety vests at the mid-block crosswalks along SR-A1A during all field observations.

To increase visibility of the crosswalk and to properly communicate to drivers that it is state law to stop for pedestrians, stripe the mid-block crossings with STOP bars and special emphasis crosswalk markings per FDOT Design Standards Index 17346 Sheet 13.

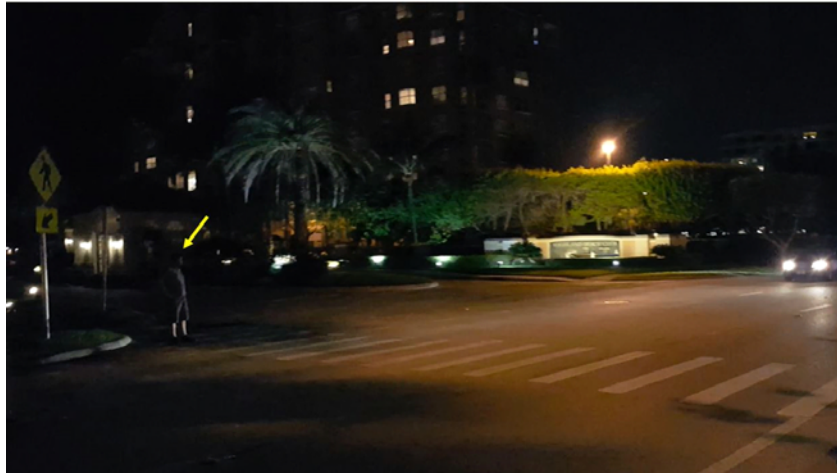
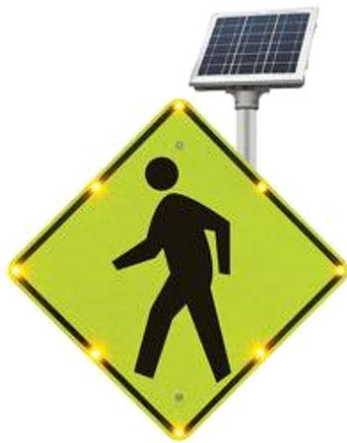
ID	Location Description:	Spot Observation Overview:	Suggestions for Consideration:
08	SR-A1A at Crosswalk 1 at the Boca Highland Beach Club	Pedestrian visibility during dark conditions is low and vehicles observed not stopping for pedestrians	Install "PEDESTRIAN WARNING" (W11-2) signs with LEDs and conduct a before and after compliance review

The crosswalks have limited lighting and pedestrian visibility is low during dark conditions. Vehicles were also observed not stopping for pedestrians with or without safety vests at the mid-block crosswalks along SR-A1A during all field observations.

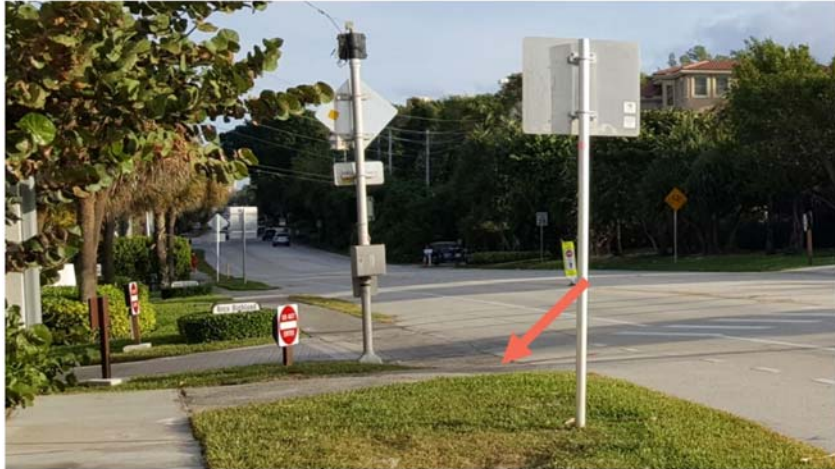
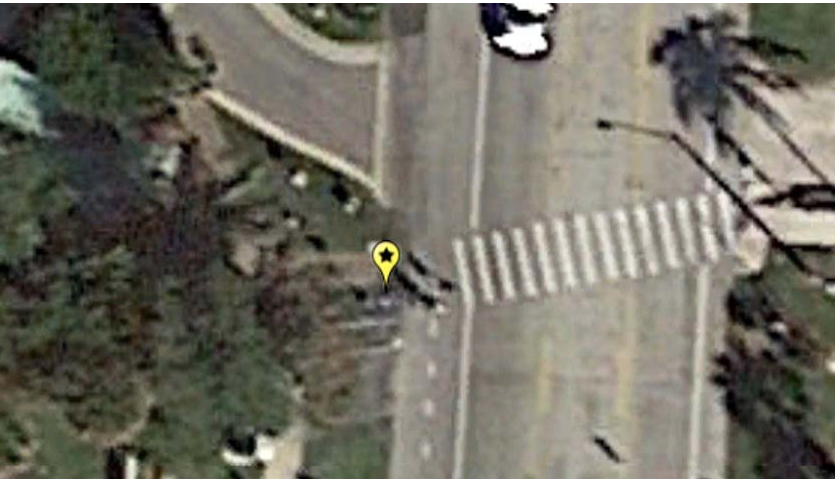
ID	Location Description:	Spot Observation Overview:	
09	SR-A1A, west sidewalk at crosswalk #1	Sidewalk transitions into the southbound shoulder	Add sidewalk on the west side of Crosswalk #1

The sidewalk briefly transitions into the southbound shoulder at crosswalk #1.

For better accessibility for pedestrians, consider reviewing the feasibility of adding a concrete sidewalk on the west side of crosswalk #1 where it is missing.

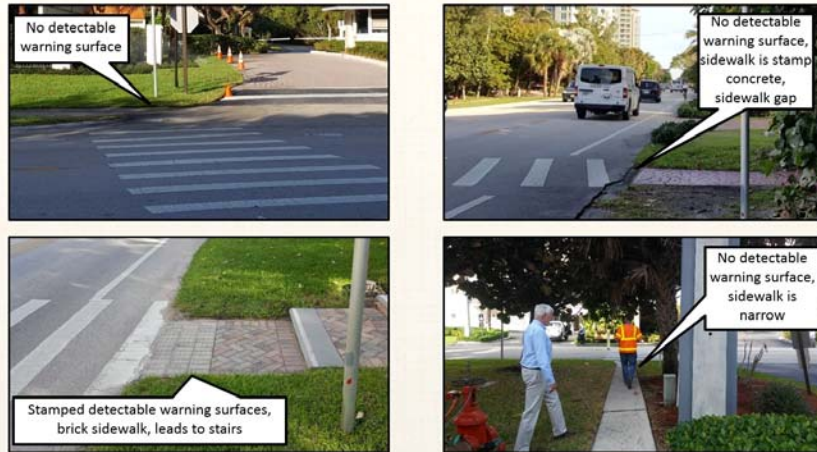
ID	Location Description:	Corridorwide Observation Overview:	Suggestions for Consideration:
<b>C01</b>	SR-A1A at the 8 mid-block crosswalks	Missing detectable warning surfaces and ADA issues	Add missing detectable warning surfaces and correct ADA issues

During field observations, missing detectable warning surfaces were observed at the mid-block crossings. Note that missing detectable warning surfaces are shown at each of the crosswalks in the table to the left. In addition, many of the sidewalks within FDOT's right of way were decorative or had ADA issues as shown on the picture to the left.

Per the table to the left, add missing detectable warning surfaces at the mid-block crossings where they are noted as missing.

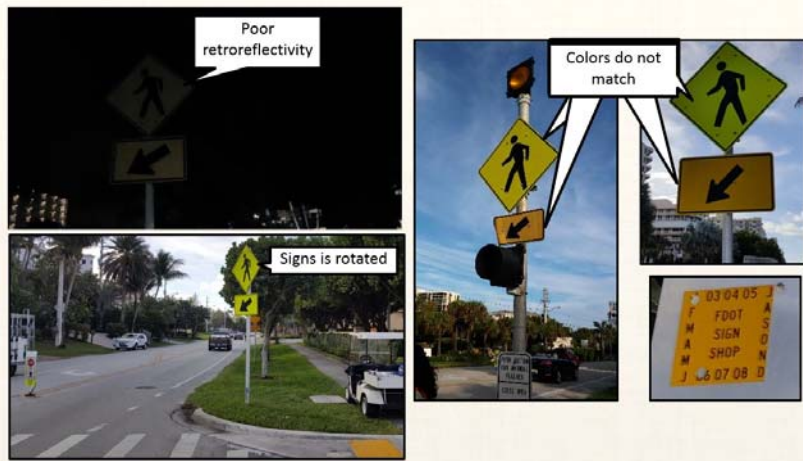
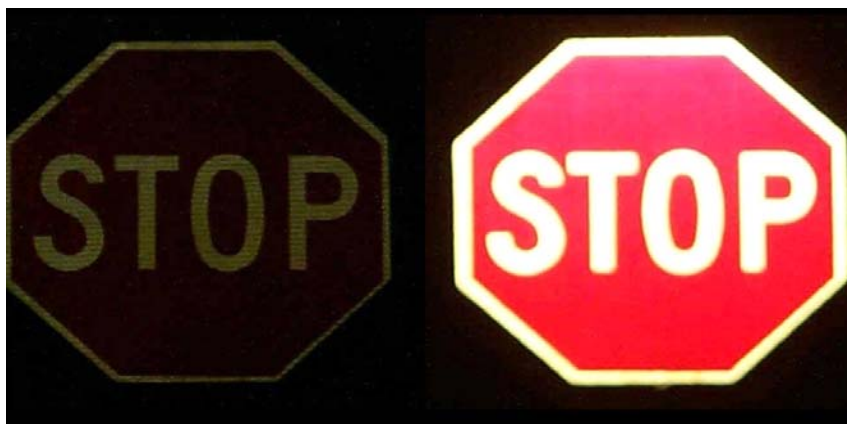
During field observations maintenance issues were observed with the signs and include the following:

Replace signs that do not have consistent colors, rotate the sign at crosswalk #4, replace signs with poor retroreflectivity, and relocate or remove the In-Street Pedestrian Crossing signs that are on the shoulder. See Appendix B for inventory and recommendations.

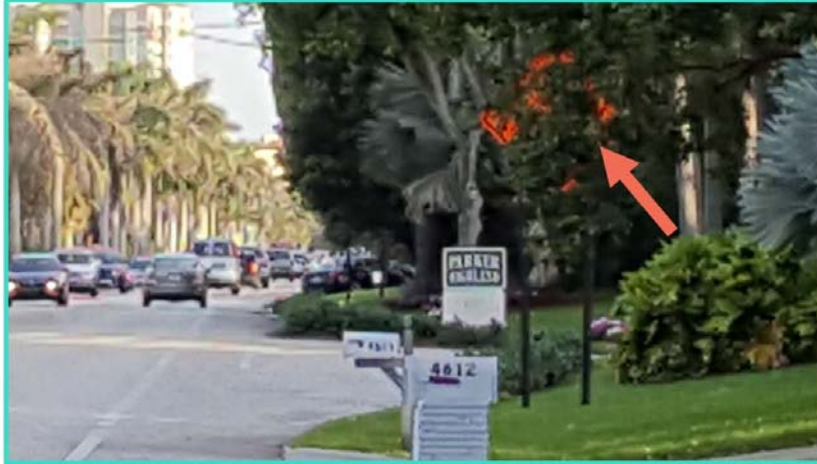
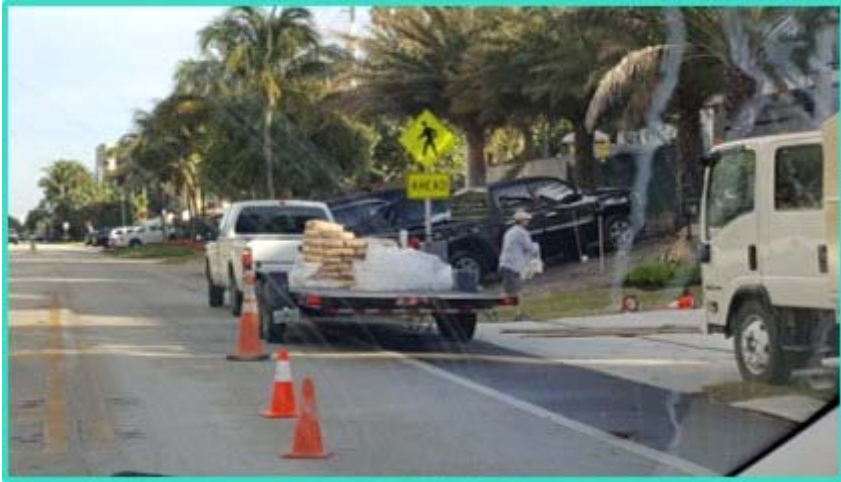
ID	Location Description:	Corridorwide Observation Overview:	Suggestions for Consideration:
C04	SR-A1A at construction sites	MOT not followed correctly at private developments	Enforce MOT

During field observations, Maintenance of Traffic (MOT) for private developments along SR-A1A was not followed properly. MOT related issues included the following:

- Construction trucks observed parking in the bike lanes.
- Visibility of construction signs were blocked by trees and bushes.
- Minimal visibility of "Work Zone" or "Work Ahead" warning signs to properly warn drivers of construction vehicles blocking lanes
- Incorrect placement of cones

Due to the number of private developments along SR-A1A, MOT plans need to be properly followed and enforced.
