DISTRICT 4 ROAD SAFETY AUDIT REPORT

SR-A1A (OCEAN BOULEVARD) BRIDGE

TASK WORK ORDER No. 37

FLORIDA DEPARTMENT OF TRANSPORTATION, DISTRICT 4

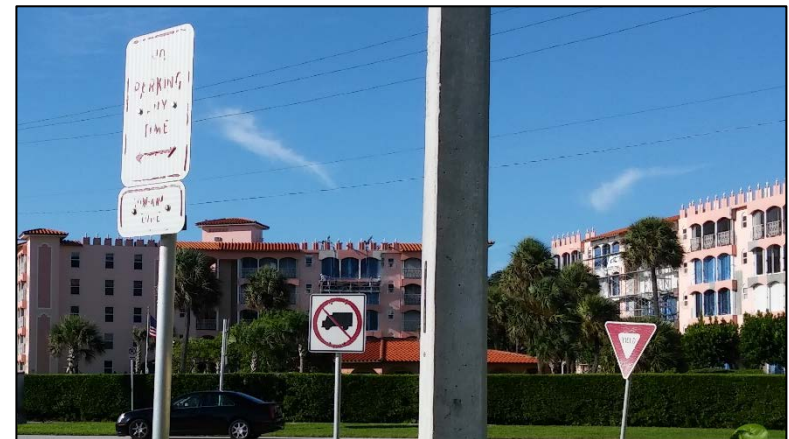
Figure 3: Worn Signs

- City of Boca Raton staff emphasized the City's desire to have continuous bike facilities along the heavily traveled SR-A1A; this includes future bike lanes along the Boca Raton Inlet Bridge.
- In addition to continuous bike lanes, City of Boca Raton staff mentioned that there are sidewalk gaps within the study area.
- City staff indicated that a pedestrian crossing is planned at Ponce de Leon Road to access the South Inlet Park entrance.
- City staff noted that a number of signs are very worn throughout the study area; these maintenance items are noted later in the report.

In addition many signs were observed as faded, worn, or peeling due to age or sun exposure. Although a sign inventory was not within this scope of work, signs that were noted as potentially needing to be replaced are shown on Figure 24. **Consider having FDOT Maintenance conduct a sign inventory to review of the corridor to review these signs and replace them where necessary.**

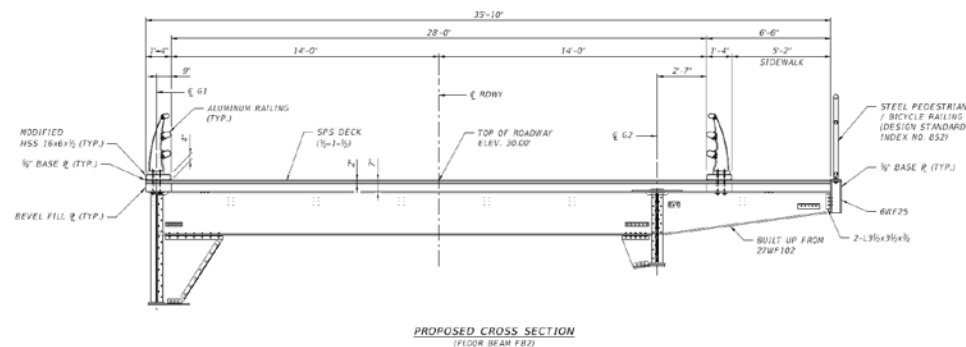
Figure 6: Proposed Configuration

A solid deck is being considered so, bicycle traffic will not be limited to the shoulder.

The traffic rail is an aluminum rail UK; see the Aluminum TL-4 Traffic Railing on the attachment.

Beyond the proposed cross section, sidewalk will be installed on the east side of the corridor, leading to and coming off the structure. **Because of to the 13 (52%) nighttime crashes that have occurred in the study area, consideration should be given to pedestrian level-lighting** along new sidewalk sections. Also, two crossings on A1A will be installed to link the new and existing sidewalk networks.

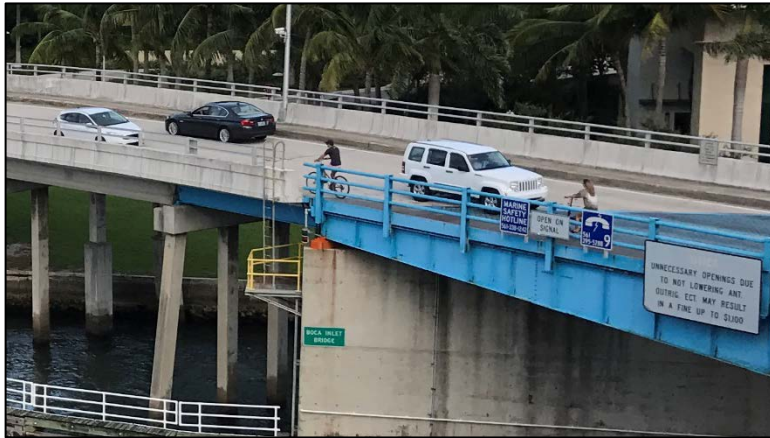
Figure 7: Recreational Cyclist Traversing Boca Raton Inlet Bridge

Bicycles were observed traversing the SR-A1A (Ocean Boulevard) bridge along both the paved shoulder and sidewalk. As a result of the nature of the nearby residential land uses, a mix of “recreational” and “enthusiasts.” Figure 7 depicts recreational cyclists on the sidewalk traversing the bridge contraflow on the sidewalk.

Providing “sharrows” along SR-A1A on the bridge segment where there are signs indicating that bikes may take the full lane, will further encourage cyclists to use the throughway and remind drivers that cyclist are allowed on the road. Note that there were four crashes reported that involved a bicyclist.

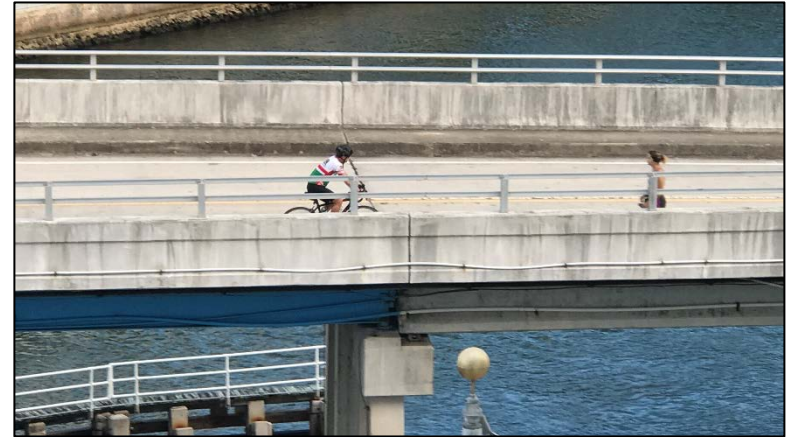
Figure 8: Enthusiast Cyclist Traversing Boca Raton Inlet Bridge

Figure 8 depicts a cyclist traversing the Boca Raton Inlet Bridge along the paved shoulder. Note that in this image, a pedestrian is walking along the sidewalk. The behavior depicted in the images is representative of the general behavior of cyclists and pedestrians along the bridge; cyclists on road bikes generally travel along the through lanes, cyclists on cruisers travel on the sidewalk on the west side of the bridge, and pedestrians travel on the sidewalk on the west side of the bridge.

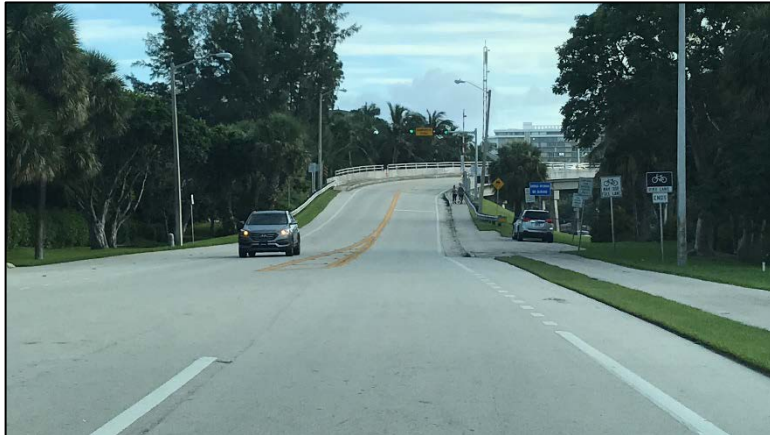
Figure 9: Southbound Approach to Boca Raton Inlet Bridge

There are no curve warning signs on approach to the S-curve along the Boca Inlet Bridge on either approach. Although the approach speed of 35 mph may seem comfortable along SR-A1A (Ocean Boulevard), the approach may be problematic, particularly for southbound drivers at night due to a dark spot in overhead street lighting. Three crashes were reported at each of the curves prior to the bridge. Figure 9 depicts the southbound approach to the Boca Raton Inlet Bridge.

Three crashes were identified at the first curve for the southbound approach to the drawbridge. Per the Crash Modification Factor Clearinghouse, installing advance static curve warning signs reduces serious injury, and minor injury crashes by 30% and property damage crashes by 8%. **Install curve warning signs on both approaches to the Boca Inlet Bridge; consider advisory speed reduction.**

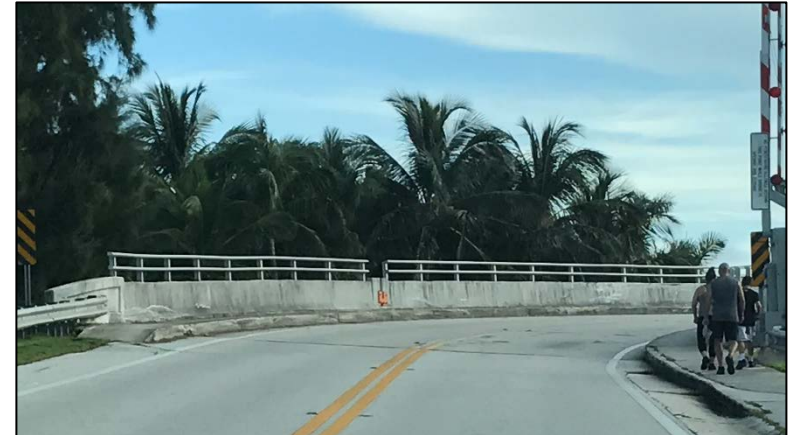
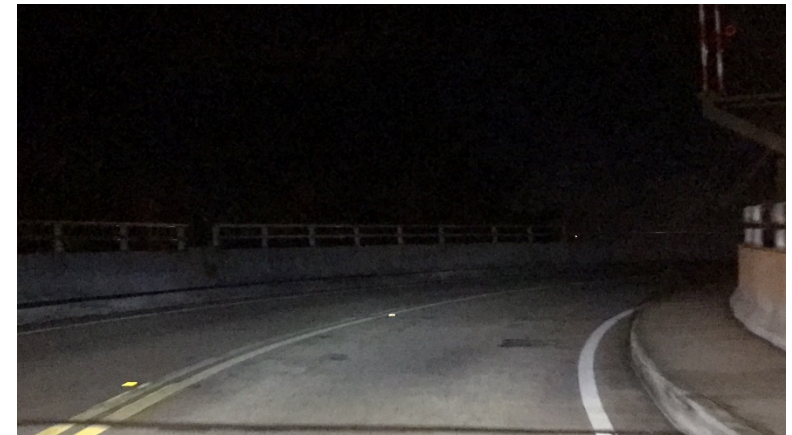
The barrier wall on the Boca Inlet Bridge does not have reflectors to delineate the bridge's curvature. Figure 10 and Figure 11 depict the southbound approach to the Boca Inlet Bridge during daylight hours and nighttime respectively.

Figure 10: Southbound Approach to Bridge Curve in Daytime

Figure 11: Southbound Approach to Bridge Curve at Nighttime

Per the FHWA's Low Cost Treatments for Horizontal Curve Safety, retroreflective material, such as reflector panels of retroreflective sheeting, can be a highly effective treatment for delineating curves, especially at nighttime. Five nighttime crashes were identified along the study bridge segment. **Install a reflective barrier delineation to better alert drivers of approaching S-curve along the Boca Inlet Bridge.** Note that on this two-lane road, the delineation would be white on both sides of the road to match the color of adjacent edge lines.

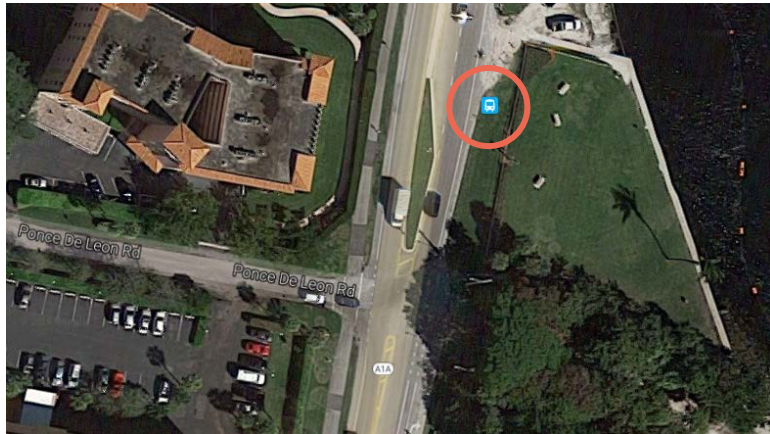
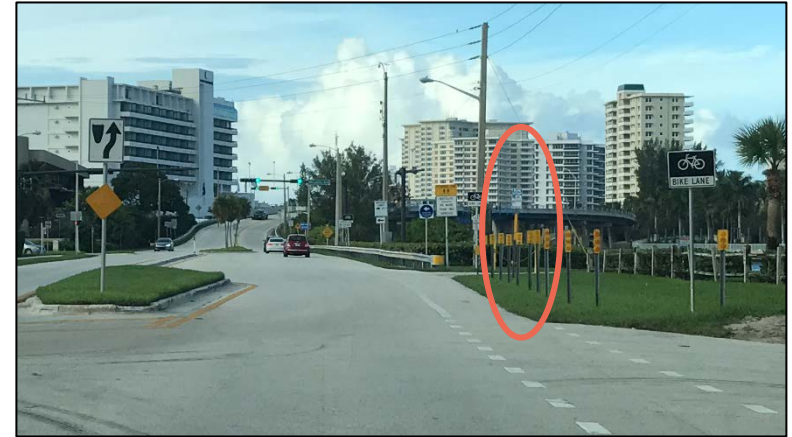
A bus stop currently is located on the east side of SR-A1A north of Ponce de Leon. Figure 13 and Figure 14 depicts the location of the northbound bus stop.

Figure 13: Northbound Bus Stop Location at Ponce de Leon

Figure 14: Northbound Bus Stop Image at Ponce de Leon

Concurrent with installing the planned mid-block pedestrian crossing (mentioned by City of Boca Raton staff during site visit) at Ponce de Leon, **coordinate with Palm Beach Transit to relocate the bus stop to the south** nearer the crossing at Ponce de Leon. Figure 15 depicts a concept drawing for the proposed mid-block crosswalk that will be implemented by FDOT.

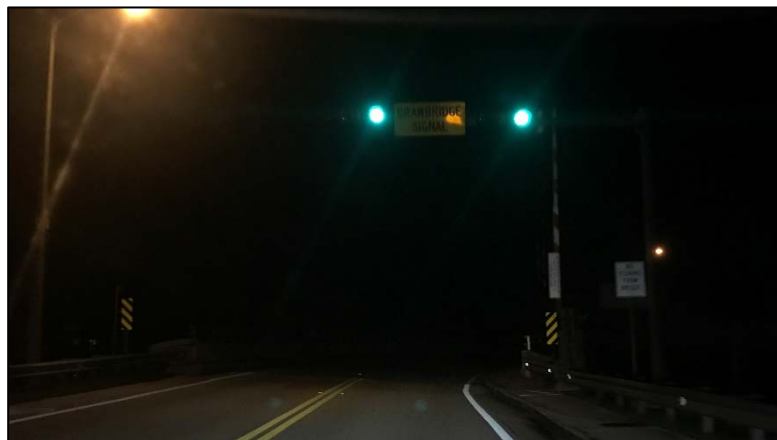
Figure 16: Drawbridge Signal Nighttime View

Figure 16 depicts a nighttime view of the southbound approach to the drawbridge signal along SR-A1A.

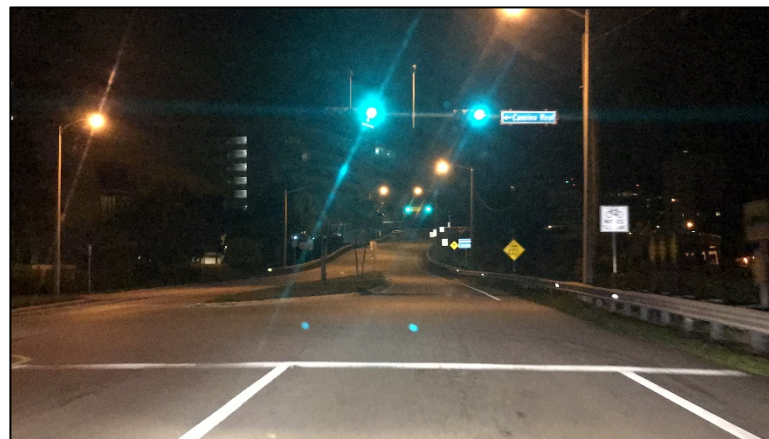
Figure 17: Northbound Approach to Camino Real at Night

Figure 17 depicts a northbound view at nighttime of the approach to Camino Real along SR-A1A (Ocean Boulevard). Per the Crash Modification Factor Clearinghouse, adding 3-inch yellow retroreflective sheeting to signal backplate reduces 15% of all urbanized area crashes.

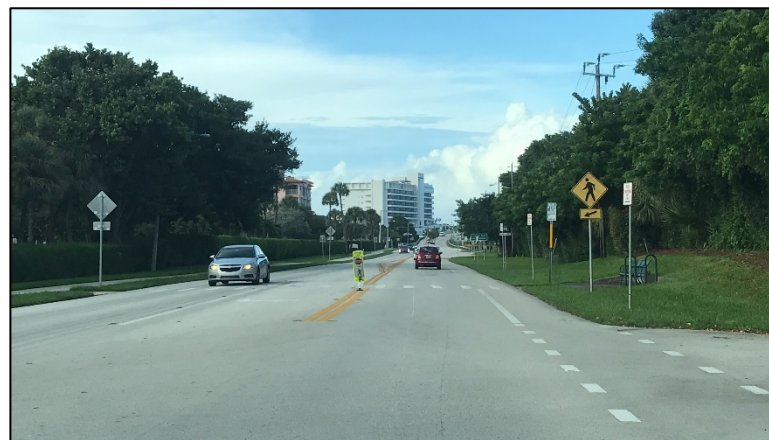
Figure 18: Mid-block Pedestrian Crosswalk

There are several mid-block crosswalks across SR-A1A (Ocean Boulevard) in the vicinity of the study area. Two crashes with a bicyclist were reported in the vicinity of the proposed and existing mid-block crossings.

Due to the two bicycle crashes, **conduct pedestrian turning movement counts to determine the feasibility of providing rectangular flashing beacons (RRFBs)** at the existing and proposed mid-block crossings. Per the FHWA's SA-09-009, RRFB are a lower cost alternative to traffic signals and hybrid signals and have been shown to increase driver yielding behavior at crosswalks significantly when supplementing standard pedestrian crossing warning signs and markings.

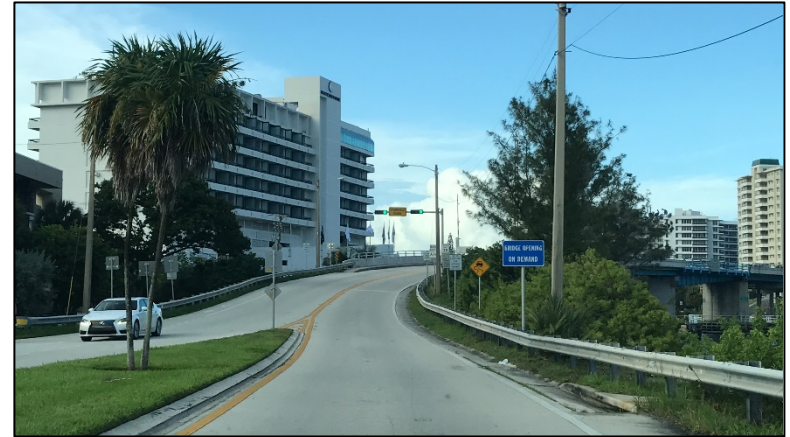
Figure 19: Northbound Approach to Bridge

In conjunction with the completion of the bridge rehabilitation work, sidewalks will need to be modified along SR-A1A on approach to the Boca Raton Inlet Bridge to access the new sidewalk on the bridge. Figure 19 depicts the northbound approach to the Boca Inlet Bridge; note that there are no sidewalks on either side of SR-A1A on the northbound approach. The eastside of SR-A1A has guardrail and drainage inlets.

Note that the work program project limits for the bridge rehabilitation work do not extend beyond the limits of the bridge. Due to the proposed drawbridge having sidewalks only on the east side, consider extending the limits of the drawbridge project south to the proposed mid-block crossing and north to Beach Club Way so the following can be considered:

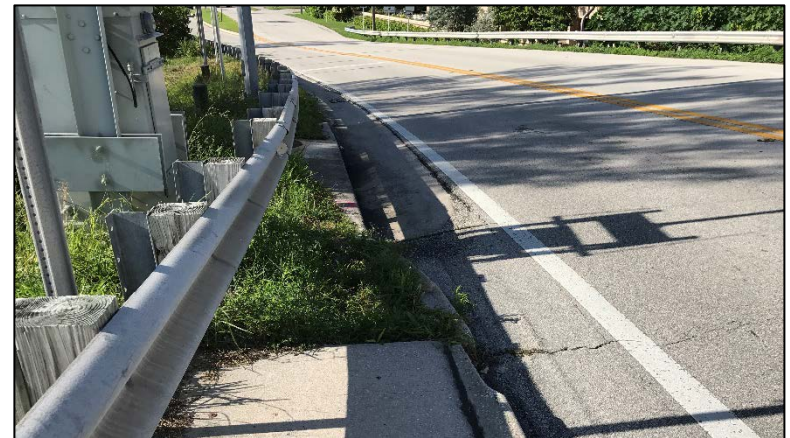
Figure 20: Southbound View on East Side of Bridge

Figure 20 depicts a view to the south at the southern end of the bridge from the east side of SR-A1A. This is the side of SR-A1A at which the only proposed sidewalk along the Boca Inlet Bridge will be after the rehabilitation project is complete.

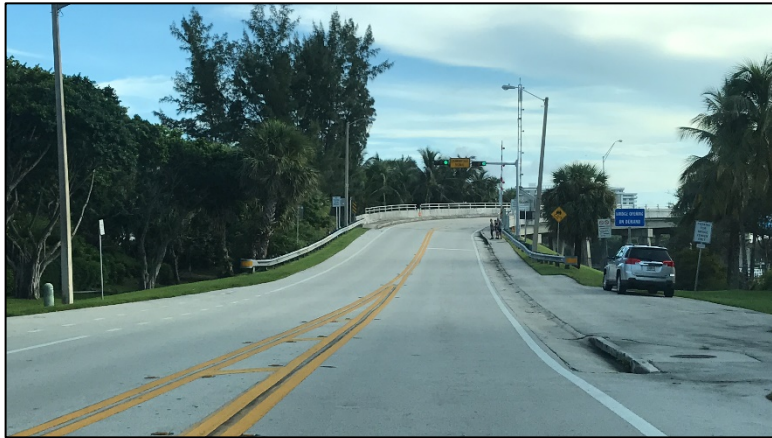
Figure 21: Southbound Approach to Bridge

Figure 21 depicts a view of the southbound approach to the Boca Inlet Bridge. The image shows a sidewalk on the west side of SR-A1A. This location currently does not meet Americans with Disabilities Act (ADA) standards as the sidewalk does not have a curb ramp and ends at a drainage inlet.

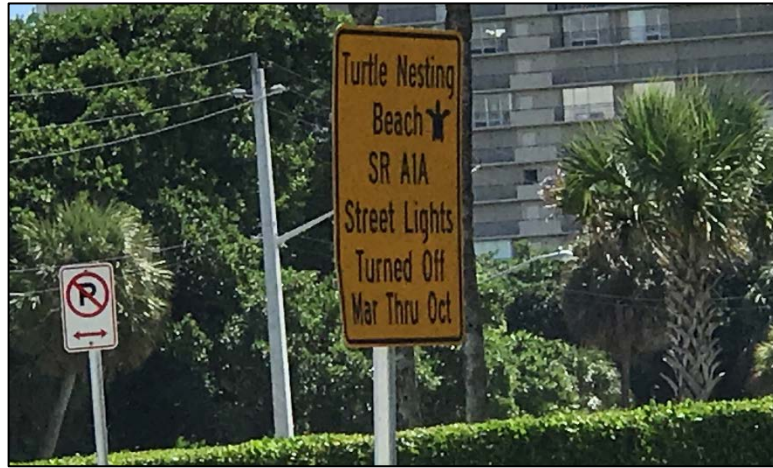
Figure 25: Sign Indicating Street Lights Turned Off for Sea Turtles

As shown in Table 1, a high number of crashes occurring during dark-lighted conditions. Signs were observed during field observations, stating that street lights are turned off from March 1st through October 31st to protect the endangered sea turtles during their nesting period. As shown in Figure 25 and Figure 26, the signs state that SR-A1A street lights are turned off during this period due to the close proximity to the beach. In addition, Section 23-242 of Boca Raton's lighting ordinances state the following:

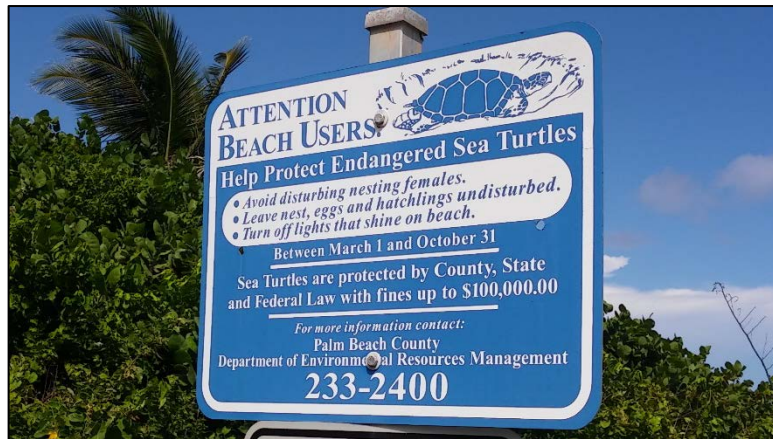
Figure 26 Sign Noting Sea Turtle Protection Warning Ordinance

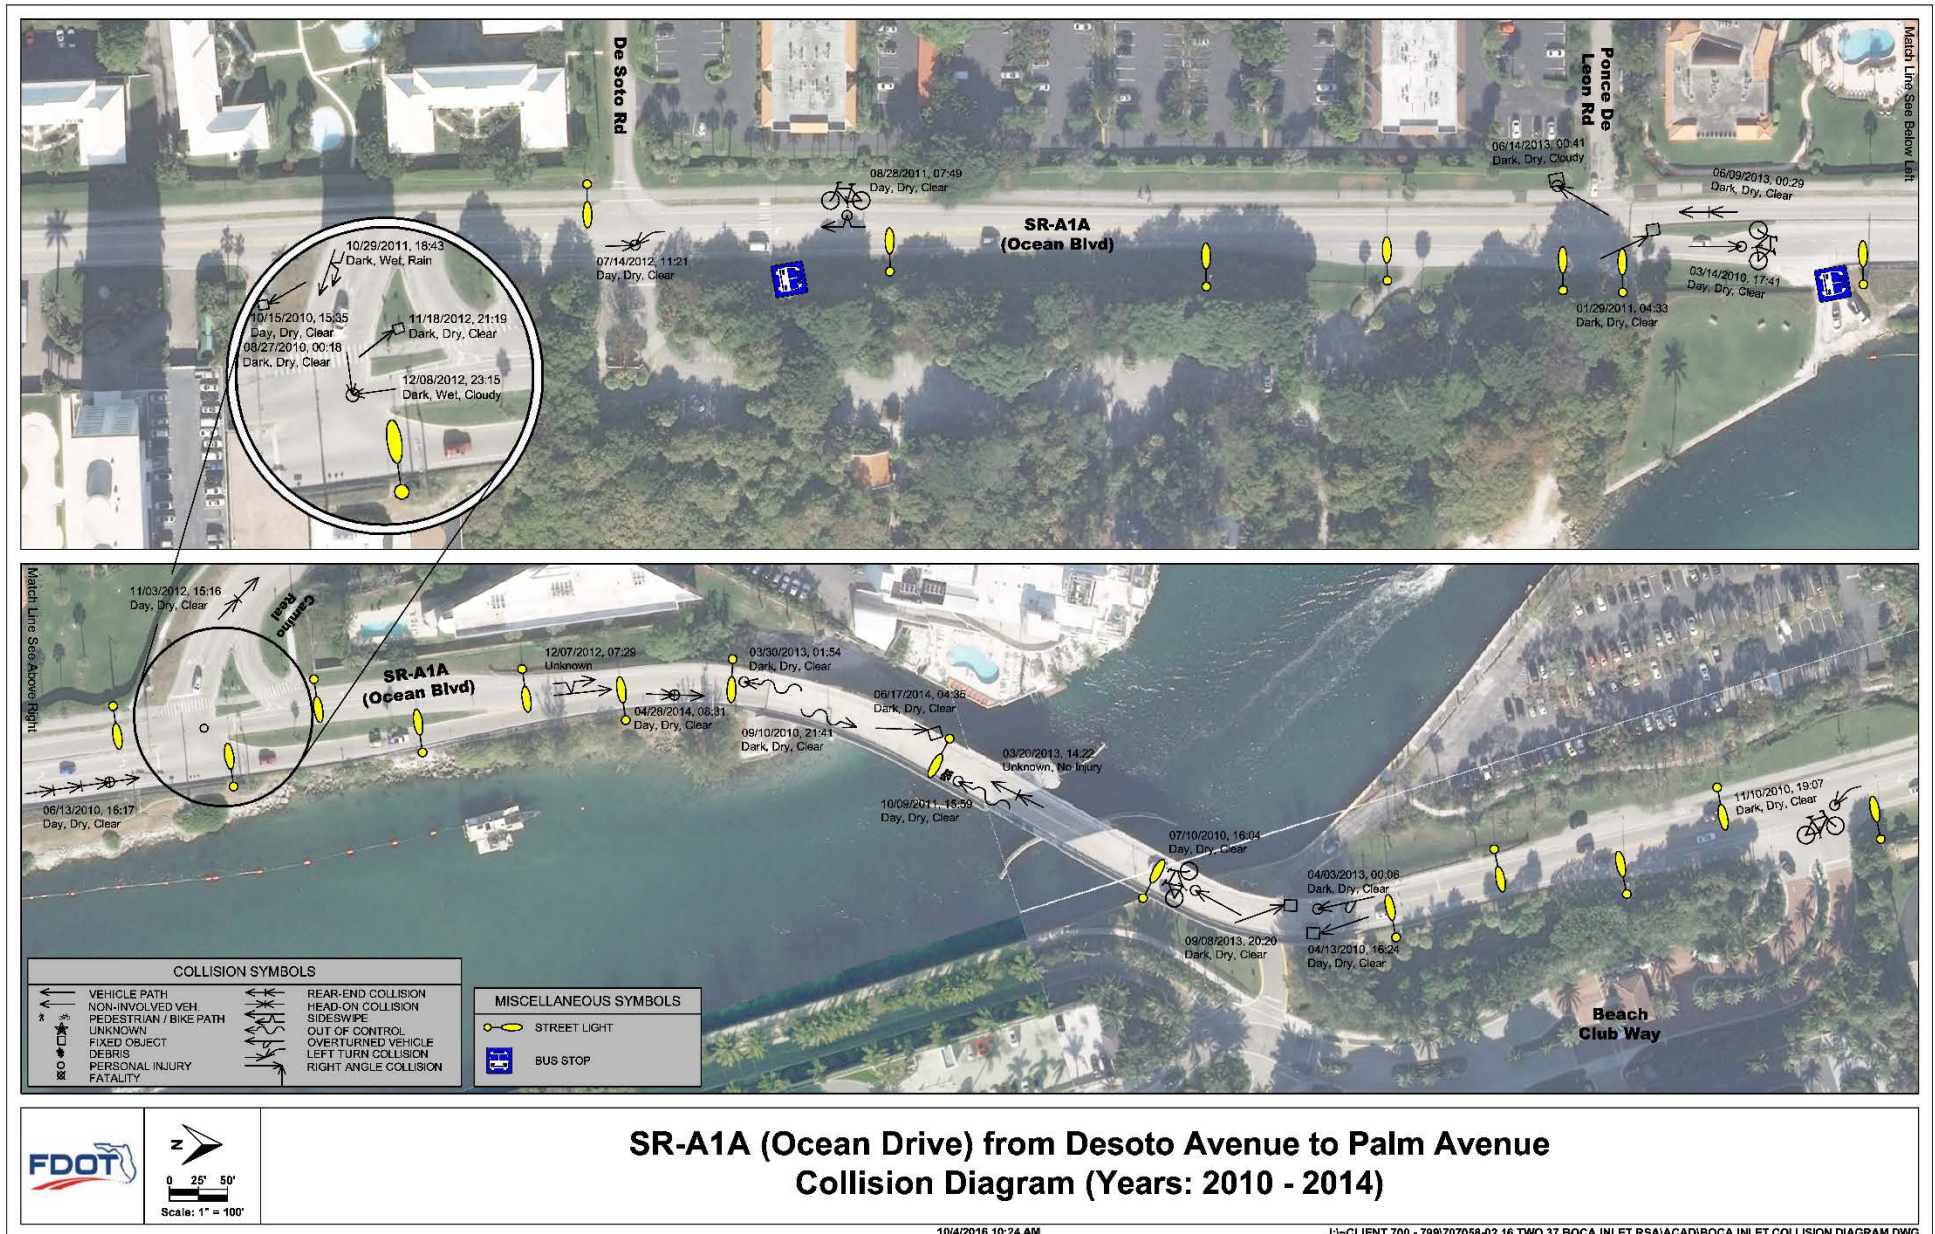
Figure 27: Collision Diagram (2010 to 2014)

Figure 27 depicts the 25 crashes reported along (SR-A1A / Ocean Boulevard) from mile post 0.894 (De Soto Road) to 1.409 (The Boca Beach Club).

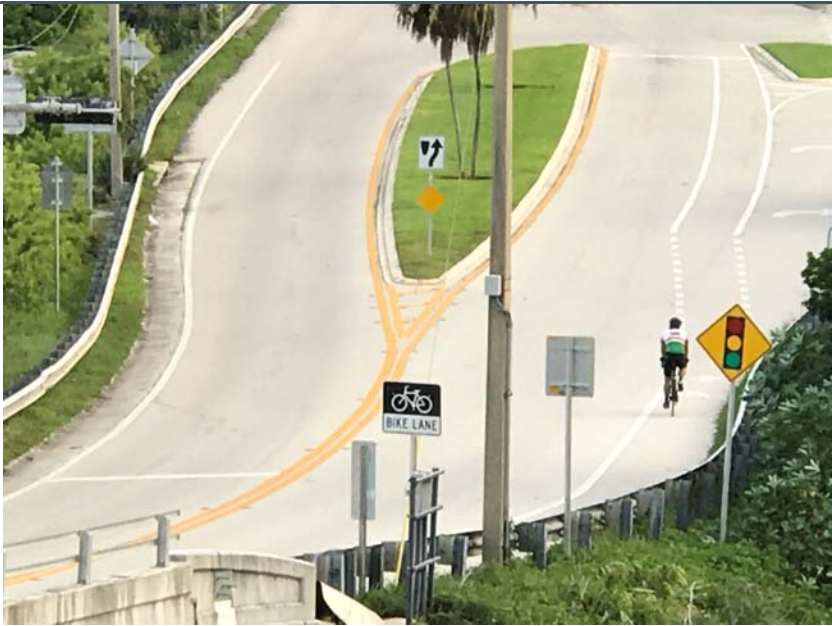
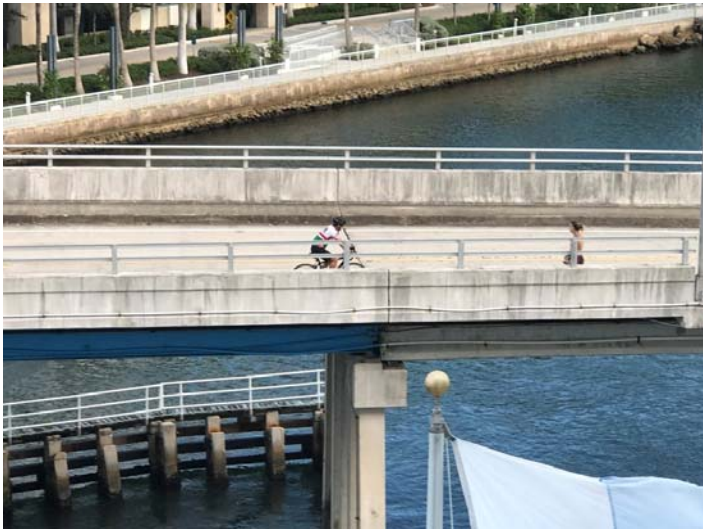
ID	Location Description:	Spot Observation Overview:	Suggestions for Consideration:
01	SR-A1A through lanes	Cyclists use both roadway and sidewalk	Provide sharrows

Bicycles were observed traversing the SR-A1A (Ocean Boulevard) bridge along both the paved shoulder and sidewalk. As a result of the nature of the nearby residential land uses, a mix of “recreational” and “enthusiasts.” Recreational cyclists were observed on the sidewalk traversing the bridge contraflow on the sidewalk. Enthusiast cyclists were observed traversing the Boca Raton Inlet Bridge along the paved shoulder. Pedestrians conflicted with cyclists on the sidewalk when cyclists travel along the sidewalk.

Providing “sharrows” along SR-A1A on the bridge segment where there are signs indicating that bikes may take the full lane, will further encourage cyclists to use the throughway and remind drivers that cyclists are allowed on the road. Note that there were four crashes reported that involved a bicyclist.

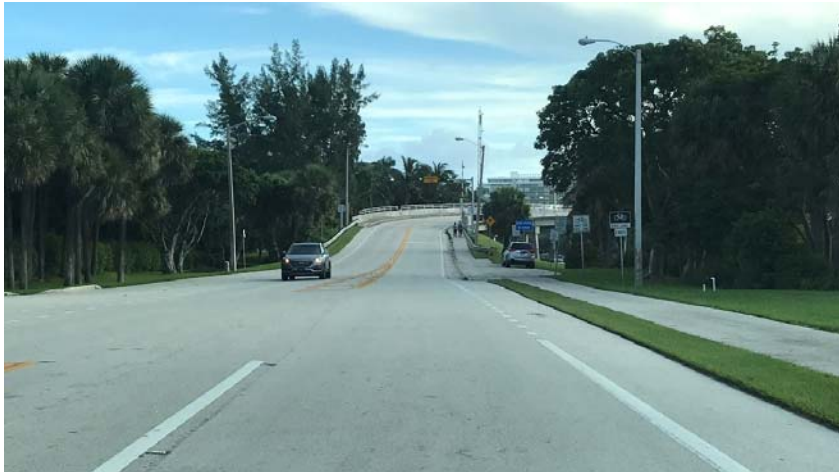
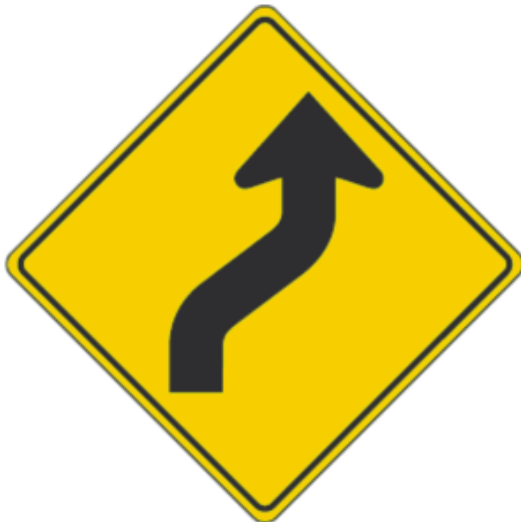
ID	Location Description:	Spot Observation Overview:	Suggestions for Consideration:
02	Northbound and southbound approach to bridge	No curve warning approach s-curve	Provide curve warning signs

<p>Spot Observation Details:</p> <p>There are no curve warning signs on approach to the S-curve along the Boca Inlet Bridge on either approach. Although the approach speed of 35 mph may seem comfortable along SR-A1A (Ocean Boulevard), the approach may be problematic, particularly for southbound drivers at night due to a dark spot in overhead street lighting. Three crashes were reported at each of the curves prior to the bridge. Per the Crash Modification Factor Clearinghouse, installing advance static curve warning signs reduces serious injury, and minor injury crashes by 30% and property damage crashes by 8%.</p>

<p>Suggestion Details:</p> <p>Install curve warning signs on both approaches to the Boca Inlet Bridge; consider advisory speed reduction.</p> <p>Note that there are currently fourteen signs on the southbound approach.</p>

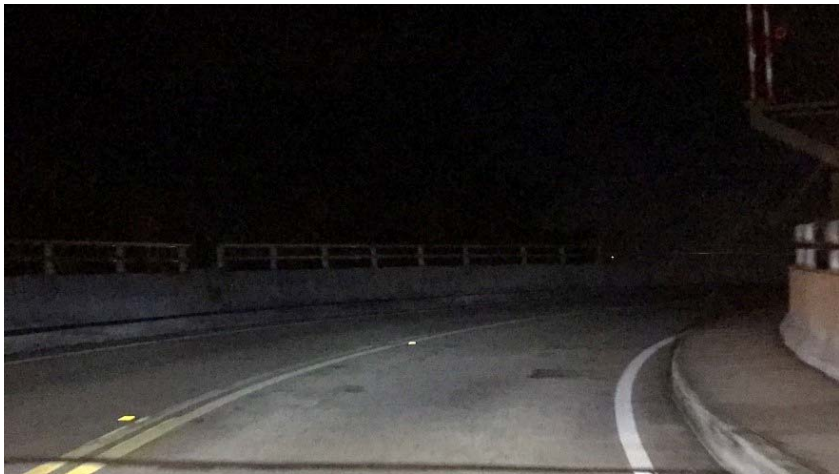
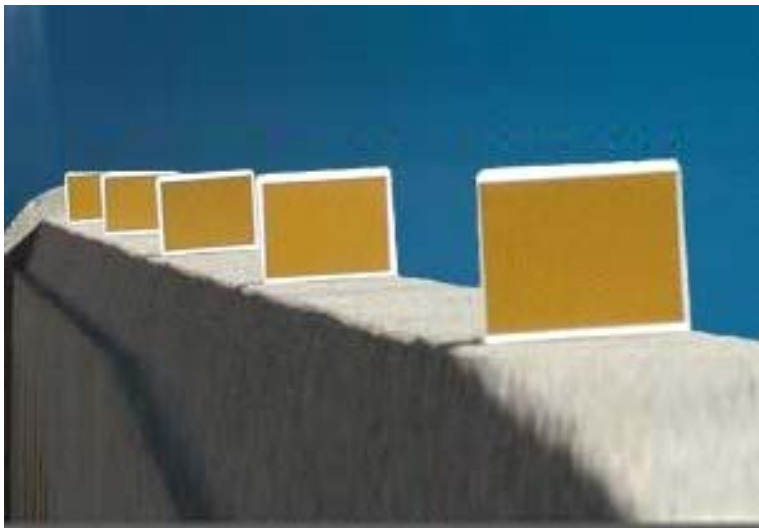
ID	Location Description:	Spot Observation Overview:	Suggestions for Consideration:
03	Barrier wall along bridge	No delineation	Provide reflective delineation

Spot Observation Details:	
The barrier wall on the Boca Inlet Bridge does not have reflectors to delineate the bridge’s curvature. Per the FHWA’s Low Cost Treatments for Horizontal Curve Safety, retroreflective material, such as reflector panels of retroreflective sheeting, can be a highly effective treatment for delineating curves, especially at nighttime. Five nighttime crashes were identified along the study bridge segment.	
Suggestion Details:	
Install a reflective barrier delineation to better alert drivers of approaching S-curve along the Boca Inlet Bridge. Note that on this two-lane road, the delineation would be white on both sides of the road to match the color of adjacent edge lines.

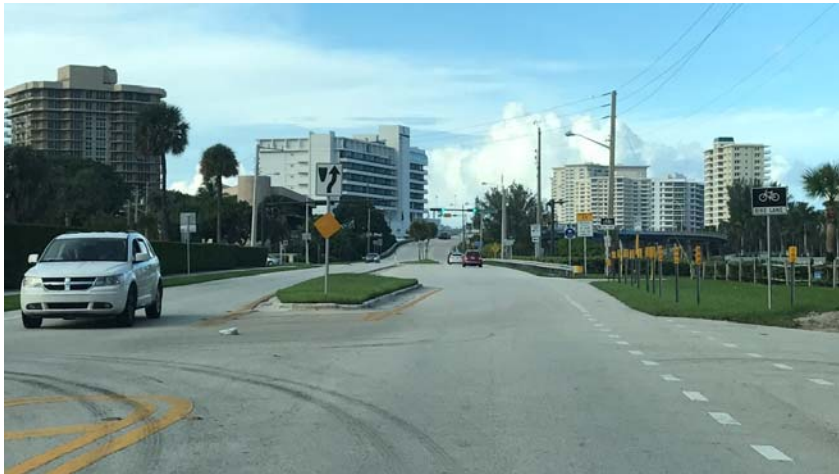
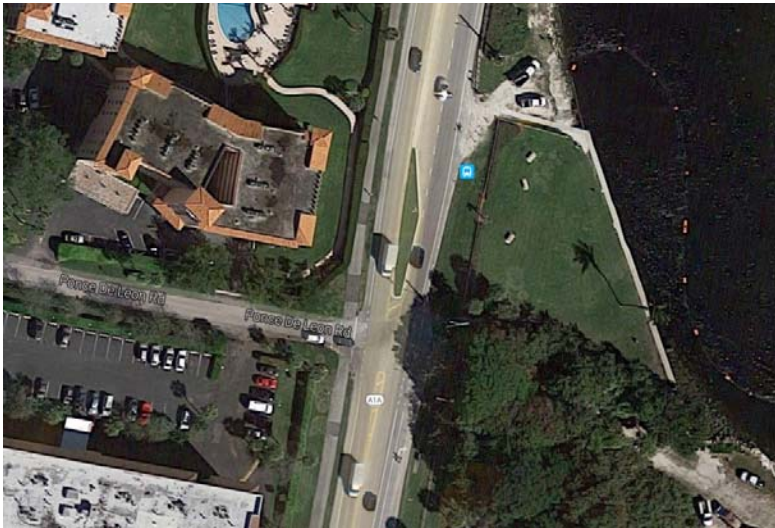
ID	Location Description:	Spot Observation Overview:	Suggestions for Consideration:
04	North of Ponce De Leon	Bus stop on east side of SR-A1A	Relocate south to Ponce De Leon

A bus stop currently is located on the east side of SR-A1A north of Ponce de Leon.

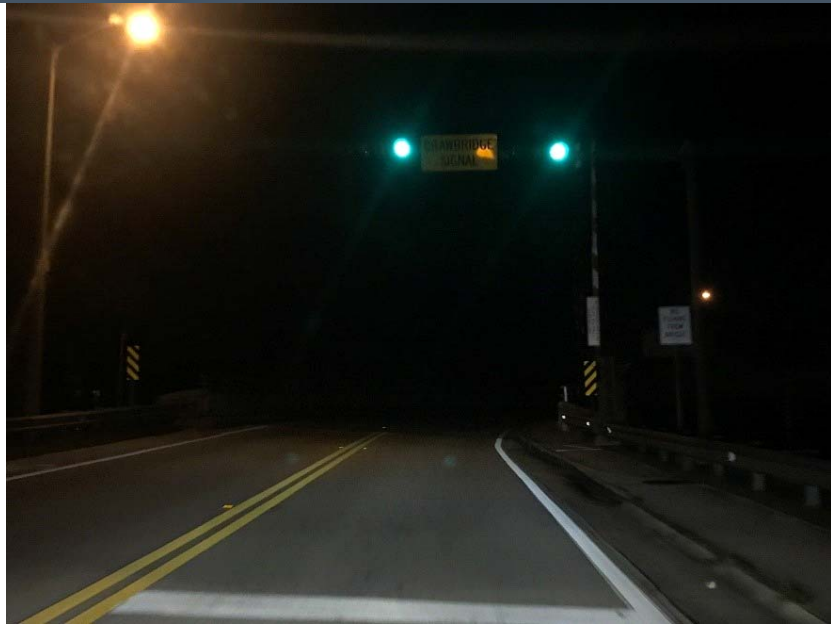
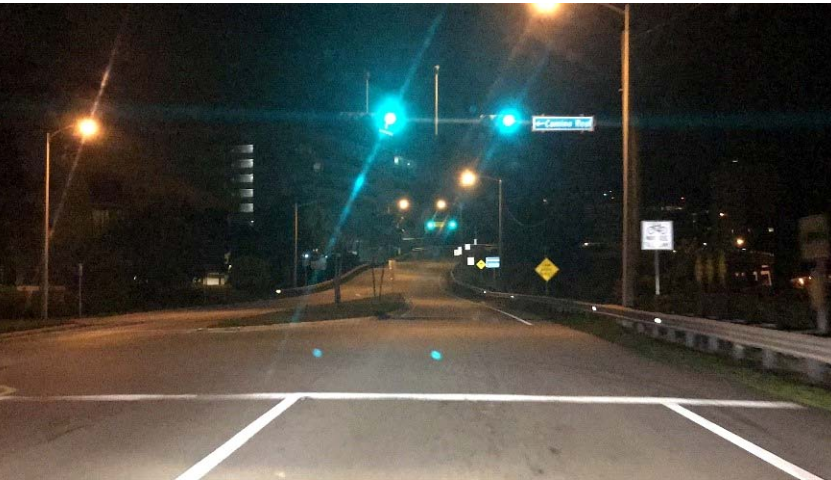
ID	Location Description:	Spot Observation Overview:	Suggestions for Consideration:
05	Signal head approaches	No backplates	Provide yellow backplates

Signal heads within the study area do not have reflective sheeting.

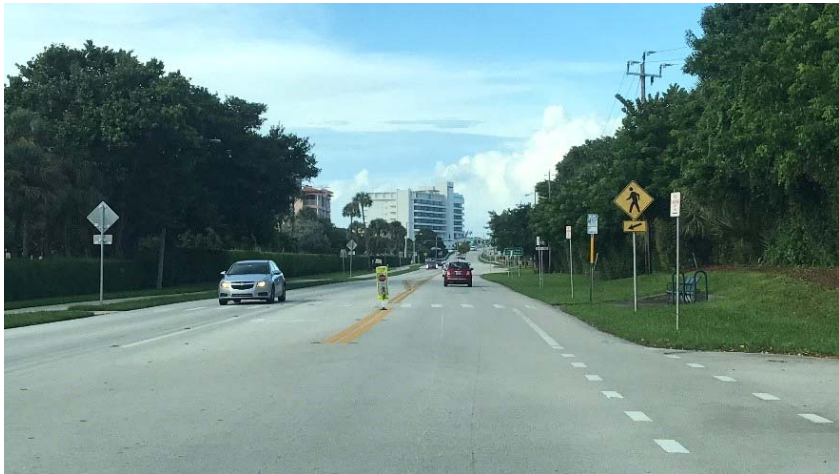
ID	Location Description:	Spot Observation Overview:	Suggestions for Consideration:
06	Mid-block crosswalks across SR-A1A	Unsignalized mid-block crosswalks	Consider RRFB
<div data-bbox="37 228 871 699">

Agency:	Improvement Type:
FDOT	Signal
Time Frame:	EEE:
Mid	Engineering
Level of Effort:	Comment:
Medium

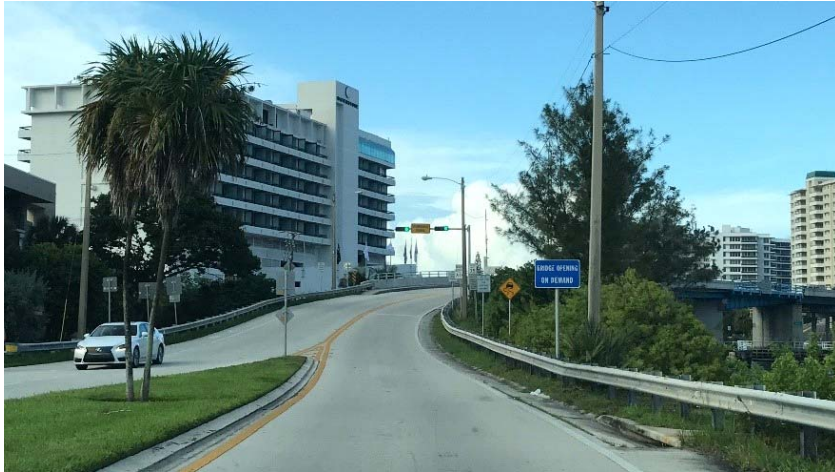
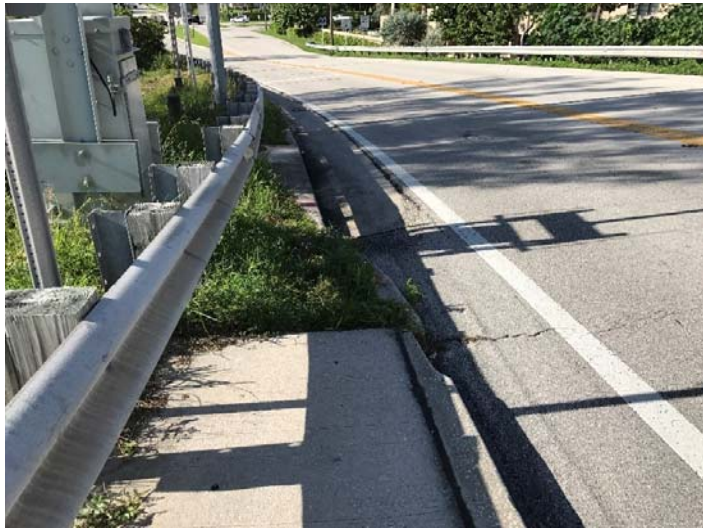
After the rehabilitation project is complete, only the east side of SR-A1A will have a sidewalk across the Boca Inlet Bridge.

In conjunction with the completion of the bridge rehabilitation work, sidewalks will need to be modified along SR-A1A on approach to the Boca Raton Inlet Bridge to access the new sidewalk on the bridge. Note that the work program project limits for the bridge rehabilitation work do not extend beyond the limits of the bridge.
