## ROAD SAFETY AUDIT REPORT

### SR-5/SR-A1A/US-1 (BROADWAY AVENUE) FROM 45<sup>TH</sup> STREET TO 59<sup>TH</sup> STREET

#### Palm Beach County, Florida

August 2019

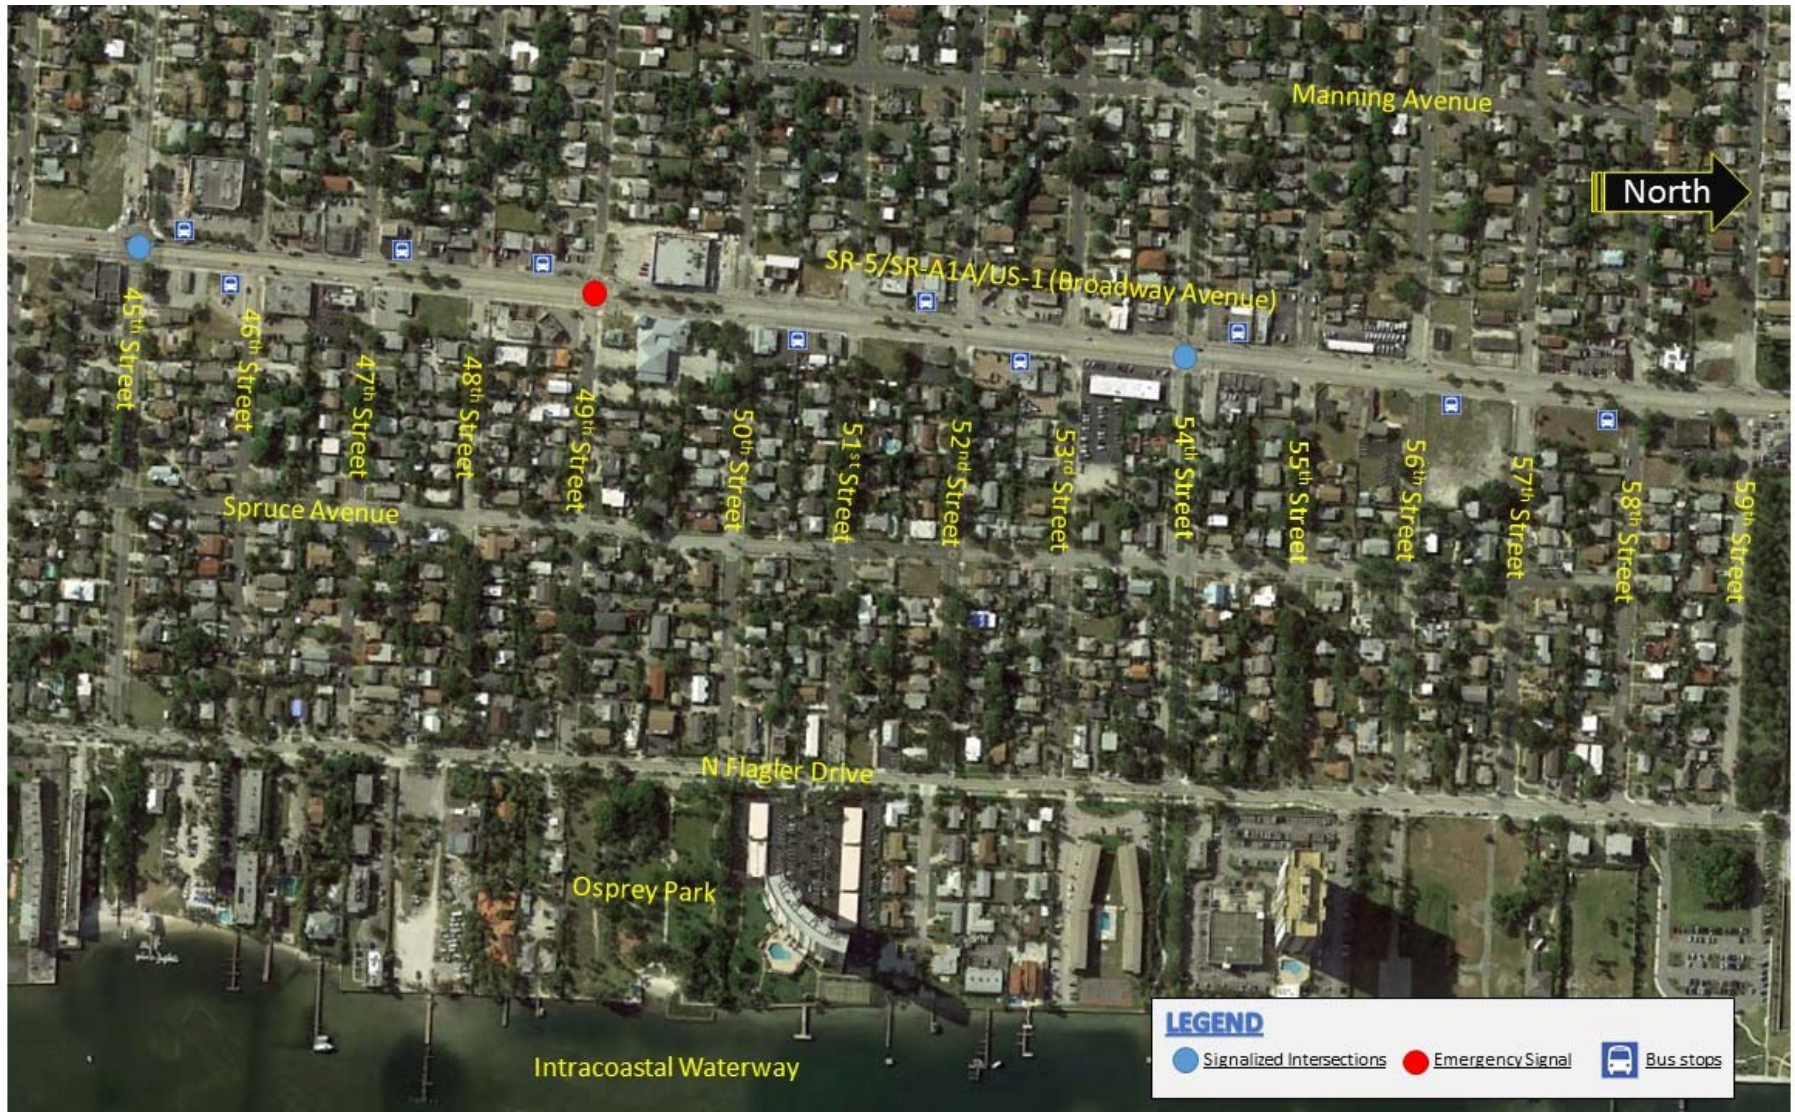
Figure 3: Existing Conditions Diagram

An existing conditions diagram of study corridor is shown in **Figure 4**.

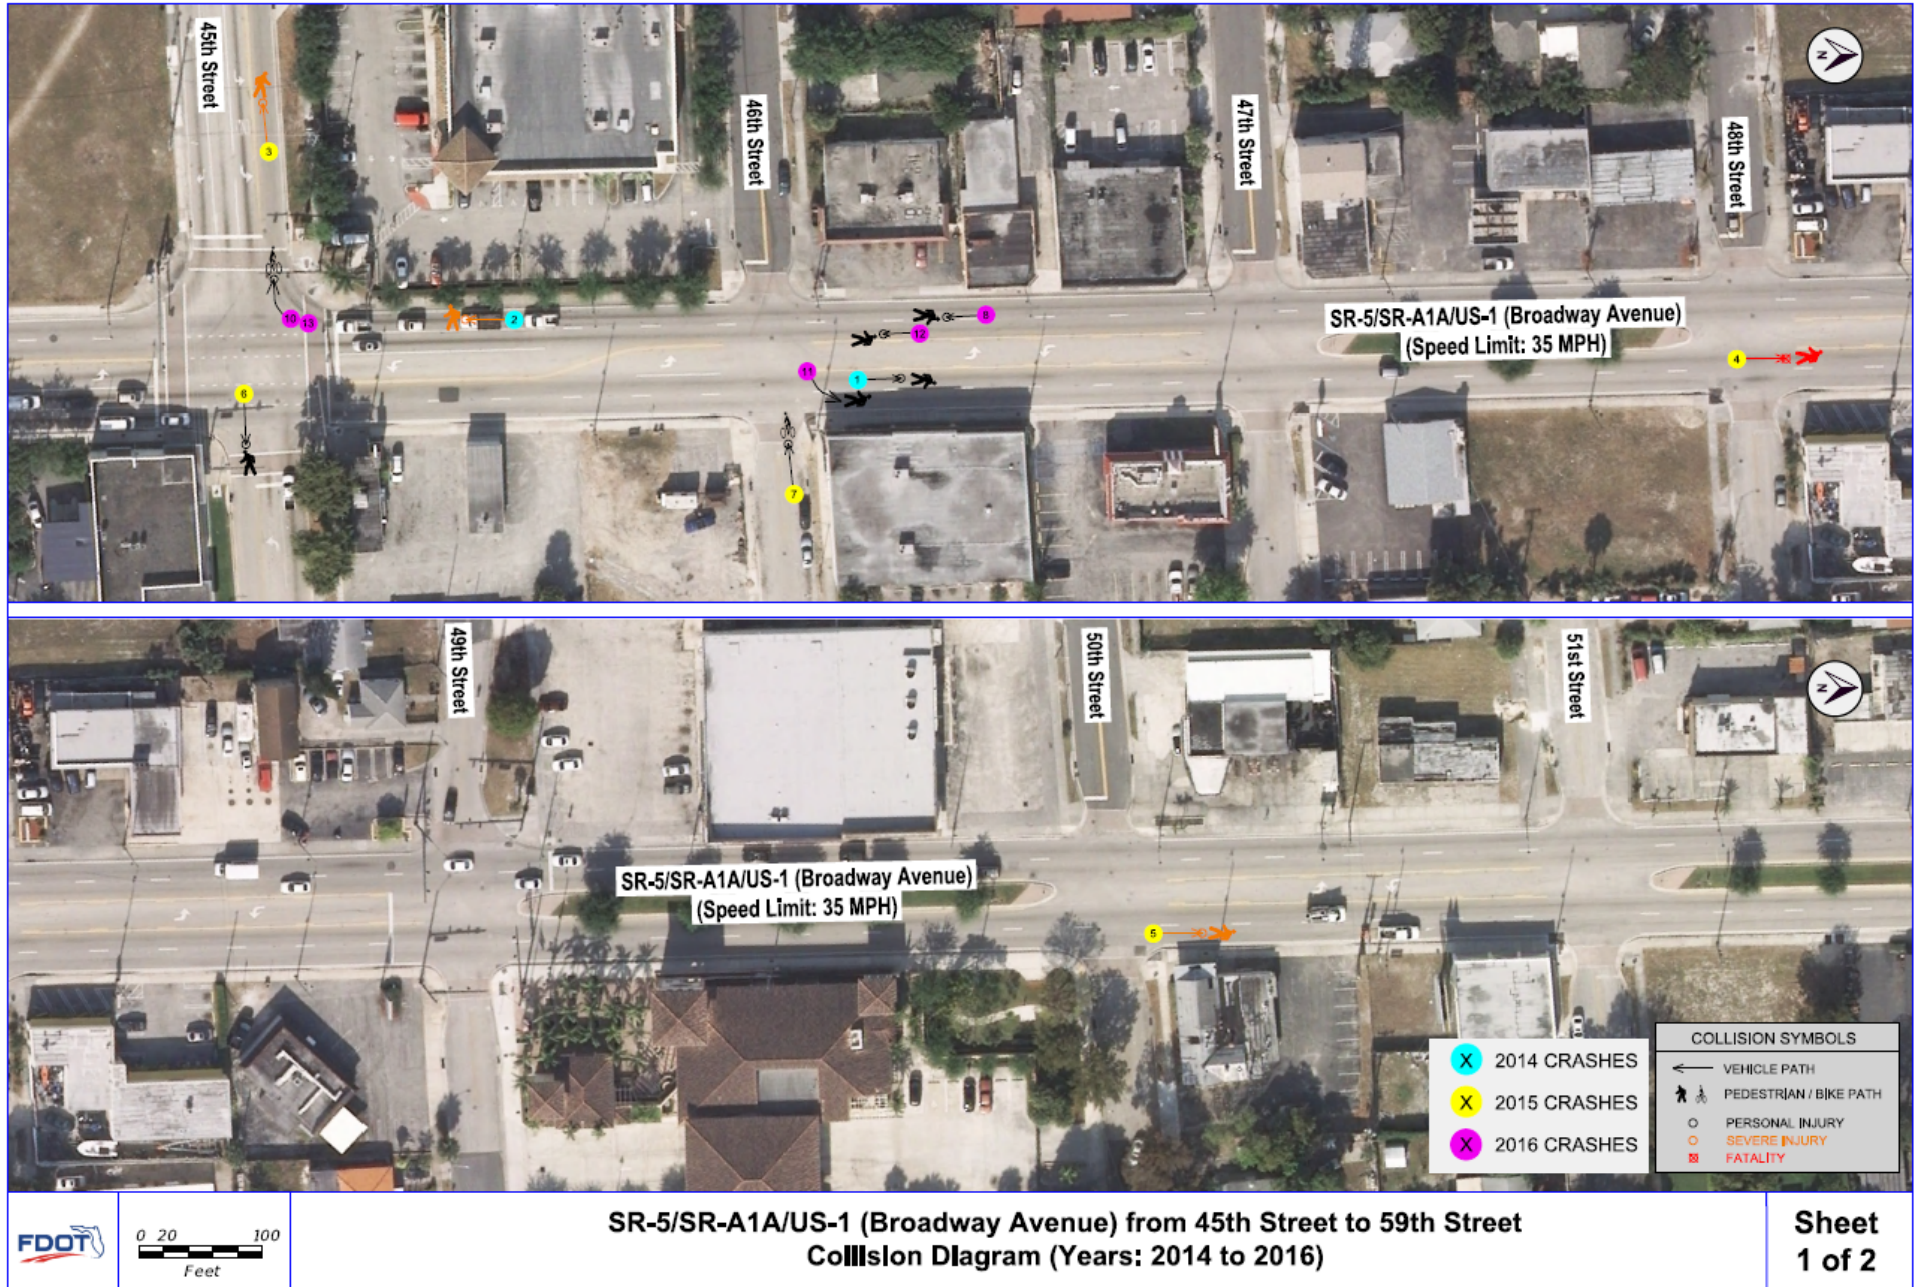
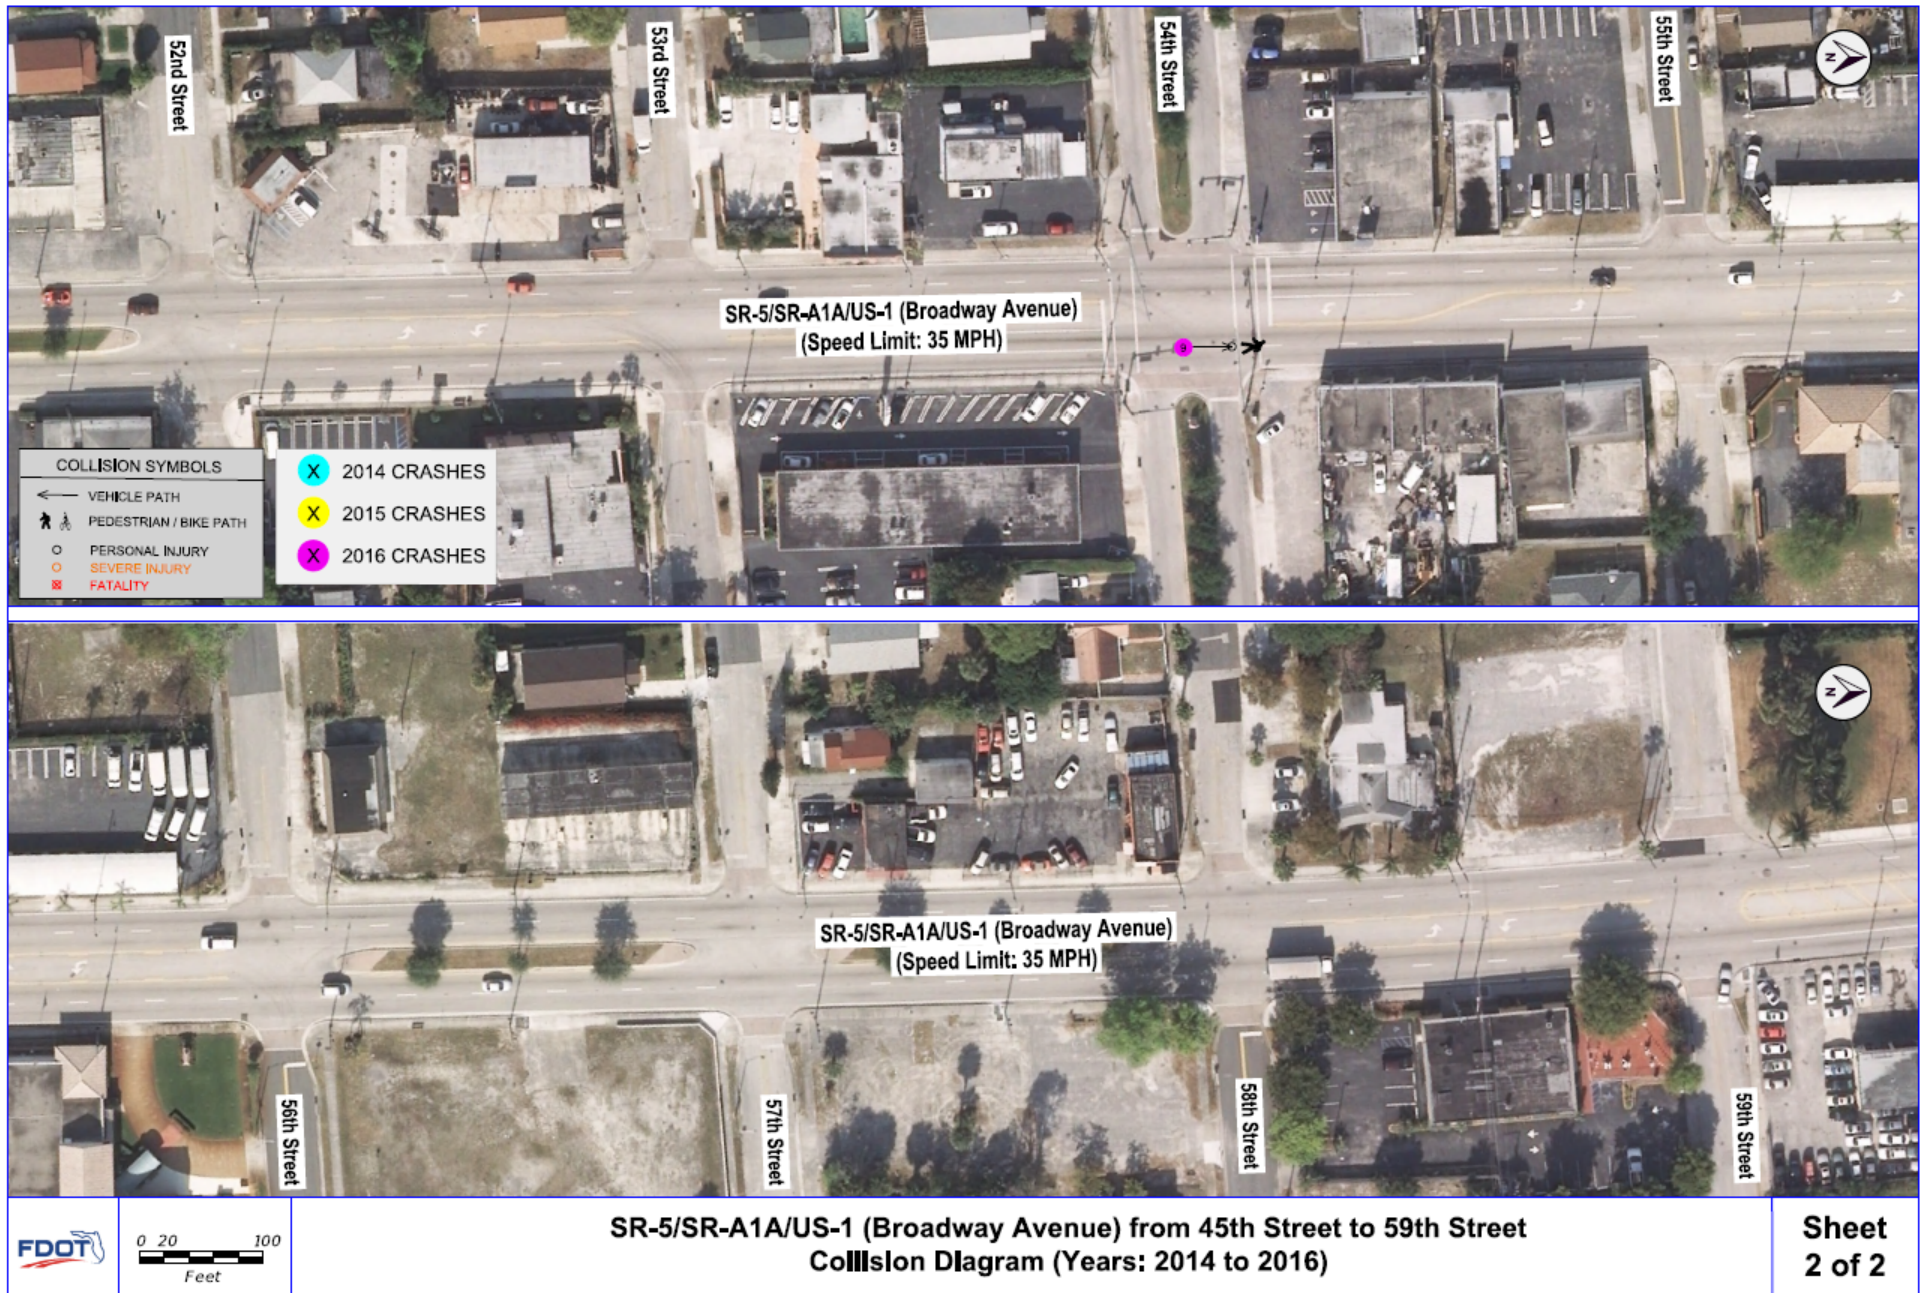
Figure 4: Pedestrian-Bicycle Crash Locations

- Descriptions of crashes indicated that the majority involved pedestrians crossing SR-5/SR-A1A/US-1 (Broadway Avenue) at mid-block or unmarked crosswalk areas near intersections.
- A total of 10 of 13 pedestrian/bicycle crashes occurred during periods of restricted lighting conditions.

Pedestrian and bicycle crash locations are presented in **Figure 4**.

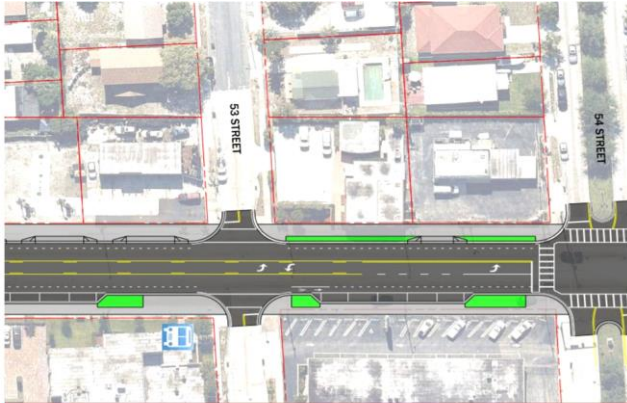
ID	Location Description:	Corridorwide Observation Overview:	Recommendations:
<b>C01</b>	SR-5/SR-A1A/US-1 (Broadway Avenue) from 45th Street to 59th Street	High pedestrian activity and pedestrian crossings	Evaluate new cross-section and lane repurposing

Example of proposed improvement plans from US-1 Multimodal Corridor Study.

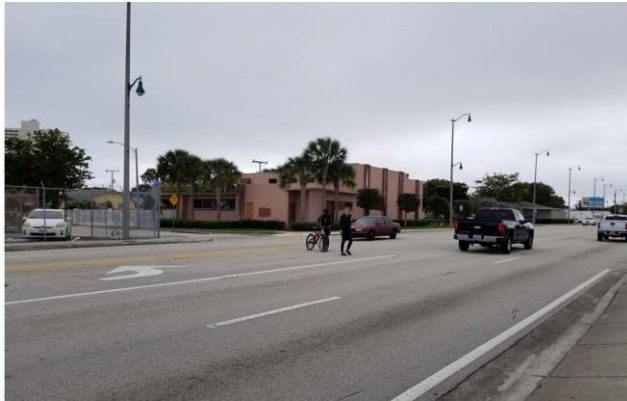
ID	Location Description:	Corridorwide Observation Overview:	Recommendations:
C02	SR-5/SR-A1A/US-1 (Broadway Avenue) from 45th Street to 59th Street	High pedestrian activity and pedestrian crossings	Conduct mid-block crossing study
		Corridorwide Observation Details:	
		Corridor experiences high pedestrian activity and mid-block crossings, including significant presence of children. Land use in area is mostly residential with small neighborhood business mainly located along SR-5/SR-A1A/US-1 (Broadway Avenue). High percentage of residents move through area by walking or bicycling.	
		Pedestrians were constantly observed staging in center lane while crossing SR-5/SR-A1A/US-1 (Broadway Avenue) due to absence of sufficient vehicular gaps.	
		Study corridor has only two existing protected crossings in a 3,700-foot stretch of roadway. Existing protected crossings are located at 45th Street and 54th Street.

Pedestrians staging in TWLT center lane.

Recommendation Details:	
		Evaluate feasibility of increasing presence of protected mid-block crossings along study area with installation of Rectangular Rapid Flashing Beacons (RRFB). Protected mid-block crossings will encourage pedestrians to use marked crosswalk and reduce number of unprotected mid-block crossings and will encourage vehicles to yield to crossing pedestrians and draw attention to sporadic crossings outside designated areas, also reducing speeding along R-5/SR-A1A/US-1 (Broadway Avenue).	
		Preliminary review and observations throughout the corridor suggest the following candidate zones for installation of protected mid-block crossing:	
		<ul style="list-style-type: none"> <li>- Zone 1: Between 46th Street and 48th Street</li> <li>- Zone 2: Between 50th Street and 52nd Street</li> <li>- Zone 3: Between 56th Street and 58th Street</li> </ul>	
		Guidance for purpose and requirements for installation of RRFB are provided in TEM Chapter 3, Section 3.8. Proposed zones figure is included in Appendix B.

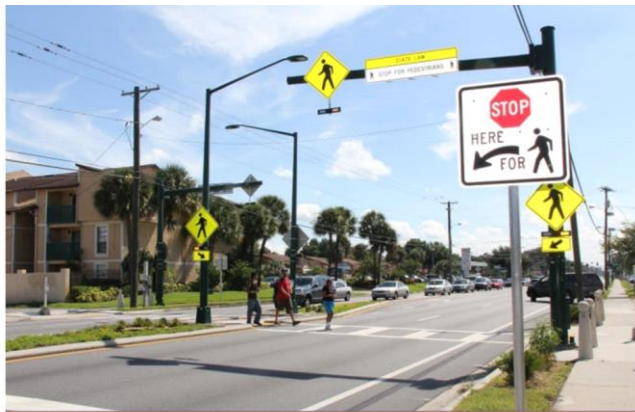
Example of mid-block crossing with RRFB and lighting.  
Excerpt from TEM Figure 3.8-2.

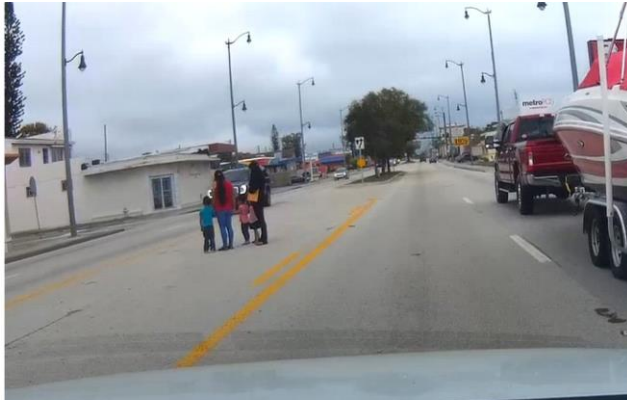
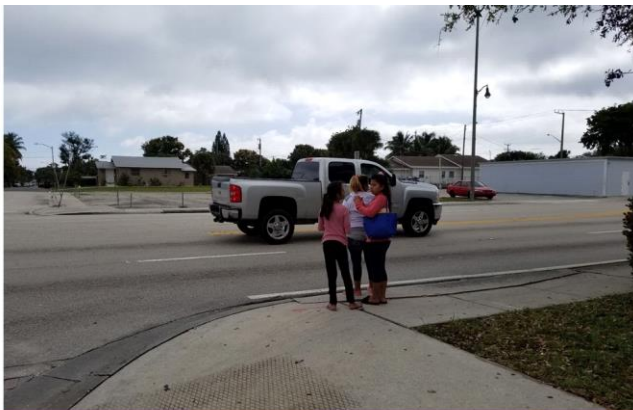
Group of pedestrians staging in TWLT center lane while crossing mid-block.

Pedestrian waiting to cross at an unmarked location at 46<sup>th</sup> Street. Looking east.

Pedestrians were constantly observed staging in center lane while crossing SR-5/SR-A1A/US-1 (Broadway Avenue) due to absence of sufficient vehicular gaps.

Evaluate with results of recommendation C02.

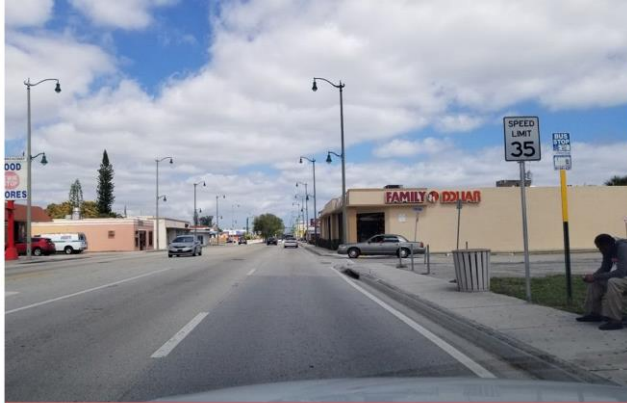
Pested speed limit along corridor is 35 mph.

Although not measured, vehicles appear to travel above posted speed limit during free-flow traffic conditions.

Conduct speed study. If study indicates significant speeding, review for countermeasures (i.e. speed feedback signs) to help reduce vehicular speeds. Consider extending this recommendation to section of SR-5/SR-A1A/US-1 (Broadway Avenue) from 25th Street to 45th street.

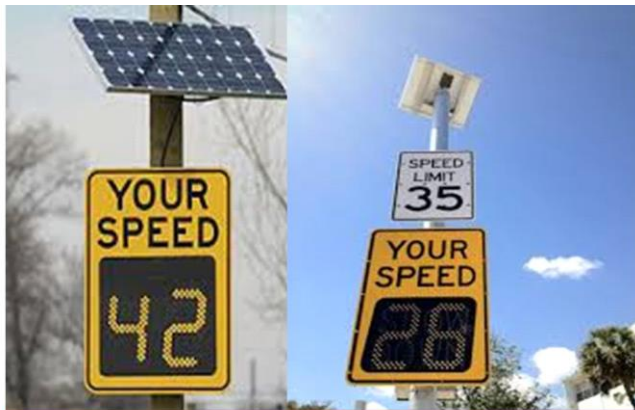
Example of speed feedback sign arrangements.

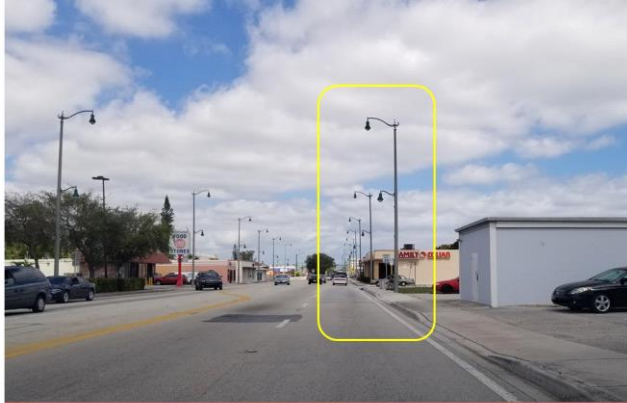
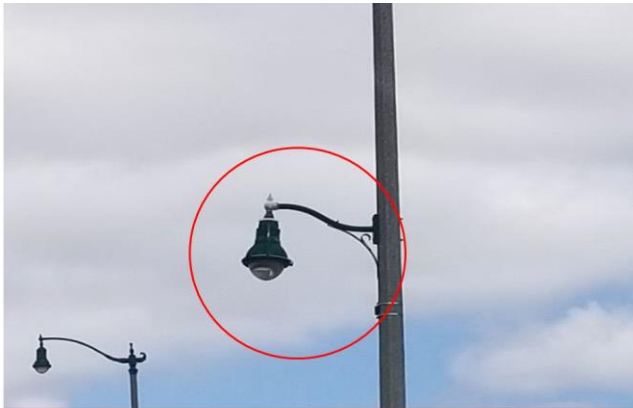
ID	Location Description:	Corridorwide Observation Overview:	Recommendations:
C05	SR-5/SR-A1A/US-1 (Broadway Avenue) from 45th Street to 59th Street	Crashes during nighttime periods	Conduct study to evaluate street lighting

Existing street lighting with pedestrian level lighting along study corridor.

Detail of existing lighting assemblies within study corridor.

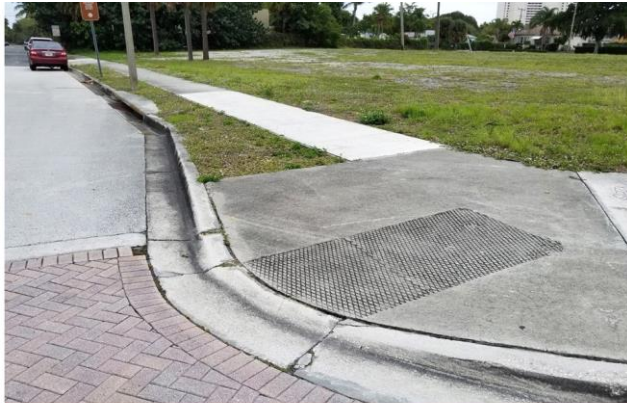
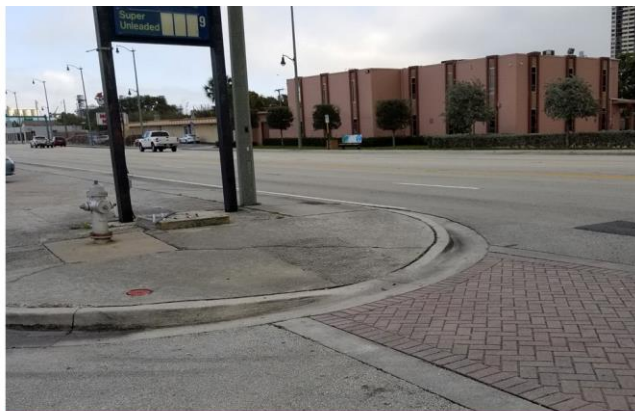
ID	Location Description:	Corridorwide Observation Overview:	Recommendations:
C06	SR-5/SR-A1A/US-1 (Broadway Avenue) from 45th Street to 59th Street	Pedestrian ramps and detectable warning surfaces not to standard	Upgrade pedestrian ramps to current standard

Typical curb ramp with substandard detectable warning surface along corridor.

Substandard detectable warning surface at 52<sup>nd</sup> Street. Looking north.

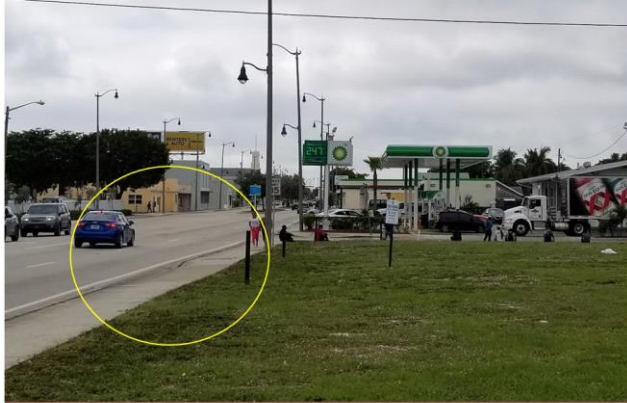
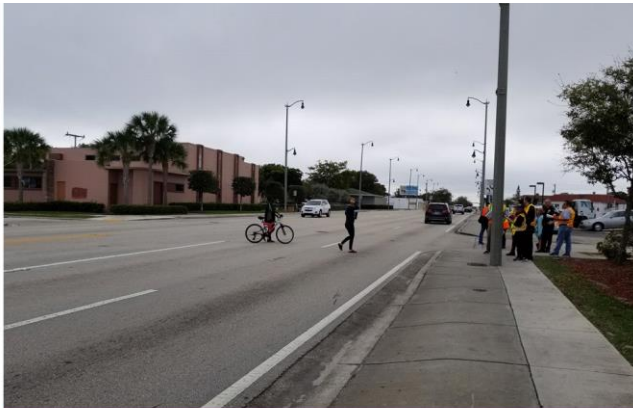
Drop curb/driveway leading to undeveloped parcel.

Drop curb with no access/driveway related.

Some driveways along the corridor appear to be not in use by any current business. Also, drop curbs can cause unsafe and uncomfortable conditions for bicyclists and other non-motorized roadway users, especially pedestrians with disabilities.

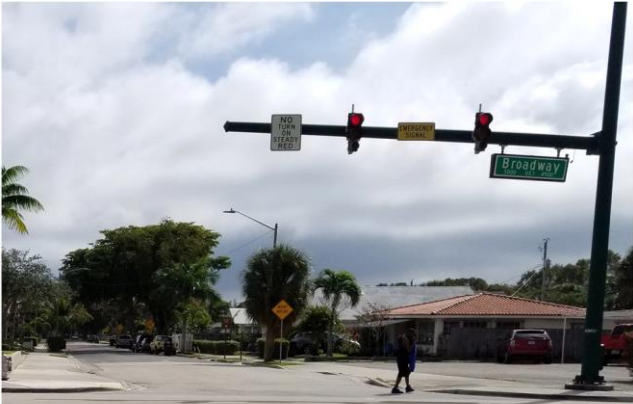
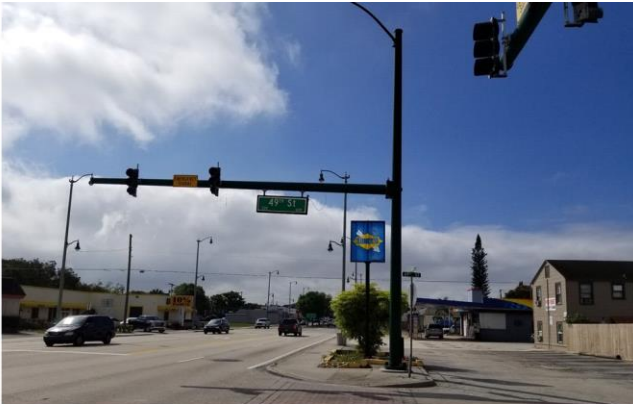
ID	Location Description:	Spot Observation Overview:	Recommendations:
01	SR-5/SR-A1A/US-1 (Broadway Avenue) at 49th Street	Existing Emergency Signal	Convert emergency only signal to pedestrian actuated signal/emergency signal
		<div>Spot Observation Details:</div> <p>Existing signal at this location functions only as emergency signal. This signal could potentially work as pedestrian actuated signal/emergency signal providing a protected pedestrian crossing. Closest pedestrian designated crossings are located 1,070 feet to south at 45th Street and 1,370 feet to north at 54th Street.</p> <p>High pedestrian crossing activity observed in area.</p> <div>Recommendation Details:</div> <p>Evaluate feasibility of retrofitting existing emergency signal to a pedestrian actuated signal/emergency signal. During evaluation process, a full signal installation will be considered.</p>	
<div>

</div> <div>Existing emergency Signal at 49<sup>th</sup> Street. Looking East.</div>

</div> <div>Existing emergency Signal at 49<sup>th</sup> Street. Looking South.</div>		<div>Agency:</div> <div>FDOT</div> <div>Improvement Type:</div> <div>Signal, Pedestrian</div> <div>Time Frame:</div> <div>Mid Term</div> <div>EEE:</div> <div>Engineering</div> <div>Level of Effort:</div> <div>Medium</div> <div>Comment:</div>

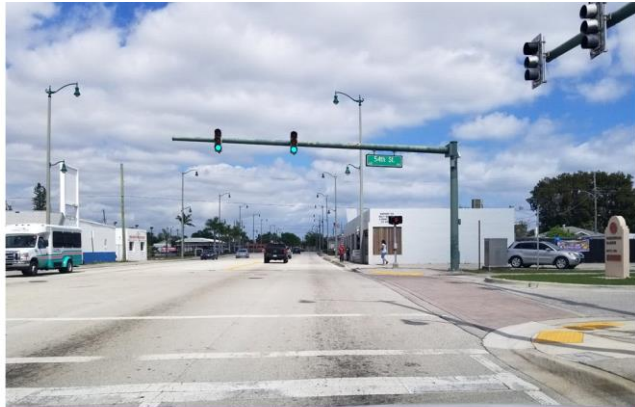
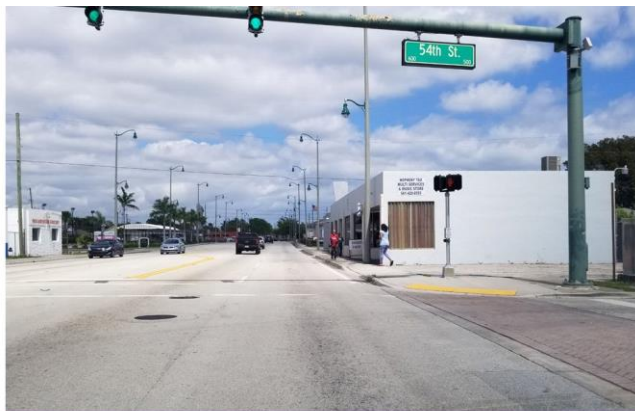
South leg crosswalk markings at 54<sup>th</sup> Street.  
Looking north.

North leg crosswalk markings at 54<sup>th</sup> Street.  
Looking north.

Crosswalk markings on north and south legs of this intersection are standard type and in poor condition.

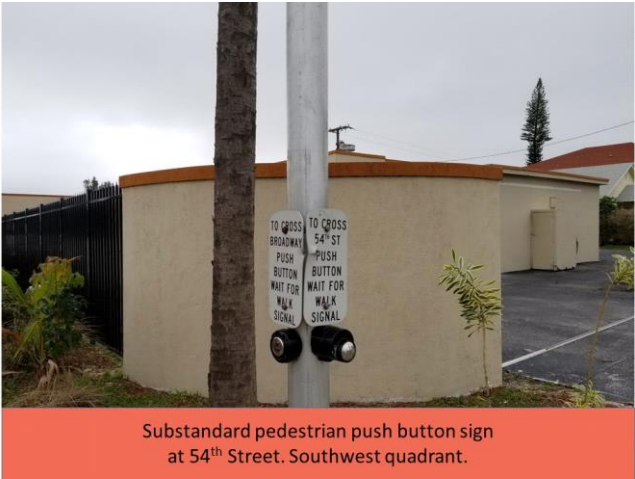
Substandard pedestrian push button sign at 54<sup>th</sup> Street. Southwest quadrant.

Replace and upgrade pedestrian push button signs.  
Current standard pedestrian push button signs are depicted in FDOT Standard Plans Index 700-102.

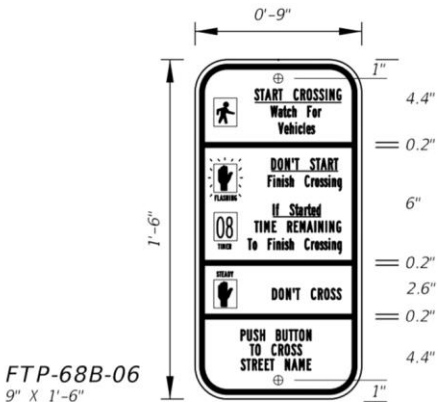
Example of push button sign.  
Excerpt from FDOT Standard Plans, Index 700-102.

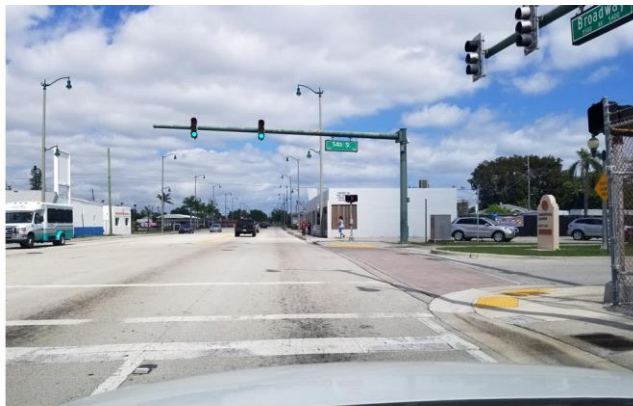
<p>Northbound approach at 54 Street. Looking north.</p></div>		<div>Spot Observation Details:</div> <p>No pedestrian signs are provided at the two intersections within study area.</p> <p>High pedestrian activity observed at these locations.</p> <p>Crash data showed two crashes involving turning vehicles and bicyclists in crosswalk at 45th Street.</p> <div>Recommendation Details:</div> <p>Install ground-mounted pedestrian signs (R10-15) to warn drivers of pedestrian presence while performing turning movements.</p>
